Doc SB STC 10070970-1 Issue 09.08.2022
---	---

## Service Bulletin SB STC 10070970-1

LS4 and LS4-a, all Serial Numbers on which the modification acc. STC 10070970 is installed

LS6, LS6-a and LS6-b all Serial Numbers on which the modification acc. STC 10070970 is installed

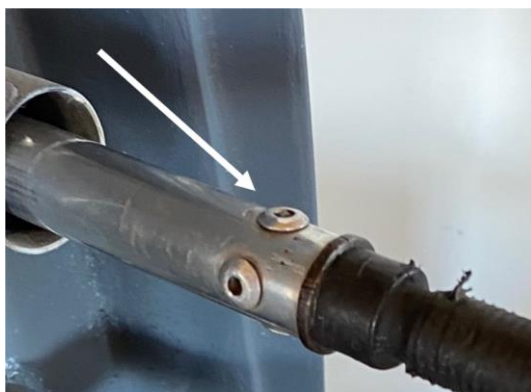
On one of the affected series (LS4), the connecting device of the airbrake control rod broke in the area of the root rib due to incorrect assembly (a thread was drilled off-center). Since it cannot be ruled out that the threads for the ball heads on other aircraft were also drilled off-center and thus incorrectly, this Service Bulletin is published.

Picture 1: Installation situation old fittings

- 3.2 Drill out the found, riveted-in connection devices (the existing ones with the external thread) with the drill and the steel drill, diameter 4 mm. Be very careful when doing this, because later the newly supplied and modified connection piece will be inserted and riveted in the same position.

- 3.3 Now pull the respective connection device out of the control rod. The old connection heads are glued in the push rods by epoxy resin. To loosen this bond, it may be needed to use a heat gun to heat the connection head to max 100° C., before pulling out the head from the push rod. When doing so, make sure that the ball head is not damaged, as this will be used again later.
