**Glaser-Dirks Flugzeugbau GmbH**  
Im Schollengarten 19-20, 7520 Bruchsal 4  
Telefon 07257-1071 Telex 7822410 GLDG  
LBA anerkannter Herstellungsbetrieb IB 25  
LBA anerkannter Luftfahrttechnischer Betrieb IIA 279.

Technical Note

No 301/12

Subject: Emergency release mechanism of the one piece canopy

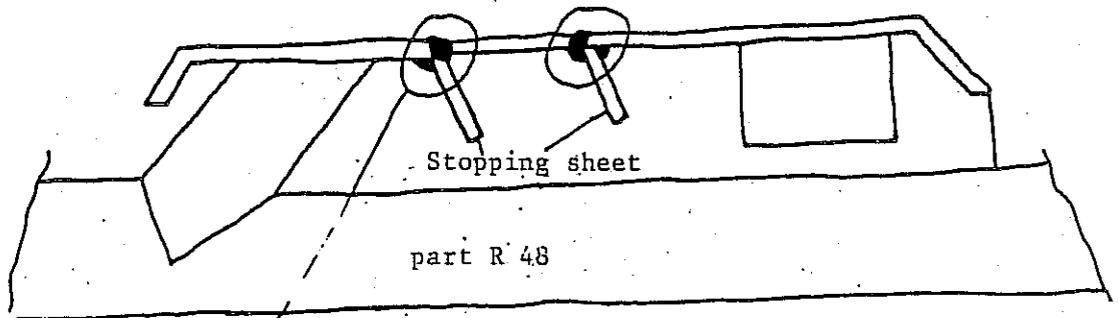
B 1) Inspect the welds of the stopping sheet at the fuselage side - canopy fitting (look at the scetch).

If they are projekting, You have to file them flat. (Protect the filed area with a rust protection paint afterwards. )

File the weld flat

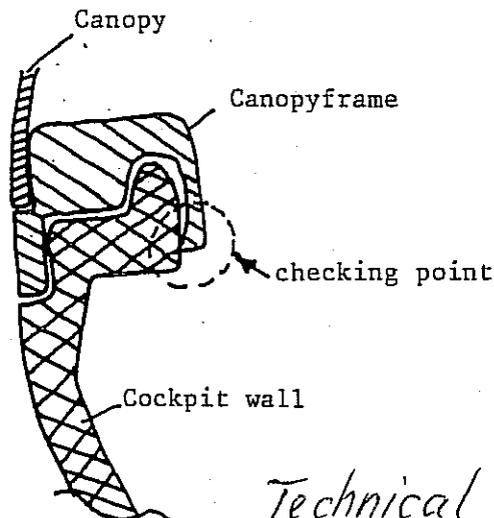
B 2) If this work was unsuccessful, You have to check, wether the canopyframe undercuts at the inner bead in the front sector. (look at the scetch)

wrong

right

If there are undercuts, (You can see it exactly at the rubpoints at the canopyframe and the cockpitwall) You have to eliminate them by sanding with an abrasive paper (60 Grit).

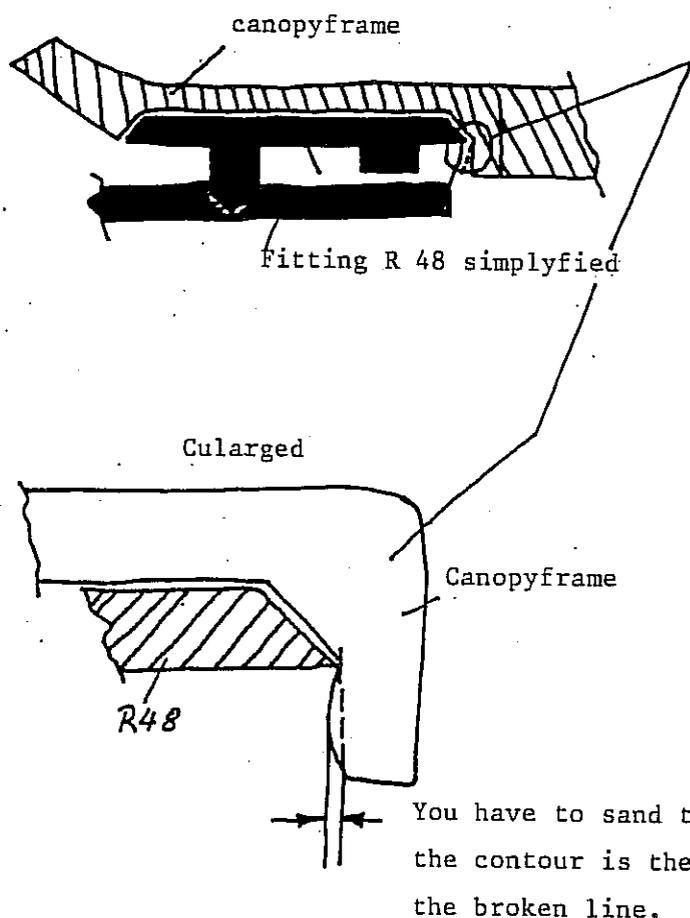
B 3) If there are no undercuts, You have to chek, wether the canopyframe undercut in the rear of the canopy fitting (part R 48).
