Subject: Aileron control in the cockpit

Effectivity: DG-100 and DG-100 G W.-Nr. 42 - 83

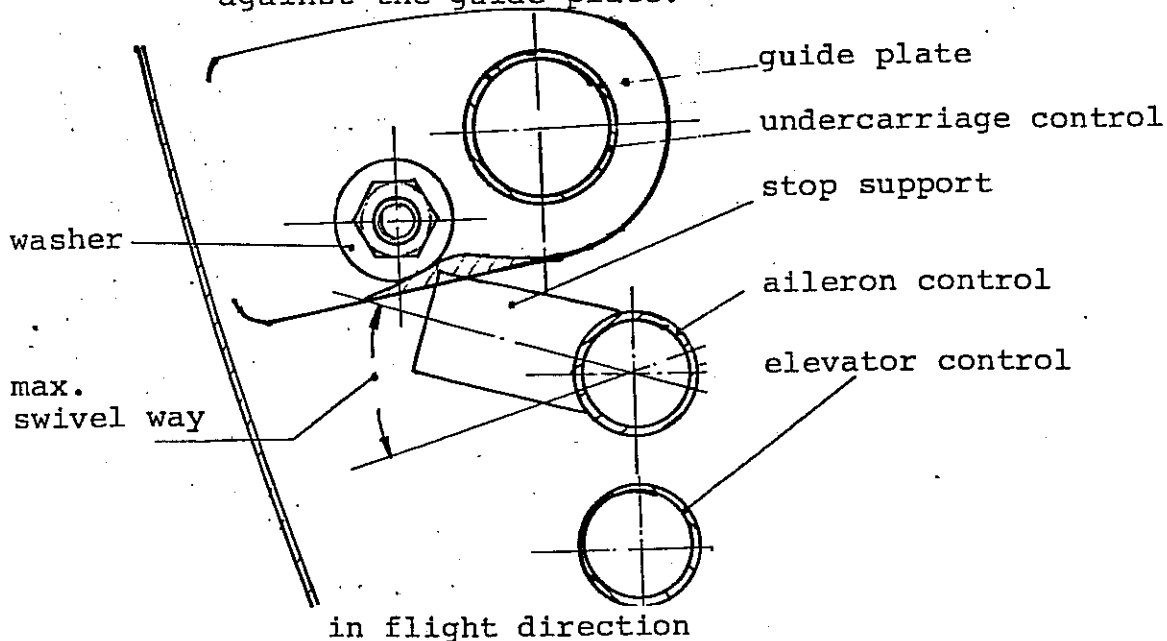
Reason: If the guide plate of the under-carriage control push rod is not filed out enough, the stop support of the aileron control push rod may butt against it.

(Pushrod turned upwards to the most unfavorable position, see figure)

This might happen during flight conditions under negativ -g- loads.

- Instructions:
1. Remove the left side covering in the cockpit.
  2. Turn the aileron control pushrod upwards (see figure) and check the stop support for butting against the guide plate.

3. If the stop support push<sup>s</sup> against the hatched region of the guide plate, file out this region. If necessary change the installed washer (outside diameter 18 mm) against one with outside diameter 12 mm. (6,4 DIN 125).
4. clean the area of filings
5. reinstall the side covering
6. Book the executed work in your log book.
