**Subject:** elevator control (bearing stand RU 19)  
**Effectivity:** DG-100 and DG-100 G W.-Nr. 5, 21 - 103  
**Accomplishment:** Before the next flight  
**Reason:** If a washer 6,4 DIN 9021 is not installed in the bearing stand RU 19 it is possible that the elevator control lever might loosen.

Exchange of the elevator control bearing stand

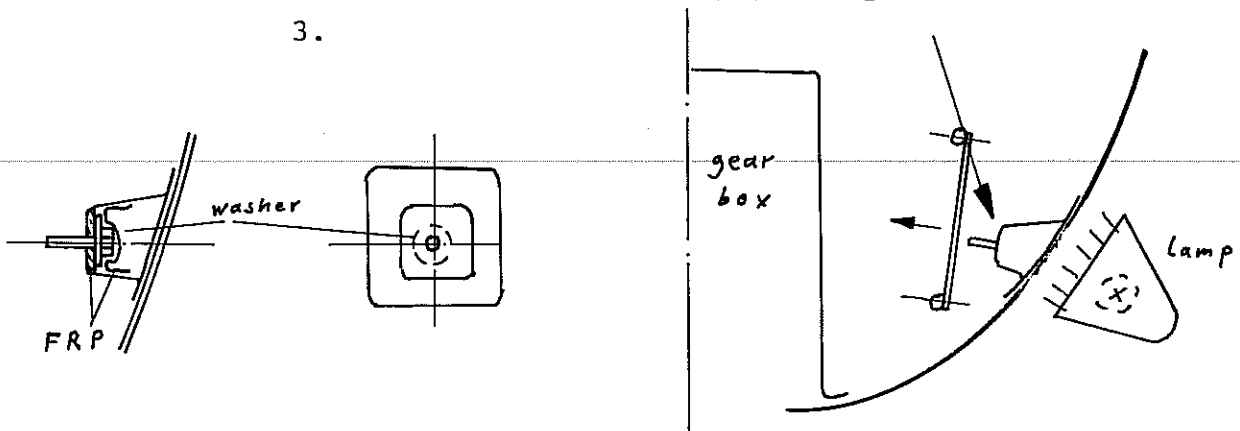
Remove the self locking nut M 6 DIN 985 from the bearing stand and draw off the control lever.

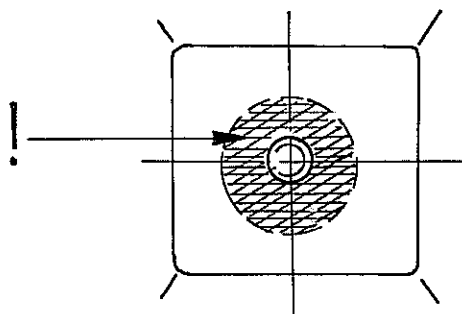
If the washer with 18 mm outside diameter is visible you can reassemble the control lever. Use a new self locking nut M 6 DIN 985.

6. b) If no washer is visible but the FRP reinforcement is appearing constantly dark the bearing stand has to be exchanged according to repair instruction 11/5/78.

Reassemble the control lever. After the exchange readjust the elevator control (see service manual page 22/23) if necessary.
