Technical Note

No 301/12

Subject: Emergency release mechanism of the one piece canopy

Effectivity: Sailplanes DG-100, DG-100 G, DG-100 ELAN, DG-100 G ELAN
Serial nos.: all with one piece canopy

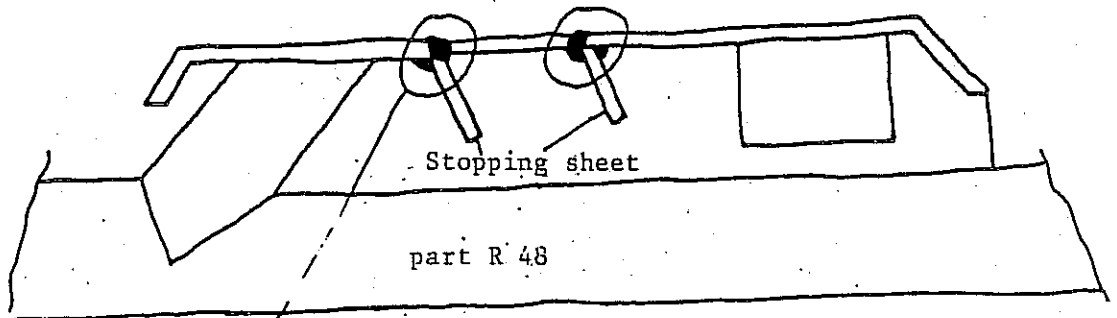
B 1) Inspect the welds of the stopping sheet at the fuselage side - canopy fitting (look at the scetch).

enlarged

wrong

right

If they are projekting, You have to file them flat. (Protect the filed area with a rust protection paint afterwards.)

File the weld flat

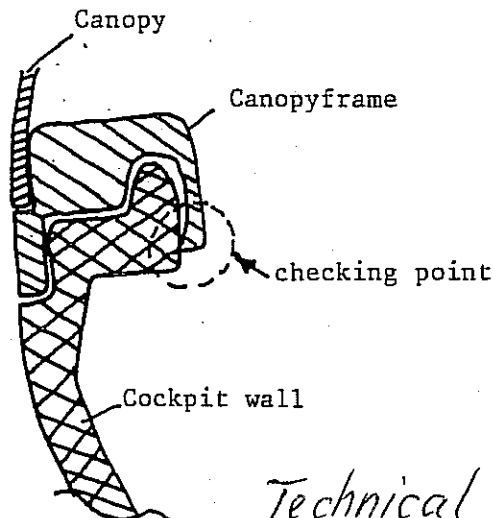
B 2) If this work was unsuccessful, You have to check, wether the canopyframe undercuts at the inner bead in the front sector. (look at the scetch)

If there are undercuts, (You can see it exactly at the rubpoints at the canopyframe and the cockpitwall) You have to eliminate them by sanding with an abrasive paper (60 Grit).

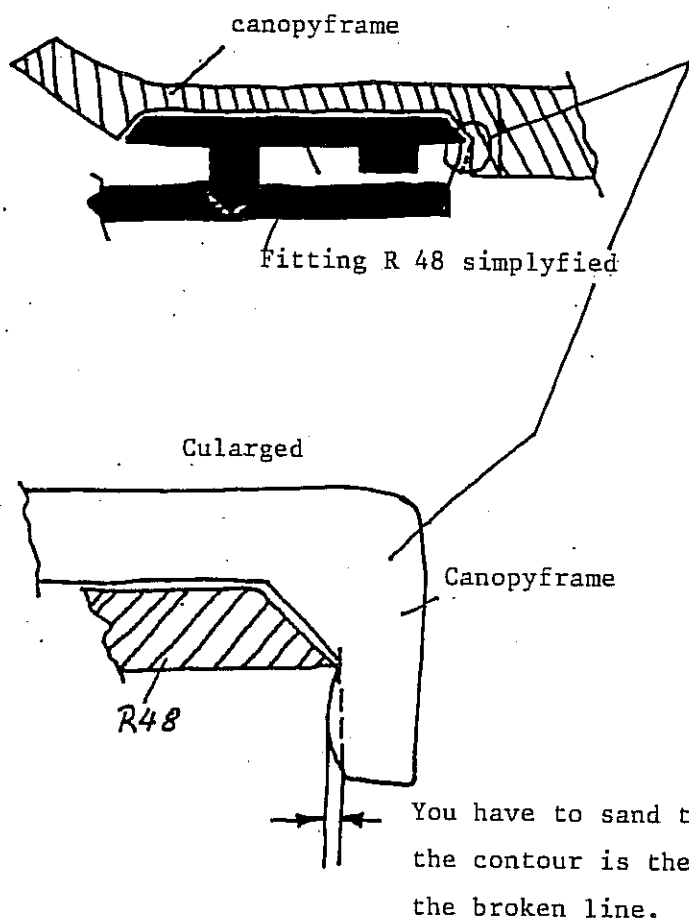
B 3) If there are no undercuts, You have to chek, wether the canopyframe undercut in the rear of the canopy fitting (part R 48).
