SUBJECT : Main fitting L 4 of the all-flying tailplane

EFFECTIVITY : DG-100 Elan from serial no. E 13 on
and all DG-100 and DG-100 ELAN where during
a repair executed 1979 or later the fitting
L 4 has been replaced.

CONCERNING: TECHNICAL NOTE TN 301/15

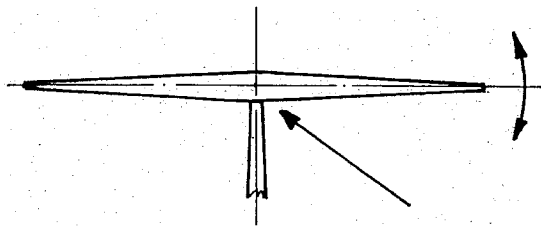
2. Check prior to each flight

± 15 daN (33 lbs.)

no permanent deformation is allowed

1b) Lift and pull down the tip of the all-
flying tailplane (aircraft rigged) with
ca. 150 N (33 lbs.) (see enclosure 2.).
If damage is detected no more flying is
allowed.

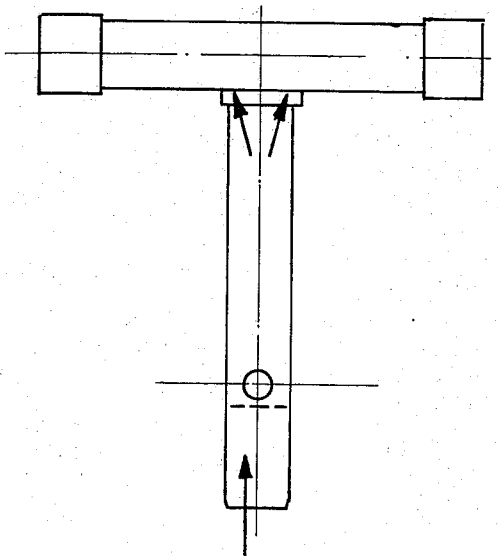
3. Inspection of the welding

Inspect the welding in the edges inside the tube by means of an Endoscope or an other suitable method.

If a plastic plug is glued into the tube, the plug is to be removed and to be glued into the tube after the inspection and repair by use of metal adhesive.

2) Inspection of the fitting L 4 for
correct welding (see enclosure 3.).
If the welding is o.k. instruction 1 may
be cancelled.
If a failure in the welding is detected
the fitting must be repaired according
to instruction 3. Until the execution of
instruction 3 further operation of the
aircraft is prohibited.

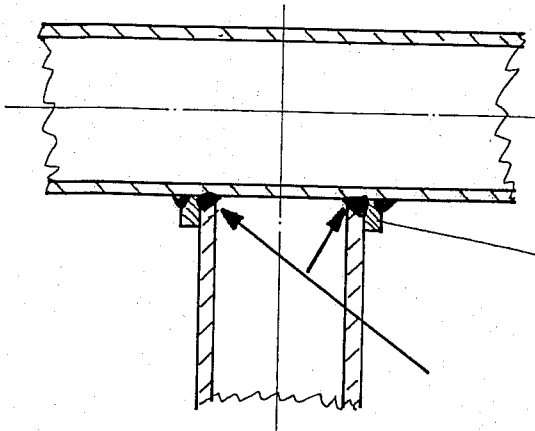
stop ring

This welding must be visible inside the tube.

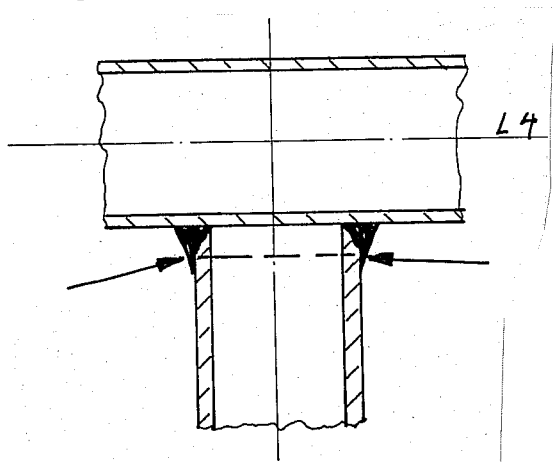
2. When making the welding at the fitting L4 it is possible, that the weld extends into the region where the fitting will project into its counterpart in the fin. So rigging the tailplane will be impossible.

In this case it is necessary to file off the excess welding carefully without filing away any material from the tube itself.

So it is necessary to inspect the tube after the filing carefully. If material has been taken away from the tube the fitting L4 must be replaced!

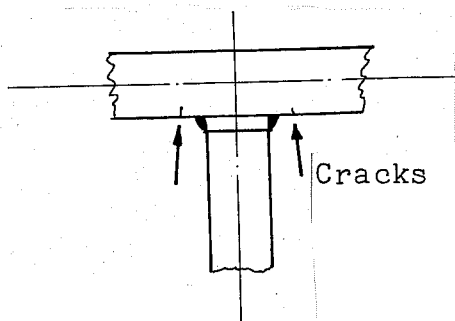
3. There have been difficulties when welding the fitting.

On one DG-100 after the welding cracks appeared next to the weld. The reason for the cracks is too fast cooling down of the weld. To avoid this any cooling of the weld is prohibited. In contrary the hot weld must be covered to achieve a slow cooling down. To avoid overheating of the ball-bearings in the fitting L4 proceed as follows:
