**Check of the actual torque of the nut which fixes the bellcrank 5St19 to the bolt of the bearing stand**

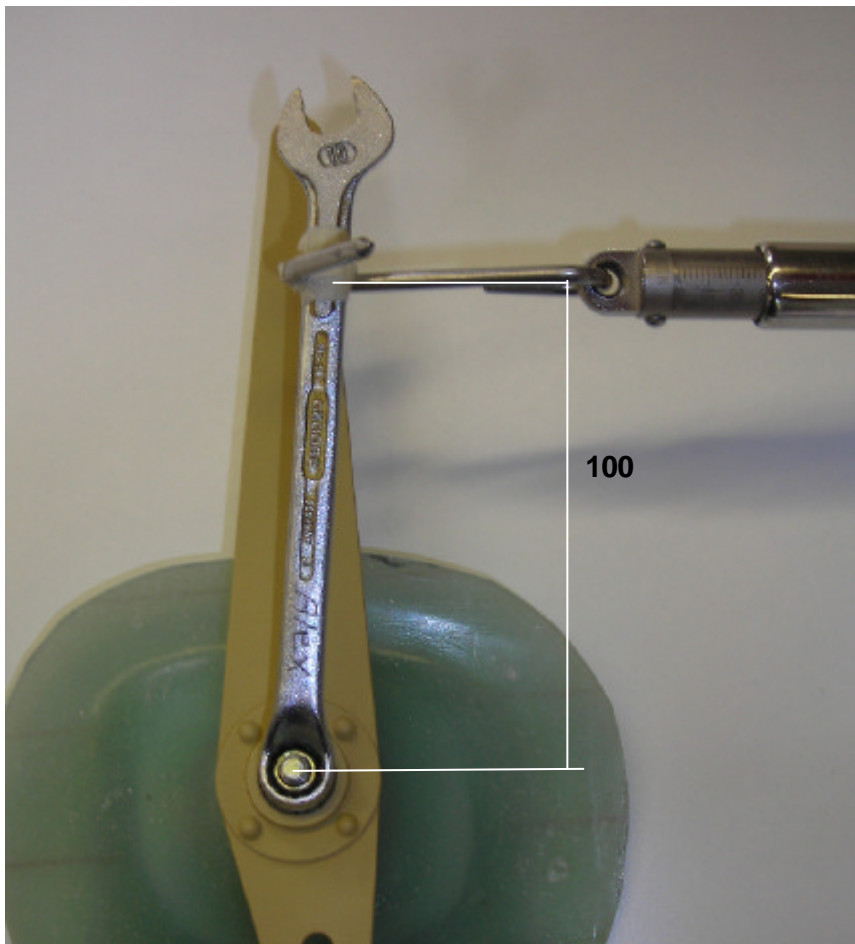
4. If no torque wrench is available which can be adjusted to a torque of 3 Nm the check may be executed with a 10mm spanner according to the photo below,  
Fix a spring balance measuring range 50N (5kg, 10 lbs.) or 100 N (10 kg, 200 lbs.) at a distance of 100mm (4 in.) from the centre of the nut to the spanner e.g. with tape.  
Retorque the nut with a force of 30 N (3 kg, 6 lbs.).  
If retorquing was possible the actual torque was too low and instruction 2 of TN1000/12 (replacing the bolt) must be executed.
5. If the nut had a torque of 3 Nm or higher and if you don't want to install the bracket (instruction 3 of TN1000/12) immediately retorque the nut with a torque wrench adjusted to a value of 12 Nm(9 ft. lb.)
6. Execute a control check.
7. Reinstall the baggage compartment floor and back cover plate.
