## Replacing the bolt of bearing stand 5RU61

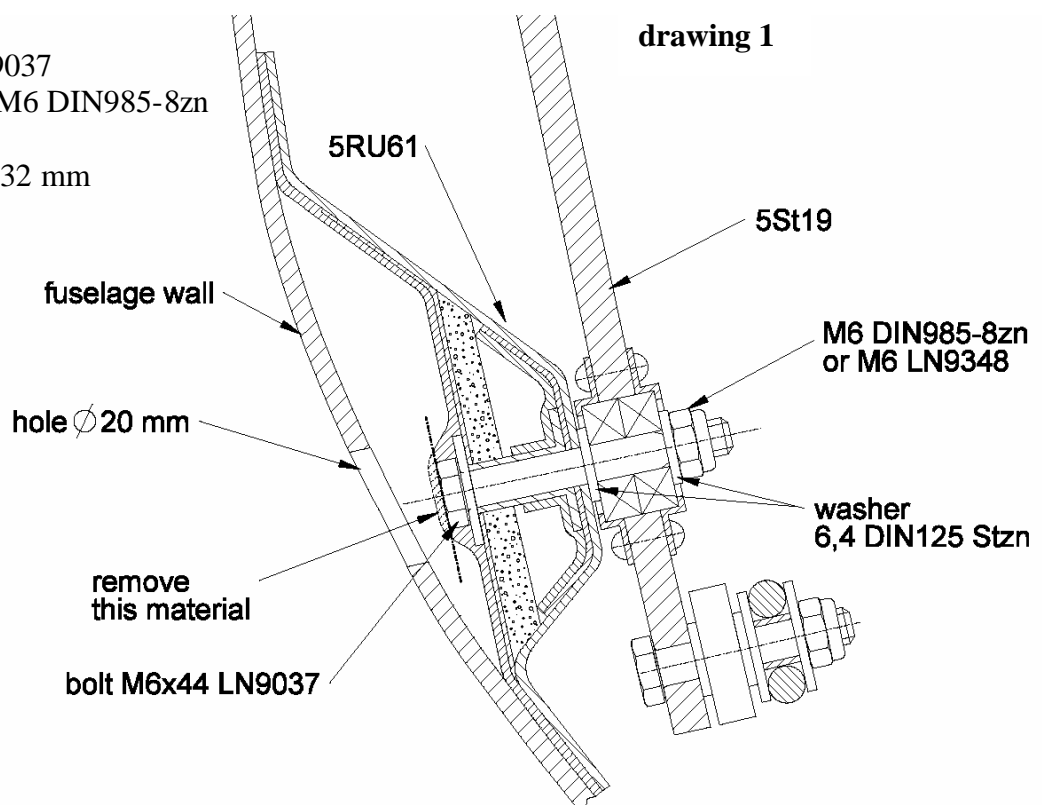
3. Use a powerful lamp to illuminate the fuselage from the inside. Mark the edges of the gluing flange of bearing stand 5RU61 on the outside of the fuselage.

4. Drill a 6mm (1/4 in.) hole in the centre of the marking according to drawing 1. Enlarge this hole with a 10 mm (3/8 in.) drill. Then enlarge it to a dia. of max. 20 mm(6/8 in.) with a 6mm (1/4 in.) hard metal rotary file. Shift the centre of the hole to the centre of the bolt head while enlarging the hole.

5. Remove any resin and the GFRP fabric located on top of the bolt head with the hard metal rotary file. Don't remove the resin and the fabric from the spanner flats of the bolt head.

6. Heat the bolt head up to approx. 120°C (250° F) with a hot air gun. The hot air gun must be equipped with a nozzle with an inside diameter of approx. 5mm.

7. Knock out the bolt from the inside of the fuselage using a steel hammer..
8. Push in the new bolt so that its spanner flats slip into the recess from the existing bolt head.
