DG Flugzeugbau GmbH Inspection instruction for the DG-1000M drive mount

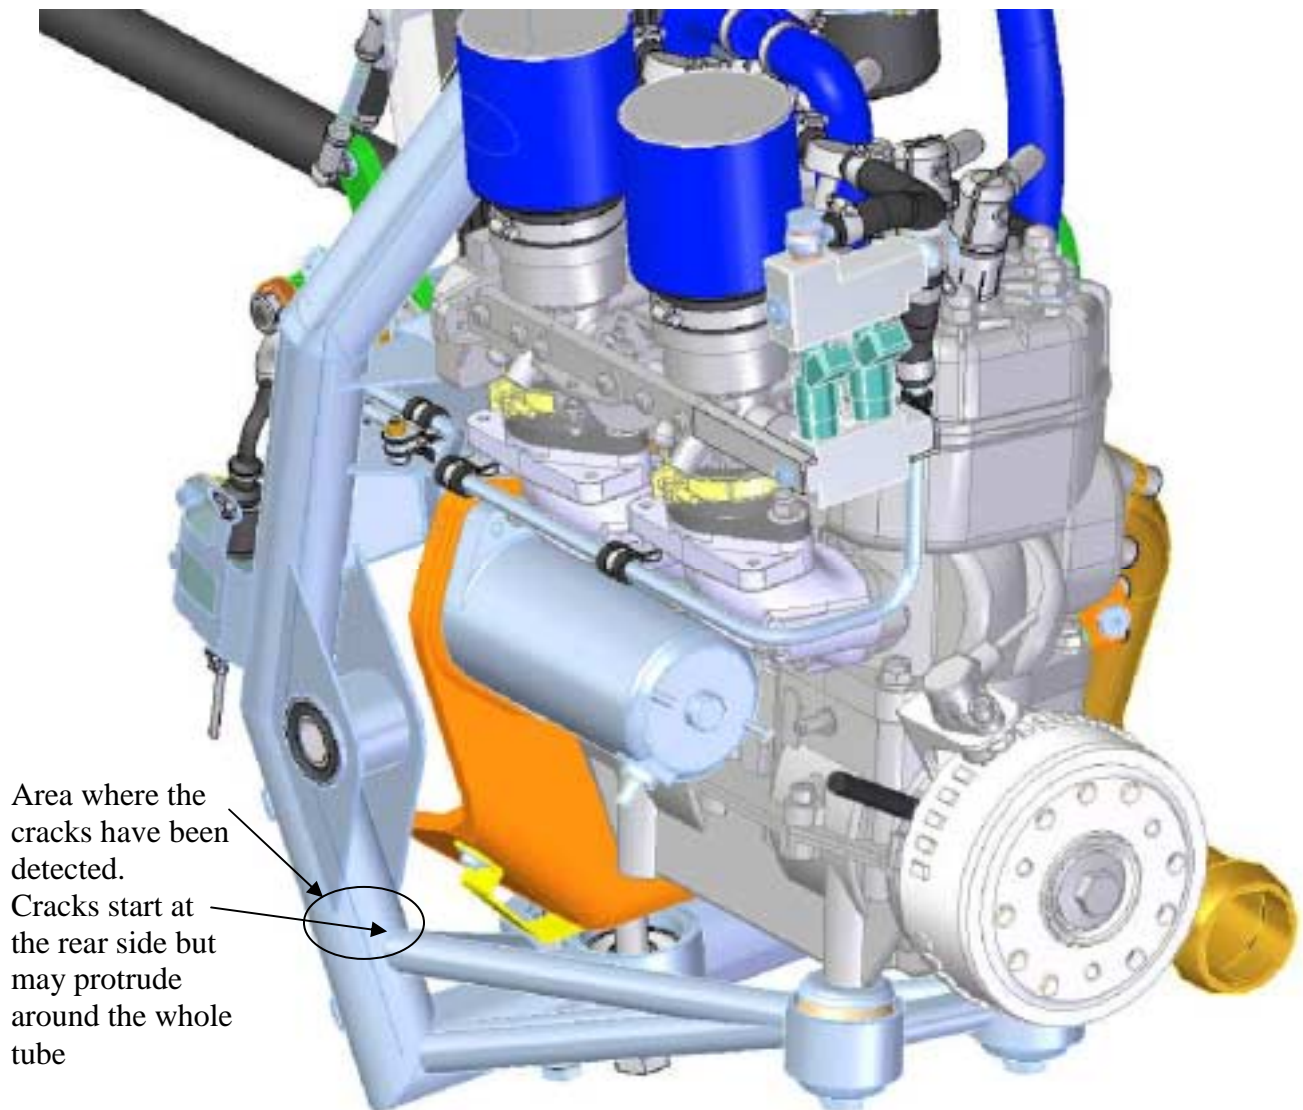
During servicing we found a crack in the drive mount of one DG-1000M which had already 46 engine hours. The crack was in the lower left hand side dia. 40 mm steel tube. As this area is hard to see when performing a visual inspection we have produced this inspection instruction.

Area where the cracks have been detected.
Cracks start at the rear side but may protrude around the whole tube

1. Extend the powerplant. Use a powerful torch to look at the left hand side to find the area shown in the picture below. Check for any cracks. Touch this area also with your fingers to find a crack.
2. It is nearly impossible to look and touch the right hand side with the engine extended, so retract the engine and stop before the engine doors close. Check the front (now upper side) of the left hand tube again and check also the right hand side. Touch around the tube with your fingers to find any crack on the lower side.
3. In case you find a crack don't operate the engine any more.
