- Subject : Adapter ring with elastomeric damper element between propeller and upper drive belt pulley
- Effectivity : DG-1000 variant DG-1000T
- Accomplishment : Prior to next engine use

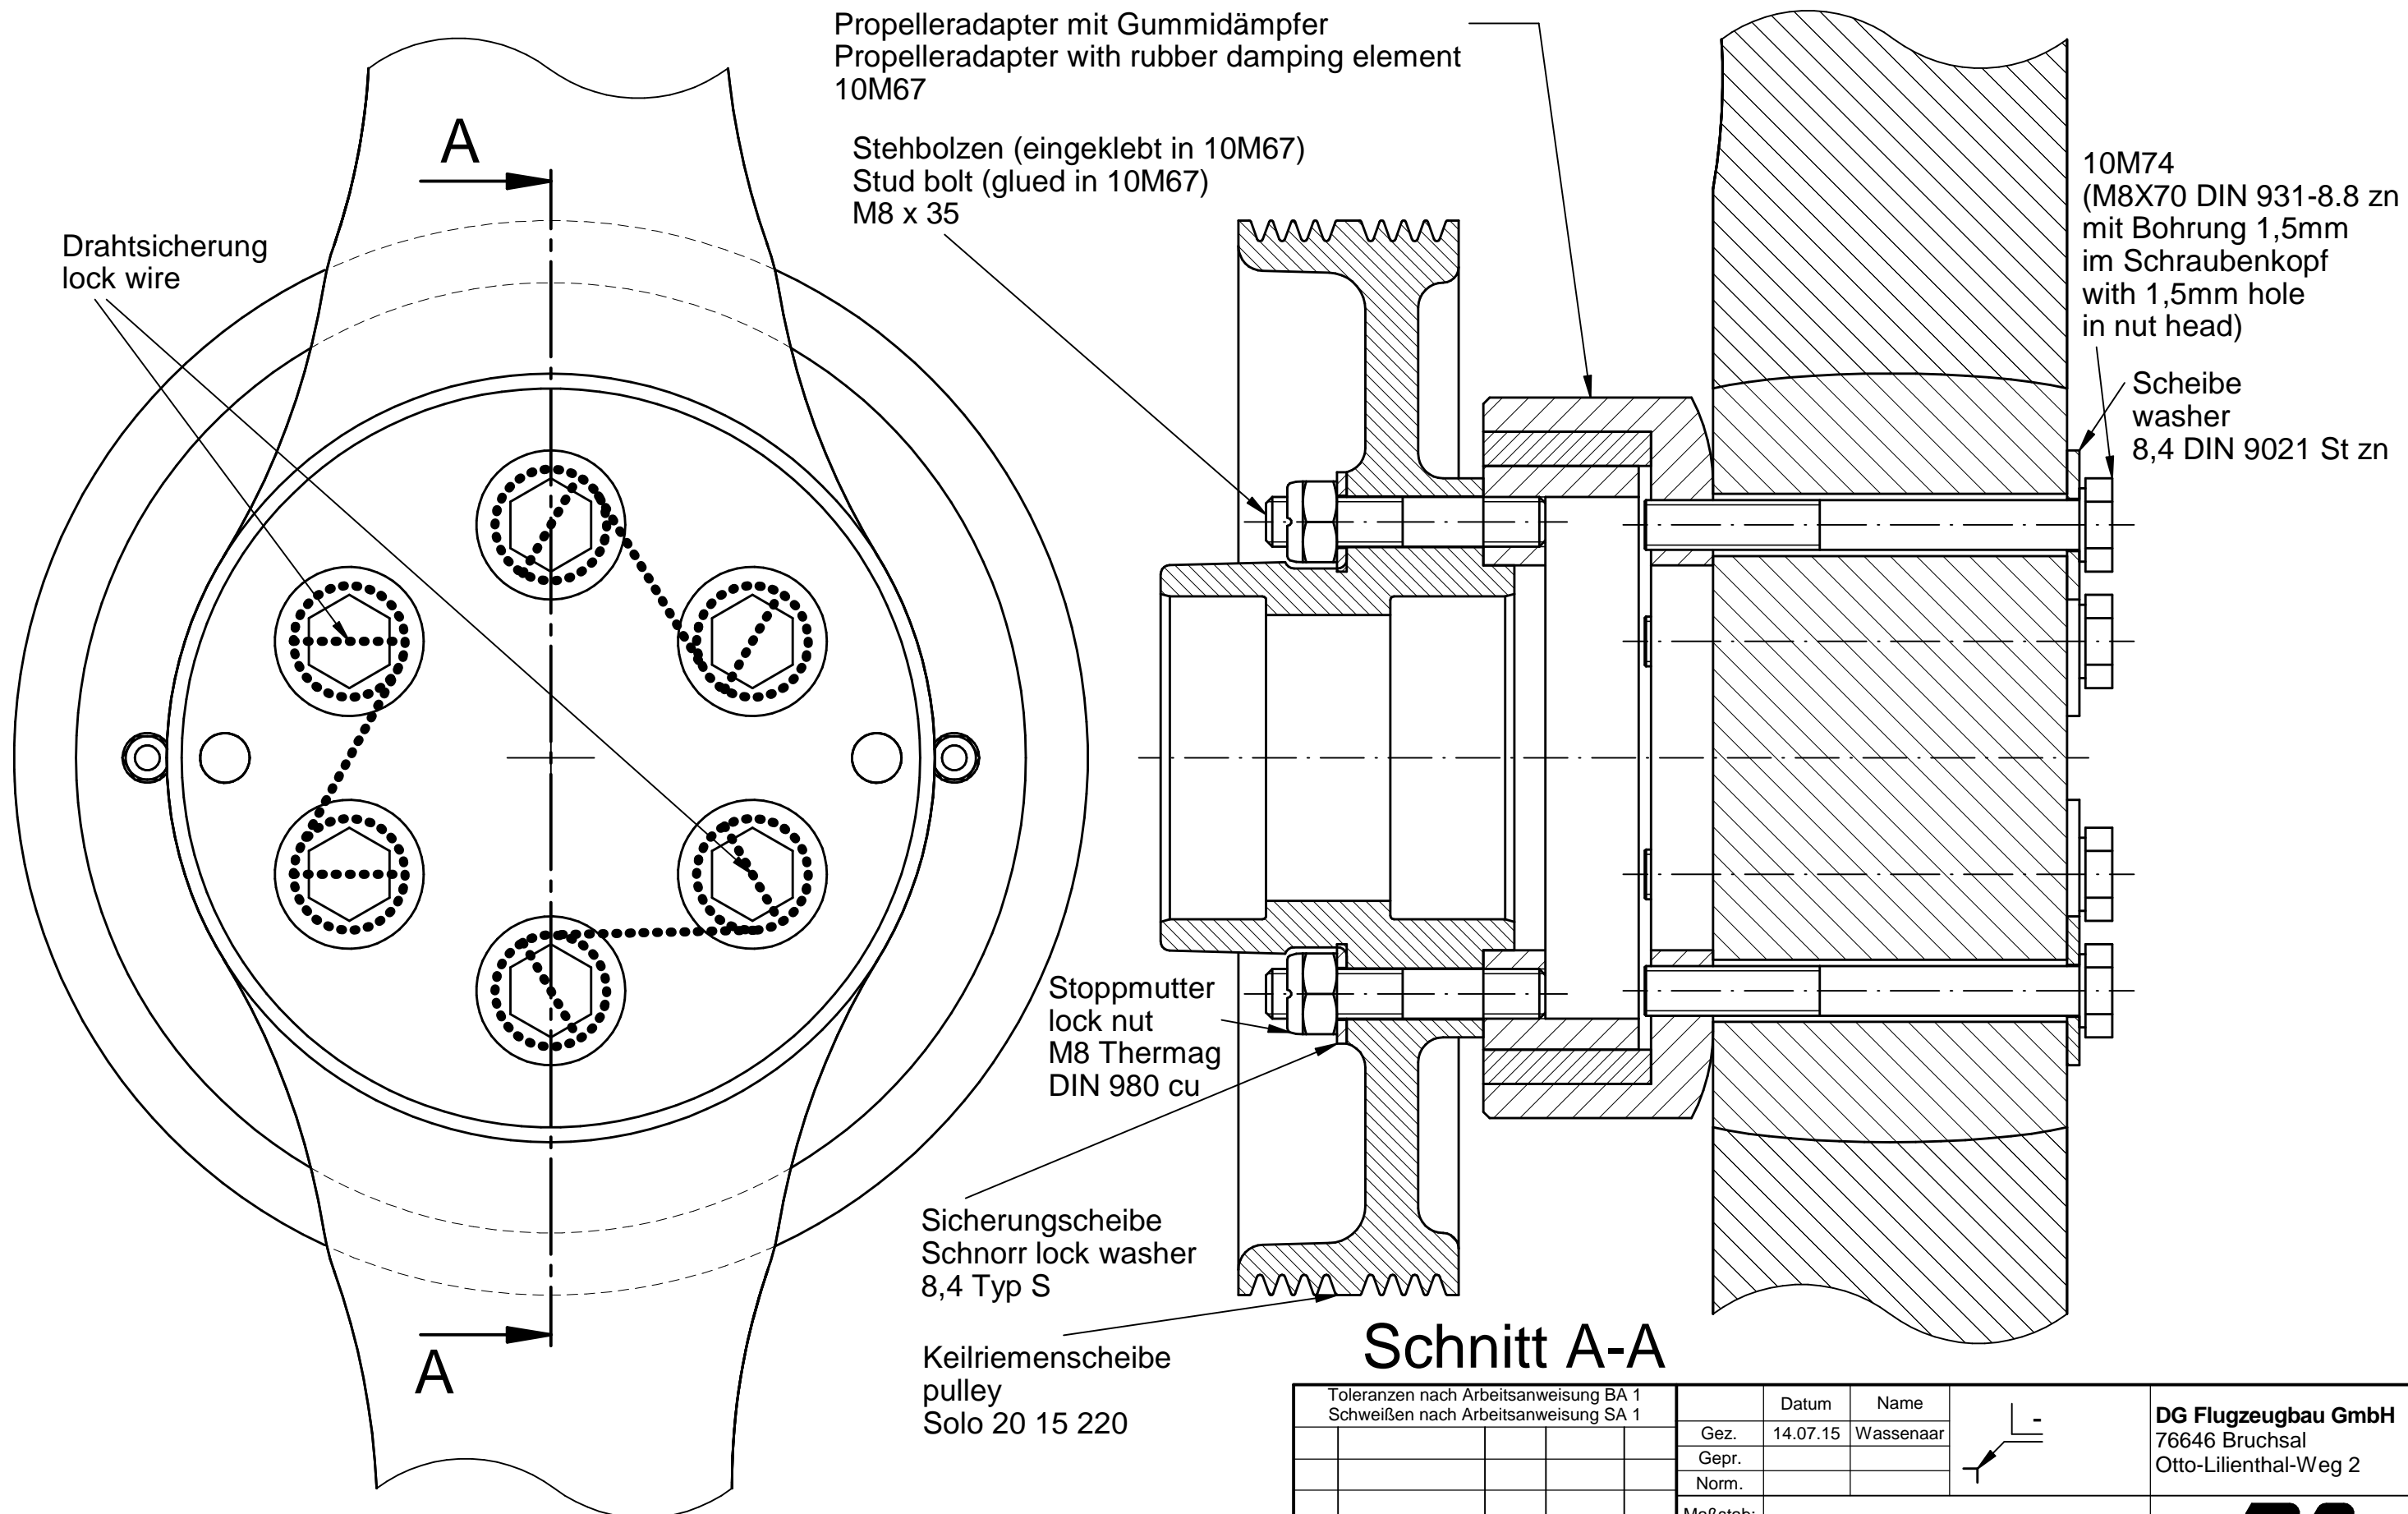
- Reason : In some cases the eccentric axle of the reduction gear of the engine SOLO 2350C failed. Even the reinforced axle (SOLO part No. 20 11 316) failed in 2 cases see EASA Emergency AD No. 2015-0052-E and SOLO inspection instruction No. 4603-1.
To reduce the loads on the axle an elastomeric damper element between propeller and upper pulley has been developed. This element enables the engine with reduction gear to perform movements against the gyroscopically "fixed" propeller disc.

- Instructions :
1. Remove the propeller. The adapter ring 10M39 won't be used anymore.
2. Remove the eccentric axle including the upper drive belt pulley according to MM section 4.10.1 d).

3. Ship the unit axle with drive belt pulley to the Solo company.
Solo will return the drive belt pulley assembled with new rear bearing and new axle Solo 20 31 211 V2 and with adapter ring with elastomeric damper element 10M67. In addition you will receive 6 bolts 10M74 for mounting the propeller.

4. Reinstall the unit according to MM section 4.10.1 d).
5. Reinstall the propeller according to MM section 4.10.2.
6. Torque the upper engine rubber mounts so that they are compressed to a value of 25 mm (1.06 in.) see MM section 4.10.6.4 item 6.

- Material : Drawing 10M072
1 unit adapter ring with elastomeric damper element 10M67 already installed to the drive belt pulley with eccentric axis with:
6 x 8,4mm Schnorr securing washer Type S
6 lock nuts M8 Thermag DIN980 cu
6 bolts M8x70 DIN931-8.8 zn with hole for lock wire 10M74
Lock wire dia. 0.8 mm
Manual Pages see above
