**DG Flugzeugbau GmbH Inspection instruction No. 1 for TN1000/30  
DG-1000M drive mount**

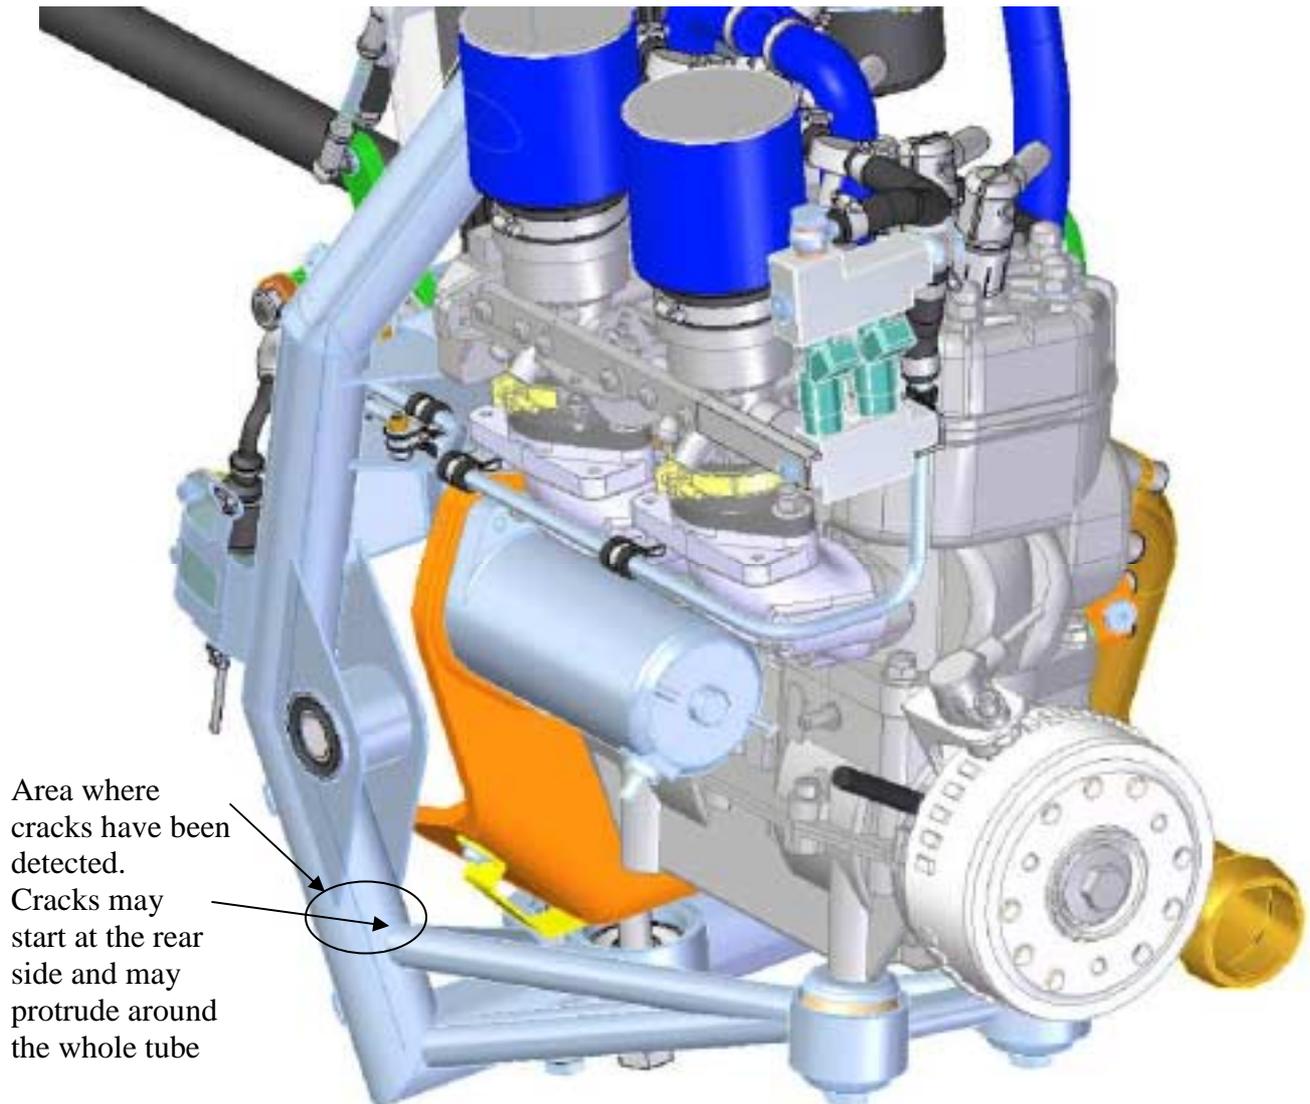
**A. Checks according to TN1000/23. These checks must only be performed in case TN1000/23 instruction 2 (installation of stiffeners) has not been performed so far. Check during each daily inspection and during the 25 h inspection.**

1. Extend the powerplant. Use a powerful torch to look at the left hand side to find the area shown in the picture below. Check for any cracks. Touch this area also with your fingers to find a crack.
2. It is nearly impossible to look and touch the right hand side with the engine extended, so retract the engine and stop before the engine doors close. Check the front (now upper side) of the left hand tube again and check also the right hand side. Touch around the tube with your fingers to find any crack on the lower side.
3. In case you find cracks don't operate the engine any more.

**Caution:** In case cracks are found according to TN1000/30 the drive mount must be exchanged against a mount of the new design prior to next engine use.

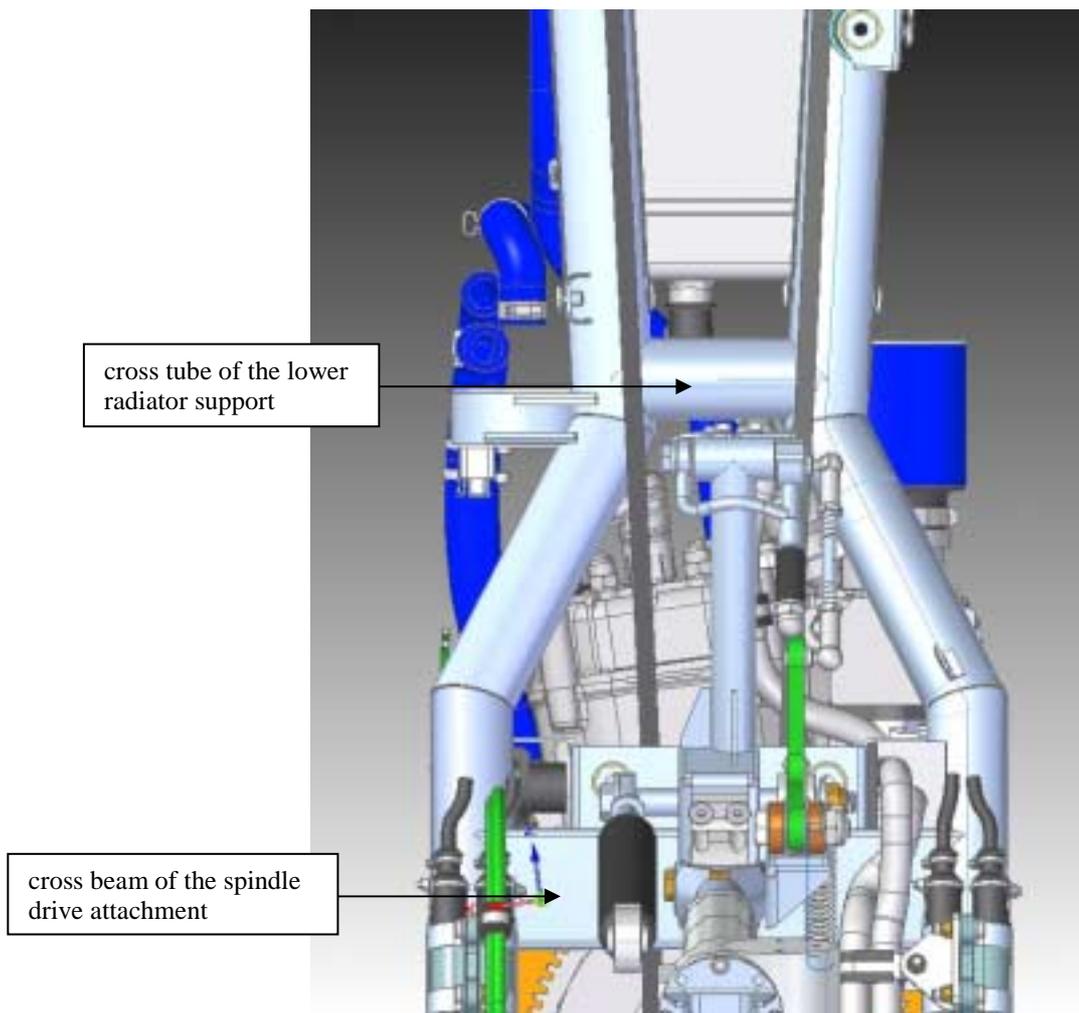
**B. Checks for cracks at other areas of the drive mount. Check during each daily inspection and during the 25 h inspection.**

1. Extend the power plant half-way, so that the front of the drive mount is completely visible.
2. Check the complete drive mount for cracks.  
Especially check the right main tube in the area between the cross beams of the spindle drive and the cross tube of the lower radiator suspension for cracks, both the front as well as the rear parts. The area around the upper cross tube is partly covered by the drive belt cover. Checks of this area see C.
3. Then check the left main tube between the two cross bars for cracks.
4. In case you find cracks don't operate the engine any more.
