Technical Note/ No. 1000/38 Doc.-No.:

TM1000-38 FE-29-01 **English version**

Subject : PU fuel hoses, limitation of life-time, replacement by new types of fuel

Effectivity type: DG-1000

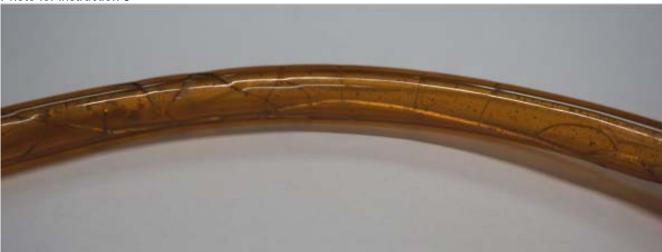
Photo for instruction 3

During maintenance work on a 10 years old DG-808C a broken hose was found. In addition the look of the hoses had changed. Therefore the life-time of the PU fuel hoses will be limited to 6 years.

PU hose with crack lines starting at the inside of the hose

Replace all fuel hoses in the fuselage by fuel hoses DIN 73379-2A and fire resistant fuel hoses ISO 7840-A1 in the engine area according to the fuel system diagrams 15 resp. 15a issued with this TN.
