DG-100	TN 301/16
DG-200	TN 323/7
DG-400	TN 826/28

**SUBJECT** : Securing of L'HOTELLIER quick-connectors according to LBA AD 93-001 issued March 3. 1994

**EFFECTIVITY** : DG-100, DG-200 and DG-400 all serial no's on choice

Safety device for  
L'HOTELLIER ball and  
swivel connectors

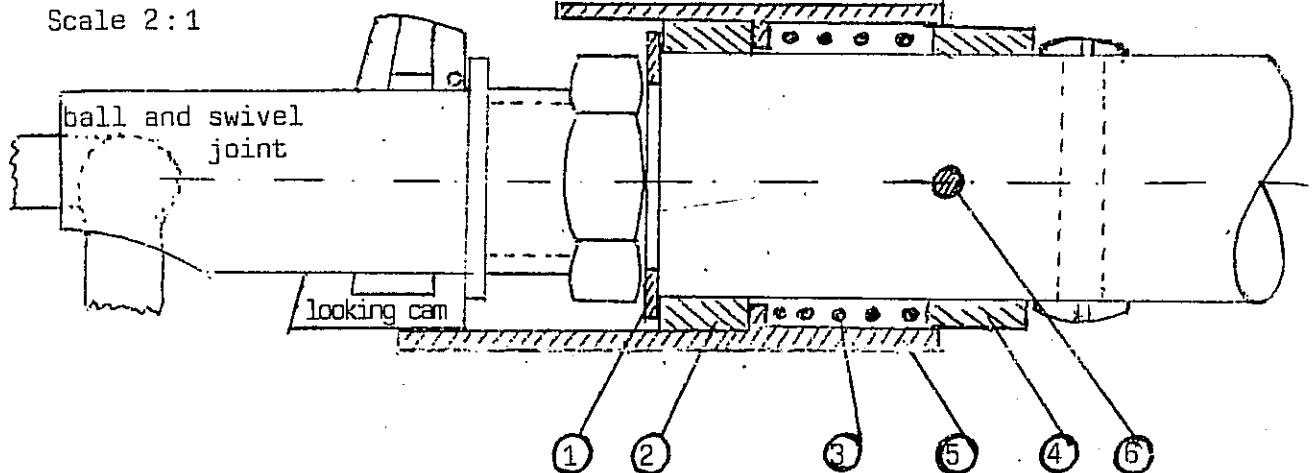
Only the coupling ball fully home in the swivel joint, the WEDEKIND safety sleeve (5) will slide over the lower end by the wedge-shaped looking cam and secures the latter from being released unintentionally. The safety sleeve is held in the "secured" position by a compression spring (3) with a force of 1,5 N.

The WEDEKIND safety sleeve is also a protection against improper control connections as it will not slide over the lower end of the wedge-shaped looking cam if the coupling ball is not fully home in the swivel joint.

The WEDEKIND safety sleeve consists of the following parts (shown cross-hatched in the above sketch):

1 off washer, $\phi$ 20 x $\phi$ 12,5 x 1,0 mm	Part 1
1 off bushing, $\phi$ 20 x 1,8 mm, lenght 6 mm	Part 2
1 off compression spring, $\phi$ 19 x 0,8 mm, lenght 20 mm	Part 3
1 off bushing, $\phi$ 20 x 1,8 mm, lenght 7 mm	Part 4
1 off safety sleeve, $\phi$ 23 mm, lenght 36 mm	Part 5
1 off roll pin, DIN 1481, $\phi$ 2 x 22 mm	Part 6

With the "L'Hotellier" swivel joint unscrewed from the control rod (be sure to measure the length of engagement reach of its threaded shaft in the rod as otherwise a re-adjustment of the control surface is required), slide the components of the safety sleeve on the free end of the rod in the following order: ④, ③, ⑤ and ②. Re-install the swivel joint - with lock washer No. ① fitted to the threaded portion of the shaft - and screw it into the control rod until the correct length of engagement is obtained, then tighten lock nut.

Slide bushing No. ② 2 mm into the safety sleeve No. ⑤. Hold the bushing No. ④ in the position by fixing with an adhesive compound, e.g. Cyanoacrylate. Drill a 2 mm hole through the bushing and body of the "L'Hotellier" connector at 90 deg. relative to the wedge-shaped locking cam and 19 mm from hole center to outer face of washer No. ①, as shown in the drawing. Drive the roll pin No. ⑥ into the hole to secure bushing No. ④ in position, leaving 1 mm protruding on either side. This 19 mm distance ensures that projection ends of the roll pin are situated between the cut-outs of the safety sleeve with the latter in "looked" position - thus preventing the sleeve from rotating and becoming dislocated.

To secure the wedge-shaped locking cam properly, an overlap of the safety sleeve of 3 mm relative to the lower end of the slide is sufficient.

Should the travel of the safety sleeve be more, its front end can be shortened (by filing). This might be required in the case of swivel joints being screwed deeply into a control rod, allowing the sleeve - the travel of which is only limited by the length of the channel for the compression spring - to move too far forward.
