Subject : Rod end in control column

Effectivity : DG-100 all variants, DG-200 all variants

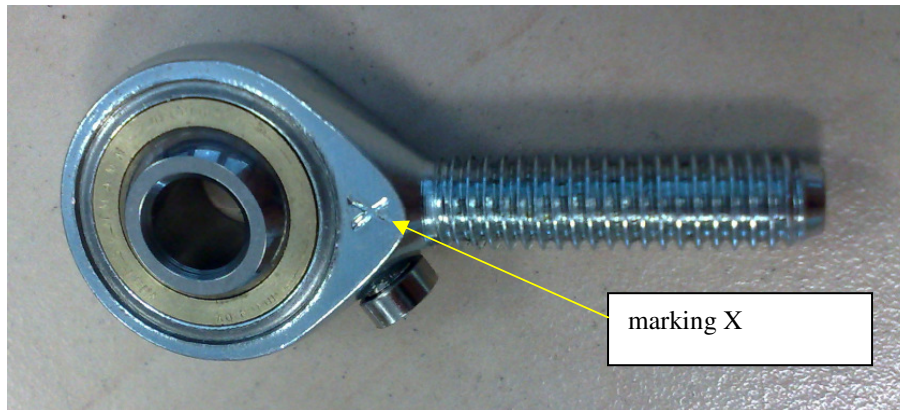
Reason : On one DG-100 during pre-flight inspection a broken rod end of the aileron control push rod in the control column was detected.  
In the first years at Glaser-Dirks rod ends made from machining steel were used, later parts from high strength steel marked with an X (see photo) have been used.  
All parts without an X have to be replaced by rod ends marked with an X

Instructions : 1. a. Remove the control column boot and check if the rod end is marked with an X. If the X is not visible from the top look with a mirror from the underside see photo 2.  
If the rod end is not marked with an X and no damage or cracks are visible the glider may be operated with this rod end up to the execution of instruction 2.  
b. If any damage was detected the rod end must be replaced prior to the next take-off.  
2. Exchange the rod end against a new one marked with an X. Use a new self locking-nut.

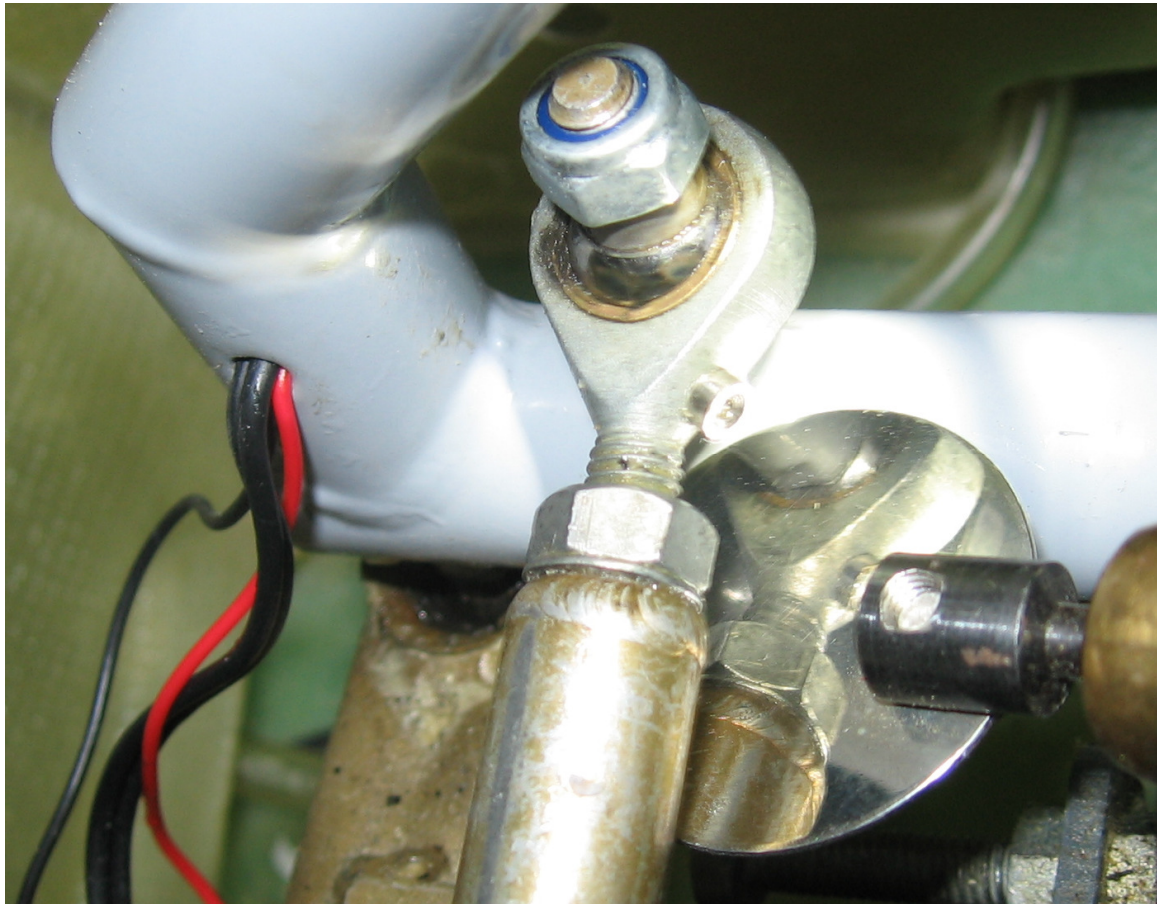
Inspection with a mirror, no X is existing, rod end must be replaced.
