No. 301/23
323/14
359/21
826/44

No. 348/18
843/21
370/9
866/10

- Subject : Lower mounting of the rudder
- Effectivity : DG-100, DG-200, DG-300, DG-400, all models and all ser.no.'s
DG-500, DG-500M all models up to 5E23
DG-600, DG-600M all models and all ser.no.'s.

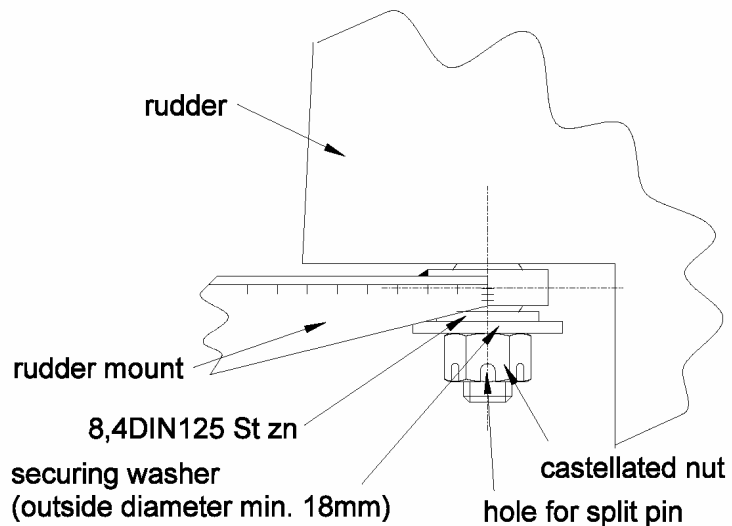
- Reason : On a DG-100 the universal bearing of the lower rudder mounting slipped out of the bearing support and the rudder fell out.
As the design is similar on all DG-types this kind of failure may occur on all DG's.
On later models this connection was secured by an extra securing washer.
Such a washer must be retrofitted to all DG-types with this TN.

3. Check if a securing washer (min. outside diameter 18mm, 0.71 inch) is installed according to the sketch.
 - a) If yes: The execution of this TN can be entered in the aircraft logs by a licensed inspector without further work to be done.

- b) If no: Remove the castellated nut, install the washer 8.4 DIN9021 and reinstall the nut.
 1. Check if the washer is interfering with the rudder mount. If yes, use a washer 6,4DIN9021 St zn instead, enlarge the 6mm hole to 8mm to enable installation.

2. Check if the split pin can be installed. If yes, secure with a new split pin 2x20 DIN94 zn.If this is not possible, mark the position for a new hole and remove the rudder. Drill a new hole (diameter 2mm, .08 inch) 90° to the existing hole. Reinstall the rudder, use new split pins.
