Technical Note No. 826/15

DG-400

Powerplant - cable guides

Powered sailplane DG-400 Serial No. 4-1 up to 4-140

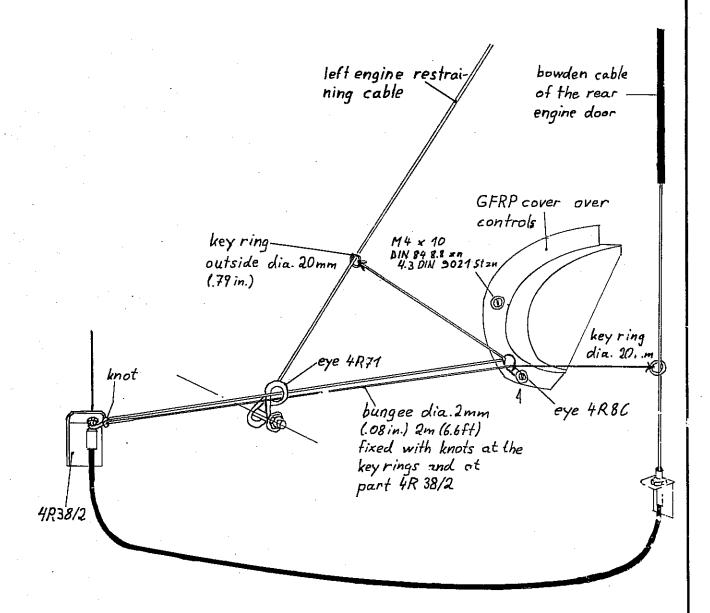
Power plant - cable guides

It is possible under unfavourable conditions that the left engine restraining cable or the bowdencable of the rear engine door may catch the engine and block the engine

extension.

The above mentioned cables will be secured with bungees referring to the enclosed installation plan. The present bungee fixed at the bowdencable of the rear engine door

has to be removed.

Don't tighten the bungee too much Make 3 knots everywhere and cut off the excessive bungee.

Grease the cables at the key rings with vaseline.
