Glaser-Dirks Flugzeugbau GmbH

Technical Note TN 826/18 Page 1 of 2

Subject: Engine extension/retraction drive.

Applicability: DG-400's works numbers 4-1 to 4-188.

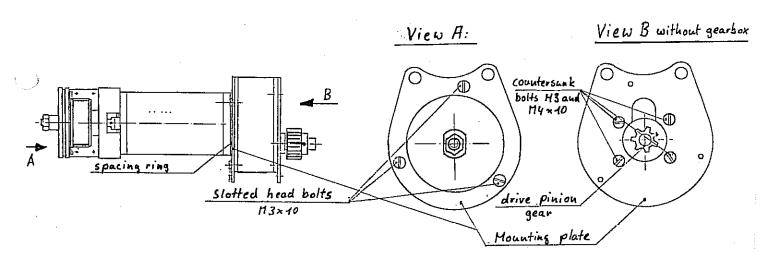
- 2. Remove the large brass gear wheel (4R12) by bending the tab-washer (A 30 DIN 70952 St) back carefully with a screwdriver and undo the slotted nut (M 30 x 1,5) with a crescent wrench (45/50).
- 3. Lift the gear wheel carefully using a rubber hammer.
- 4. Remove the two M 60 x 50 bolts that attach the drive motor mechanism and disconnect all of the wiring connected to the motor. The electrical connectors are located on the cover of the flap operating lever on the left hand side of the engine compartment, and in order to disconnect them the heat-shrink tubing must be cut off.
- b) Disassembly of the drive motor and replacement of the separator plate

1. Remove the three slotted-head bolts (M3) on the underside of the separator plate and then remove the gearbox.
