Subject: Engine wiring.

Applicability: DG-400's with works numbers 4-1 to 4-178 inclusive.

Technical Note TN 826/19 Page 3 of 3

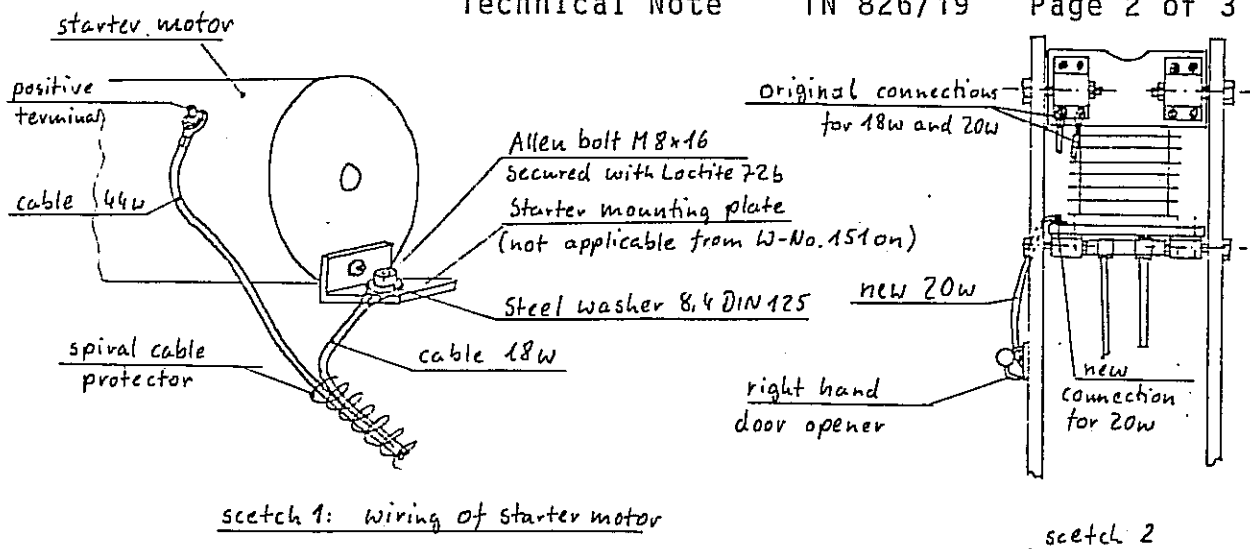
Description: On some DG-400's engine vibration has caused the cable terminal connectors to break on cables 18 w (on the engine frame), 44 w (connected to the positive terminal on the starter motor) and 20 w (the connecting cable between the right hand engine mount and the associated rubber engine mount).

- a) 44 w : The positive cable at the starter motor; see sketch 1.
- b) 18 w : The ground cable between the engine frame and the upper right engine mount. (see scetch 2)
- c) 20 w : The loop of cable between the upper right engine mount and the right-hand engine door opener.

Visually inspect the terminals of cable 44w and 18w at the starter motor (see scetch 1).

To remedy this the cables 18 w and 44 w have to be modified with reinforced terminal connectors, and for DG-400s with works numbers 4-1 to 4-105, cable 20 w is being replaced with a thinner, more flexible cable.

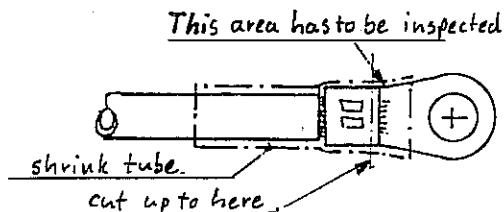
Note: Before making the visual inspection of the terminal connectors the heat-shrink tubing on the connectors must be cut back as shown below:
