TN 826/20

- Subject: 1. Empty weight C.G. range  
2. Plugged piece of hose at the pneumatic fuel pump  
3. Manual revisions  
4. Locking pins on wing tips
- Effectivity: Motorglider DG-400  
Serial No. 4 - 1 up to 4-228

### Modification for easier disassembly of the C.G. tow hook

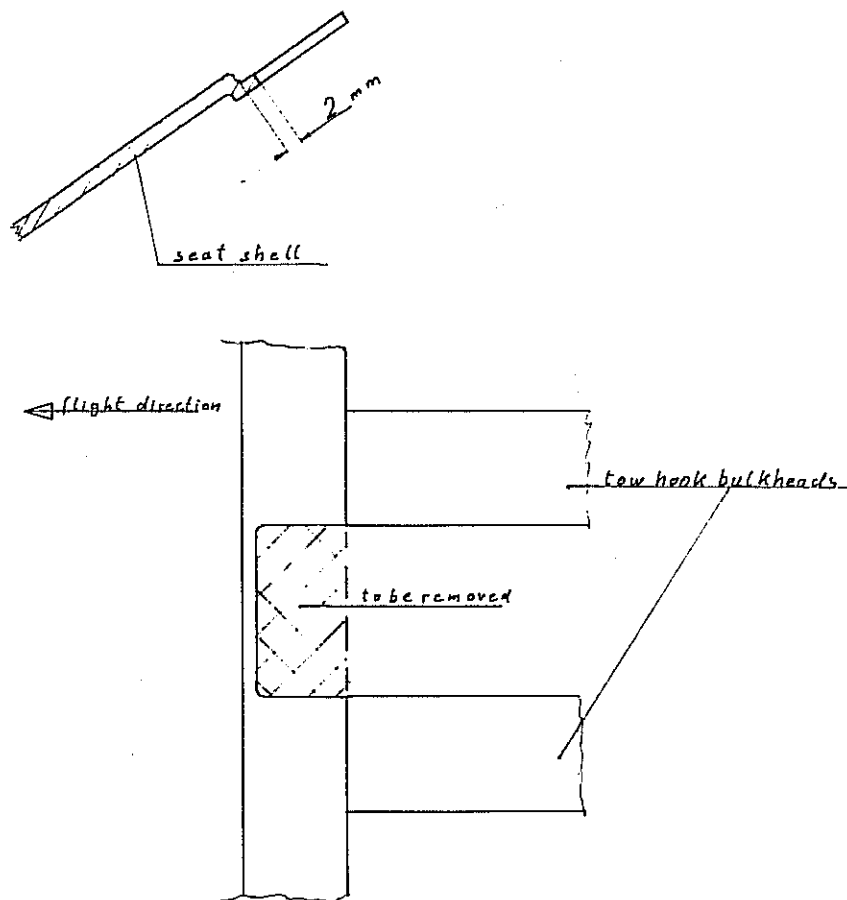
Reason: As the cut-out in the seat shell is relatively small for disassembling the tow hook it is possible to loosen the seatshell from the tow hook bulkheads when disassembling the tow hook.

Instructions: The cut-out in the sheat shell shall be enlarged to the front see scetch. This can be done with a fine rasp or with a power grinder.
