SUBJEKT : Powerplant DG-400

EFFECTIVITY : DG-400 from serial no. 4 -1 on

Working Instruction no.1
 for TN 826/25

TN 826/25

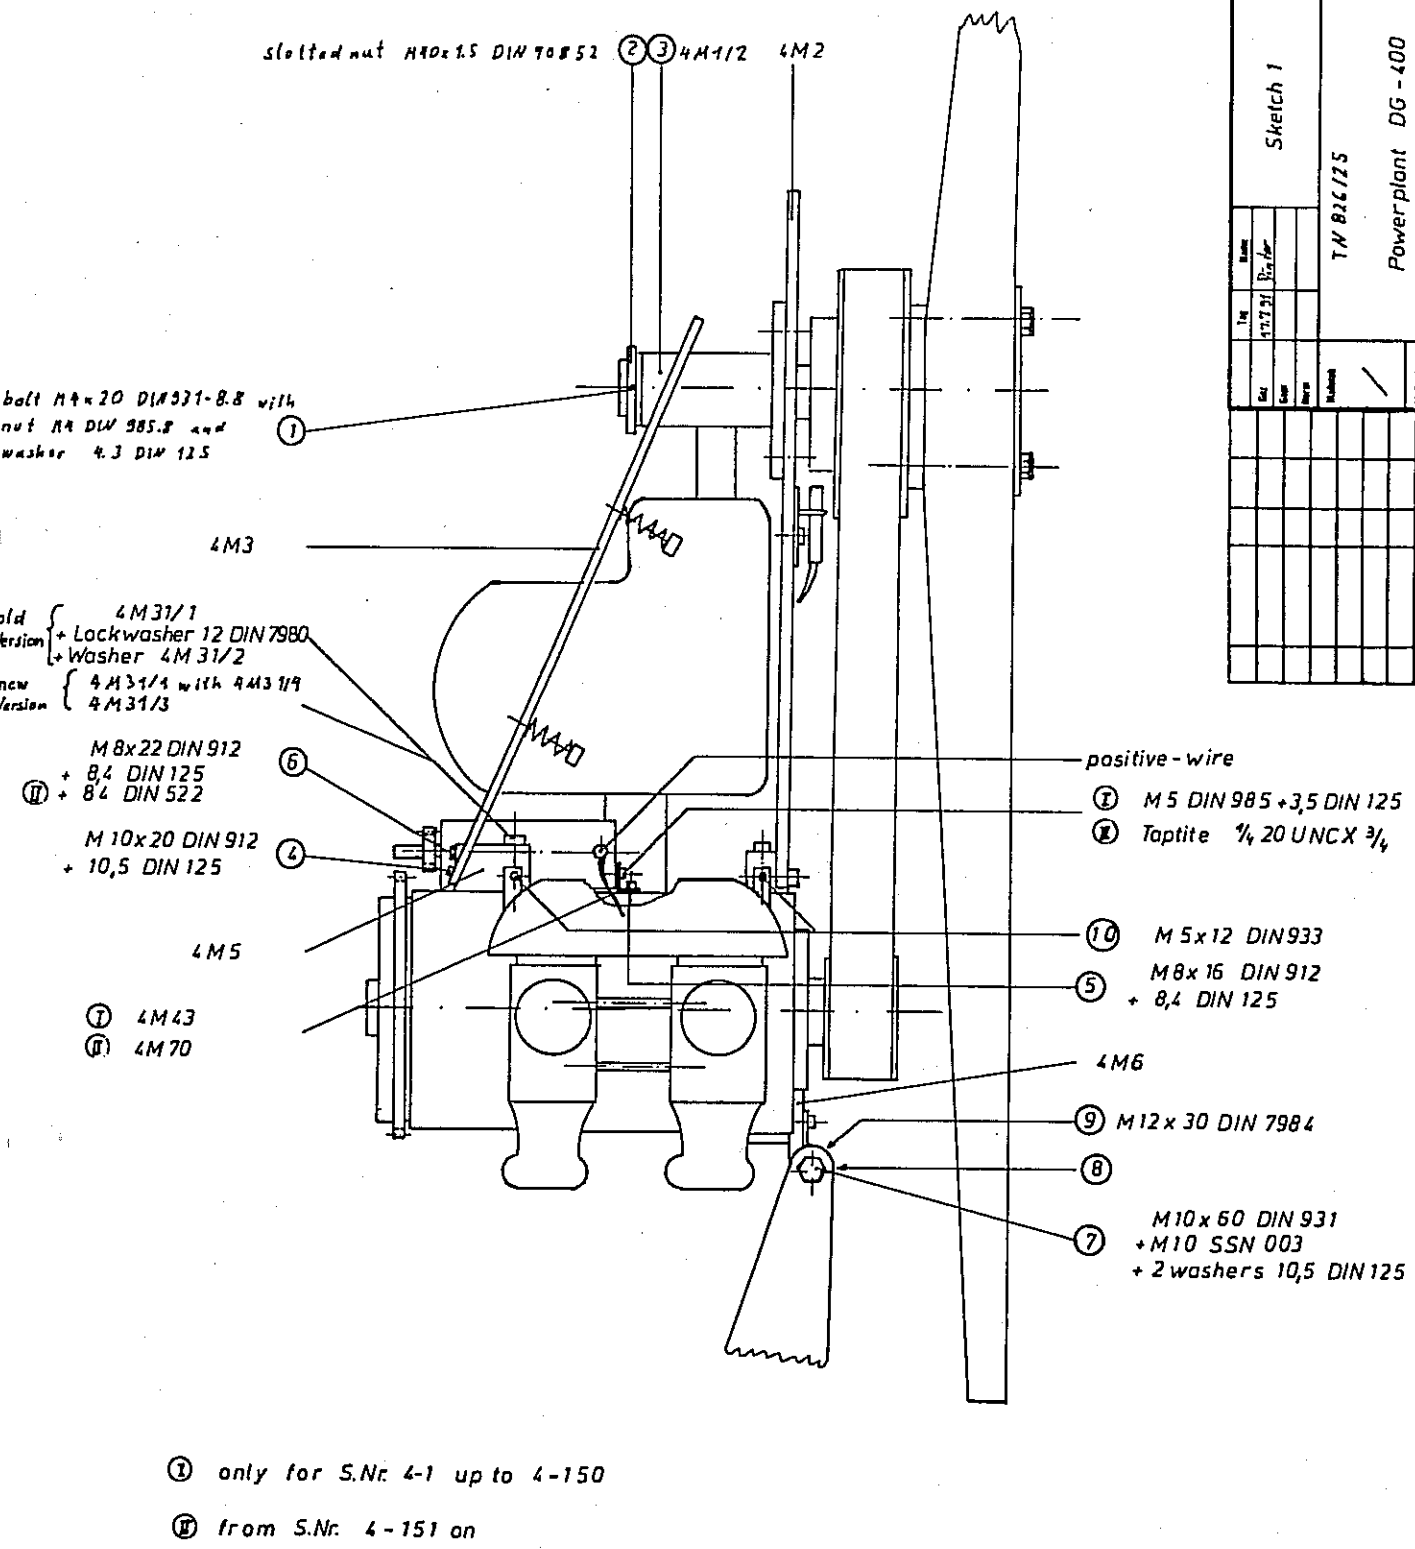
Sketch 1		TN 826125		Powerplant DG - 400			
Tag	Rev.	Rev.	Rev.	Rev.	Rev.	Rev.	Rev.
12.7.21							
Gez.	Gez.	Gez.	Gez.	Gez.	Gez.	Gez.	Gez.

REASON : 1., 2. Vibration damage occurred on some DG-400's. Our investigations resulted in the modifications which shall be executed with this technical note
3. The rubber of the fuel hoses is subject to get tears due to the high temperatures at the engine. Therefore the replacement time of 5 years is too long and must be limited to max. 3 years.

9. Dismount the front mounting bolt of the startermotor (5).
10. Remove rear mounting blocks 4M5 together with the starter motor, therefore remove the bolts 4M31/1, the washers 4M31/2 and the spring washers 12 DIN 7980. These parts will not be used for reassembly.
During reassembly the modification item 12 must be executed.

12. Mount the blocks 4M5 according to drawing 4M3 to the engine. Therefore recut the threads in the engine and check the contact surface between engine and 4M5 evenness. To prevent turning of the bushes 4M31/3 place thin sheet metal between the flat sides of the bushes and the startermotor. Remove these sheet metal plates after tightening 4M31/3. Make sure, that parts 4M5 and 4M31/3 don't touch the starter motor. The tightening torque for bolts 4M31/1 is increased to 70 Nm (52 ft lb). Tighten precisely to this value. After 10 minutes (Loctite not cured) tighten again with the same value.

13. Reassemble front starter motor mounting bolt.
14. Mount the rear propeller mounting plate 4M3 with the exhaust muffler. Place the muffler into the exhaust manifold. Position the plate 4M3 correctly and fix it with the bolts (4) to the blocks 4M5. Place a washer 10.5 DIN 125 underneath the bolt heads. Fix the spring from muffler to manifold. Install propellershaft with pulley. Mount the part 4M1/2 (3), springwasher 4M27 and slotted nut (2). Further work see section 4.1 maintenance manual "Mounting and tensioning of the drive belt".

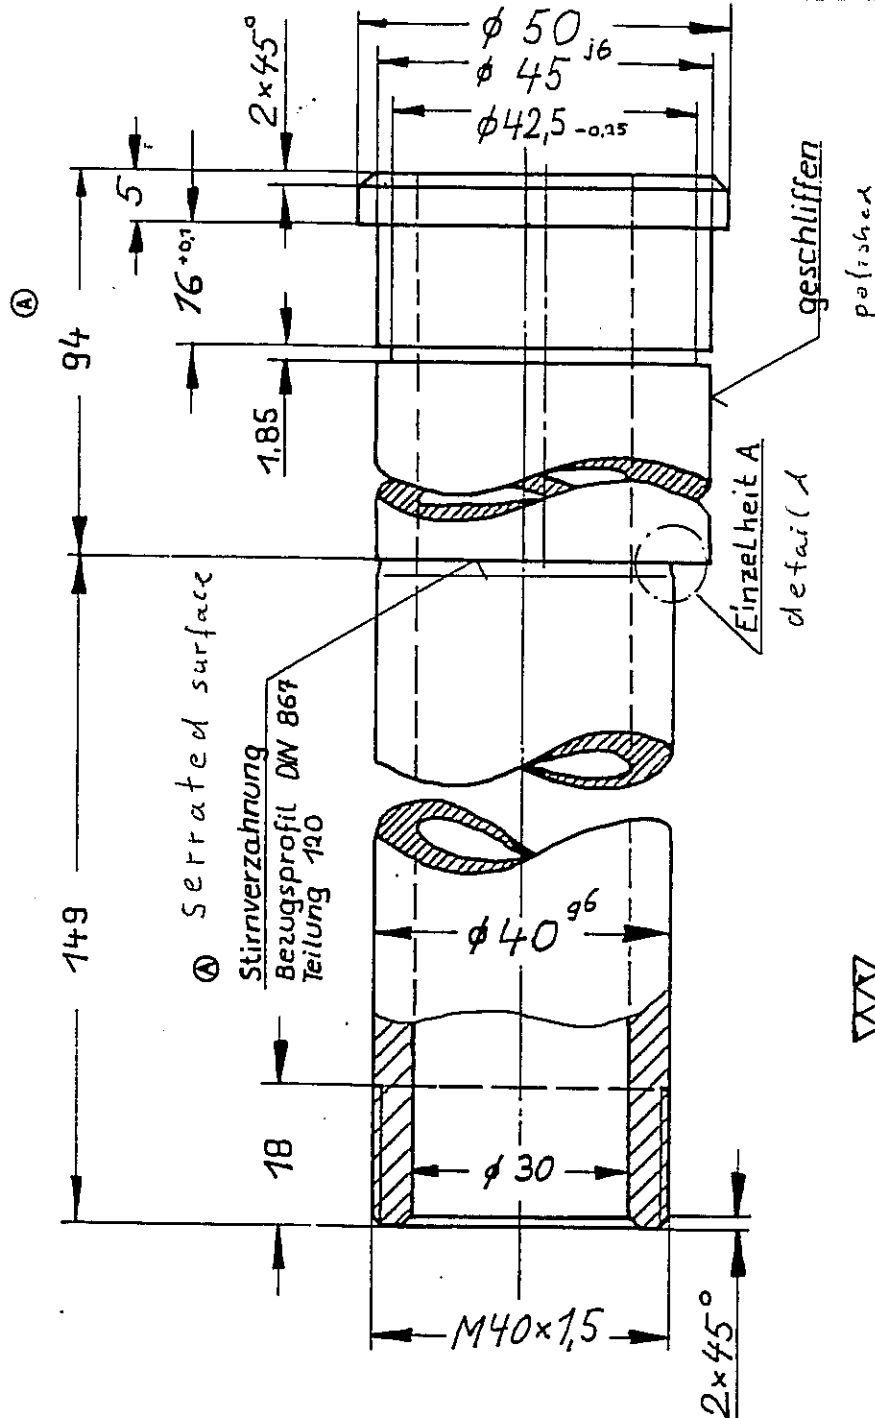
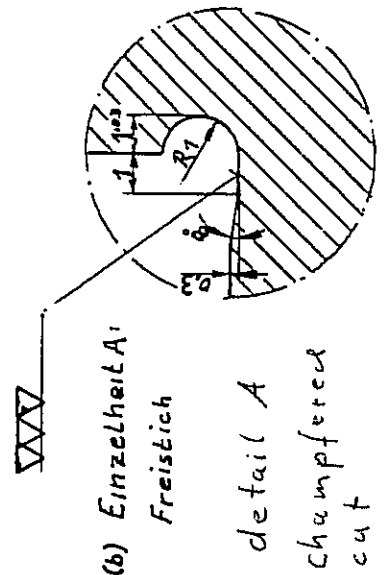
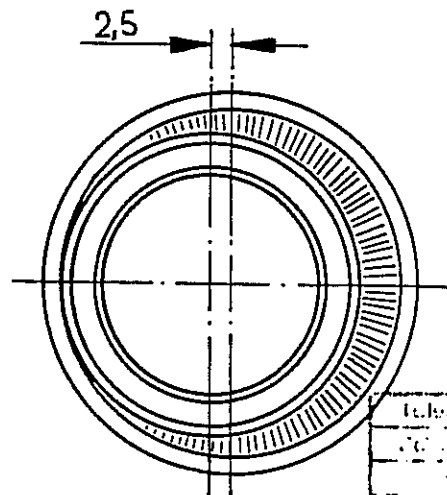
4M 24

- 5a) Execute an inspection for cracks of the propellershaft 4M24 at the intersection of the 40mm (1.57in) diameter shaft to the eccentric.
Crack-inspection must be done with a dye penetration method, approved by MIL I-25135C e.g. MET-L-CHEK. *by a qualified person.*

- b) If no cracks can be detected, the shaft can be remachined according to detail A on drawing 4M24 by a qualified workshop licensed for this kind of metal work
After remachining another inspection for cracks is necessary.

- c) If cracks are detected a new shaft must be installed.
6. Dismount the spring at the exhaust manifold.
7. Dismount the lower mounting bolts (4) of the rear propeller-mounting plate 4M3.

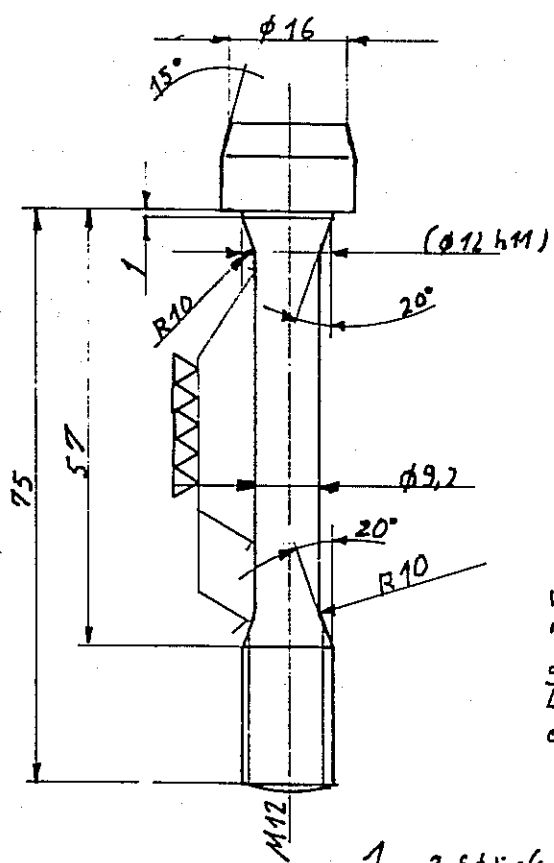
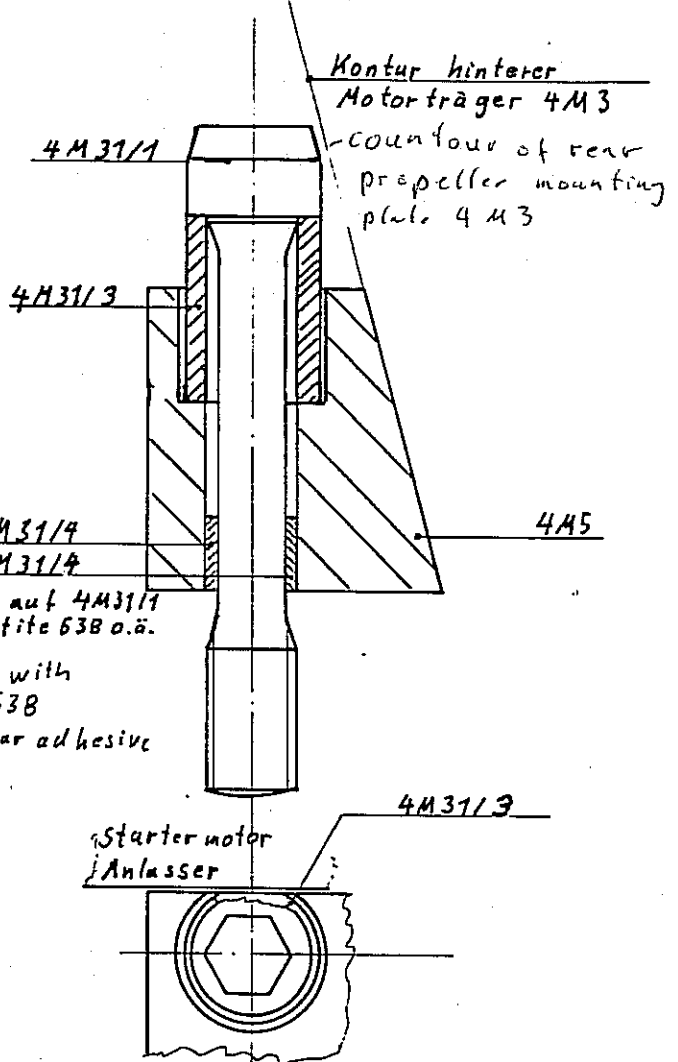
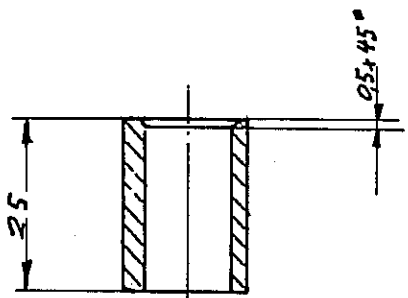
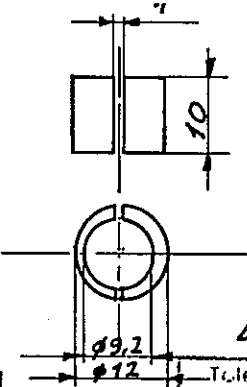
1. DESCRIPTION OF UNSAFE CONDITION: Vibration damage
 at the powerplant.
 a) propellerschaft
 b) screwed connection of rear propeller mounting plate
2. PROBABLE CONSEQUENCE, IF UNSAFE CONDITION IS NOT RECTIFIED:
 complete loss of engine power, damage to other parts of the
 powerplant, damage to the wings
