SUBJECT : Powerplant - propeller shaft

EFFECTIVITY : DG-400 all serial no's

Technical note

No. 826/33

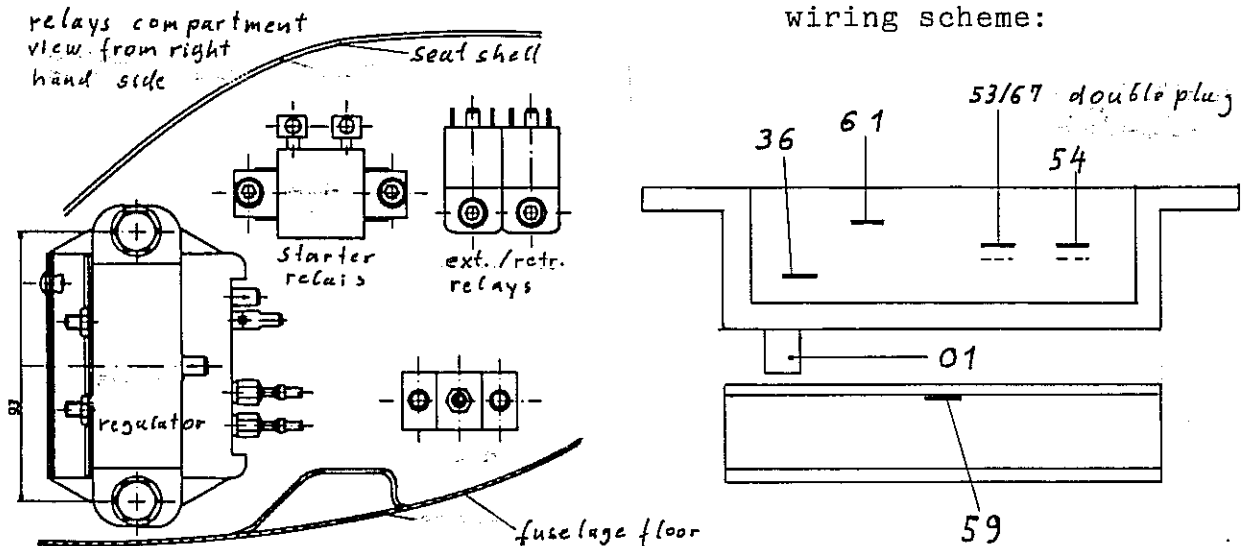
Reason: The regulator Bosch type is no longer available and has a limited life time.

For replacement a regulator type Saprisa was modified so that it can be used instead.

REASON : A Bosch regulator 0212920001 was installed in the DG-400. These regulators have a limited life time.
In recent times more and more regulators have become defective. When failing they may generate smoke in the cockpit which can impair flight safety.
Therefore the regulator must be exchanged against type 4 E 26 which is already mentioned in the DG-400 maintenance manual as interchangeable type.

Instructions: 1. Installation of the modified regulator 4 E 26. To fix the regulator 2 new holes dia. 8 mm must be drilled to the bulkhead (see sketch below). Plug the wires to the new regulator. The wires are marked with the numbers according to the scheme below.
