Subject: Airbrake torque tube in the fuselage, airbrakes in the wings

Effectivity: All types and serial numbers: DG-100, DG-200, DG-400

Inspection and reinforcement of the airbrake torque tube (DG-100, DG-200, DG-400)

Inspection and repair of the airbrakes (DG-100, DG-200, DG-400)

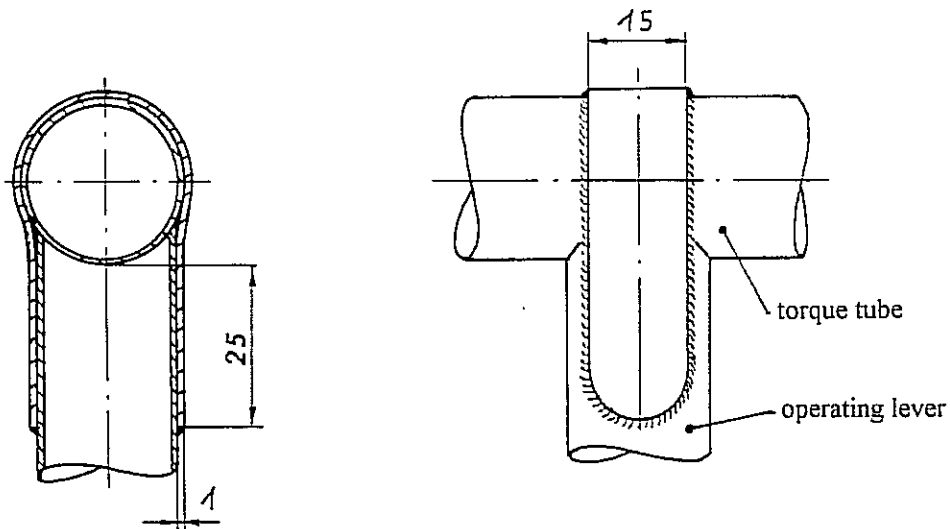
Sheet metal 1St12/2

Prior to the next flight the airbrake torque tube in the fuselage must be inspected. Check the welded joint to the operating lever on cracks or deformation when locking and unlocking the airbrakes on the rigged airplane. The airbrake torque tube can be reached through the inspection hole in the fuselage. For inspection of the welding joint use a mirror and a magnifying glass (magnification min. 5x). In case of doubt remove torque tube for closer inspection.

If there are no defects flying operation can be continued until next inspection. If there is even a minor damage suspected instructions 3 must be accomplished prior to next flight.

If necessary the welded joint of torque tube and operating lever must be reinforced by welding an additional steel sheet 1-St-12/2 made of material 1.7734.4 (s. sketch). Visible cracks or other defects of the original joint must be repaired first. All welding must be done with the TIG-welding system (tungsten inert gas) using welding wire 1.7734.2. Where welding is to be done cadmium plating or painting must be removed first by sandblasting.

If the torque tube is damaged by deep cracks and due to this corrosion inside the torque tube or the lever is suspected, the complete part 1St12 must be exchanged.

After welding all metal surfaces must be protected against corrosion. This can be done by painting with suitable primer and paint.

Thickness: 1mm

Material: 1.7734.4

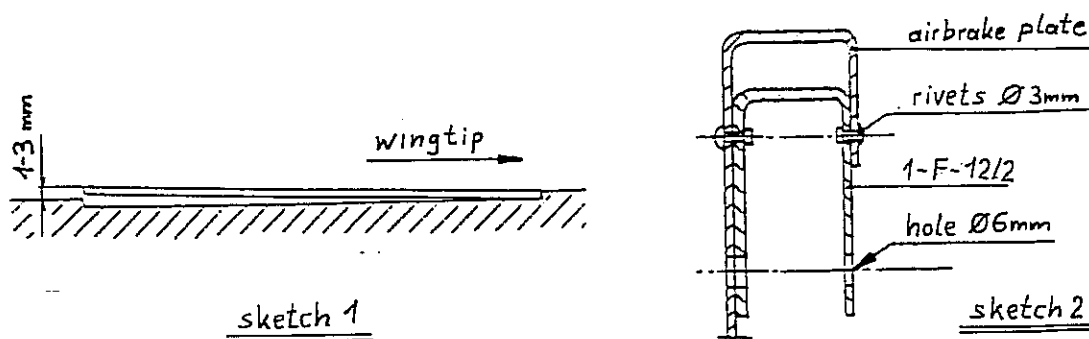
The airbrakes must retract at their outboard end first. When the airbrake cap is flush with the wing surface at the outboard end, the inboard end must be 1-3mm (0.039-0.118in) above the wing surface (s. sketch 1).

If not, modify as follows. With the modification a value of 1-3mm shall be adjusted.
