Subject : Connection of the starter ring gear to the adaptor for the lower drive belt pulley

Effectivity : DG-800B all serial No.'s up to 8-260 except for 8-247 and 8-258
DG 500MB all serial No.'s up to 5E220B15 except for 5E190B5

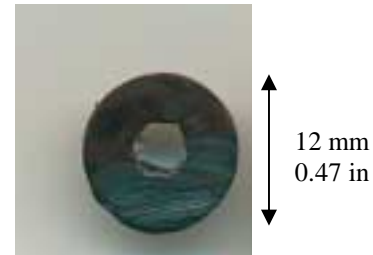
Reason : In some cases the bolts which connect the starter ring gear to the lower drive belt pulley adaptor failed. The sheared off bolt heads have been found in the engine compartment, see photo. A method is given herewith to repair the existing part for a durable connection.

bolt head which has been sheared off

Instructions : 1. Search for bolt heads prior to and after each flight. If a bolt head is found, the engine should not be used any more to prevent from further damage.
2. a) Modify the connection according to working instruction No. 1 for this TN.
b) If the aircraft logs prove that the modification has already been executed (according to DG service info 48/02) the repair has to be inspected and entered in the aircraft logs by a licensed inspector
