Subject : Connection of the starter ring gear to the adaptor for the lower drive belt pulley

Effectivity : DG-800B all serial No.'s up to 8-260 except for 8-247 and 8-258
DG 500MB all serial No.'s up to 5E220B15 except for 5E190B5

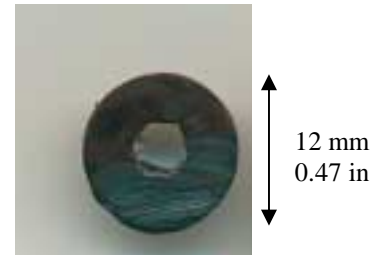
Reason : In some cases the bolts which connect the starter ring gear to the lower drive belt pulley adaptor failed. The sheared off bolt heads have been found in the engine compartment, see photo.
A method is given herewith to repair the existing part for a durable connection.

bolt head which has been sheared off

Instructions : 1. Search for bolt heads prior to and after each flight. If a bolt head is found, the engine should not be used any more to prevent from further damage.
2. a) Modify the connection according to working instruction No. 1 for this TN.
b) If the aircraft logs prove that the modification has already been executed (according to DG service info 48/02) the repair has to be inspected and entered in the aircraft logs by a licensed inspector
