- Subject : Primer valve
- Effectivity : DG-800B all Ser. No's (engine Solo and Mid West) up to 8-321, from 8-322 on standard
DG-500M all Ser. No's
DG-500MB all Ser. No's up to 5E243, from 5E244 on standard

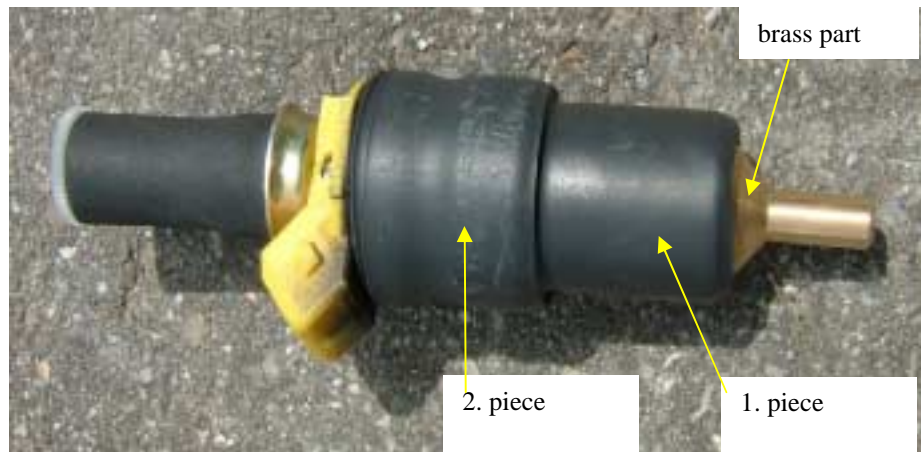
- Reason : On a DG-800B the brass part of the primer valve disintegrated from the valve and fuel was spilt.
- Instructions : 1. Pull with your hand at the brass part of the primer valve to see if it is still fixed to the valve. If the part is loose, instruction 3 must be accomplished prior to the next powered flight.

2. Dismount the pipe clamp which holds the primer valve. Remove the fuel line from the brass part of the valve. Clean and degrease the outer surface of the valve. Cut a piece 55mm (2.2 in.) long from the heat shrink tubing. Slip the tubing over the brass and the black plastic part of the valve body. Use a hot air gun (min. 200°C, 390°F) to heat the tubing until it shrinks and gives a tight fit, see photo.
It is possible that the valve will no longer fit into the pipe clamp. In this case remove the rubber anti-chafe strip from the inside of the clamp and apply a second piece of the heat shrink tubing 25mm long, see photo.
