- Subject : Spindle drive / screwed joint with adapter
- Effectivity : DG-500MB all Ser. No's
- Accomplishment : latest July 31. 2008
- Reason : On a DG-500MB the bolts connecting the adapter 5M204 to the spindle drive failed, causing the powerplant to retract itself after engine shutdown.
To improve the rigidity of the connection, higher strength bolts will be used and the parts will be glued together.

Spindle drive Stross
BSA 10 assembly

DG
5M210

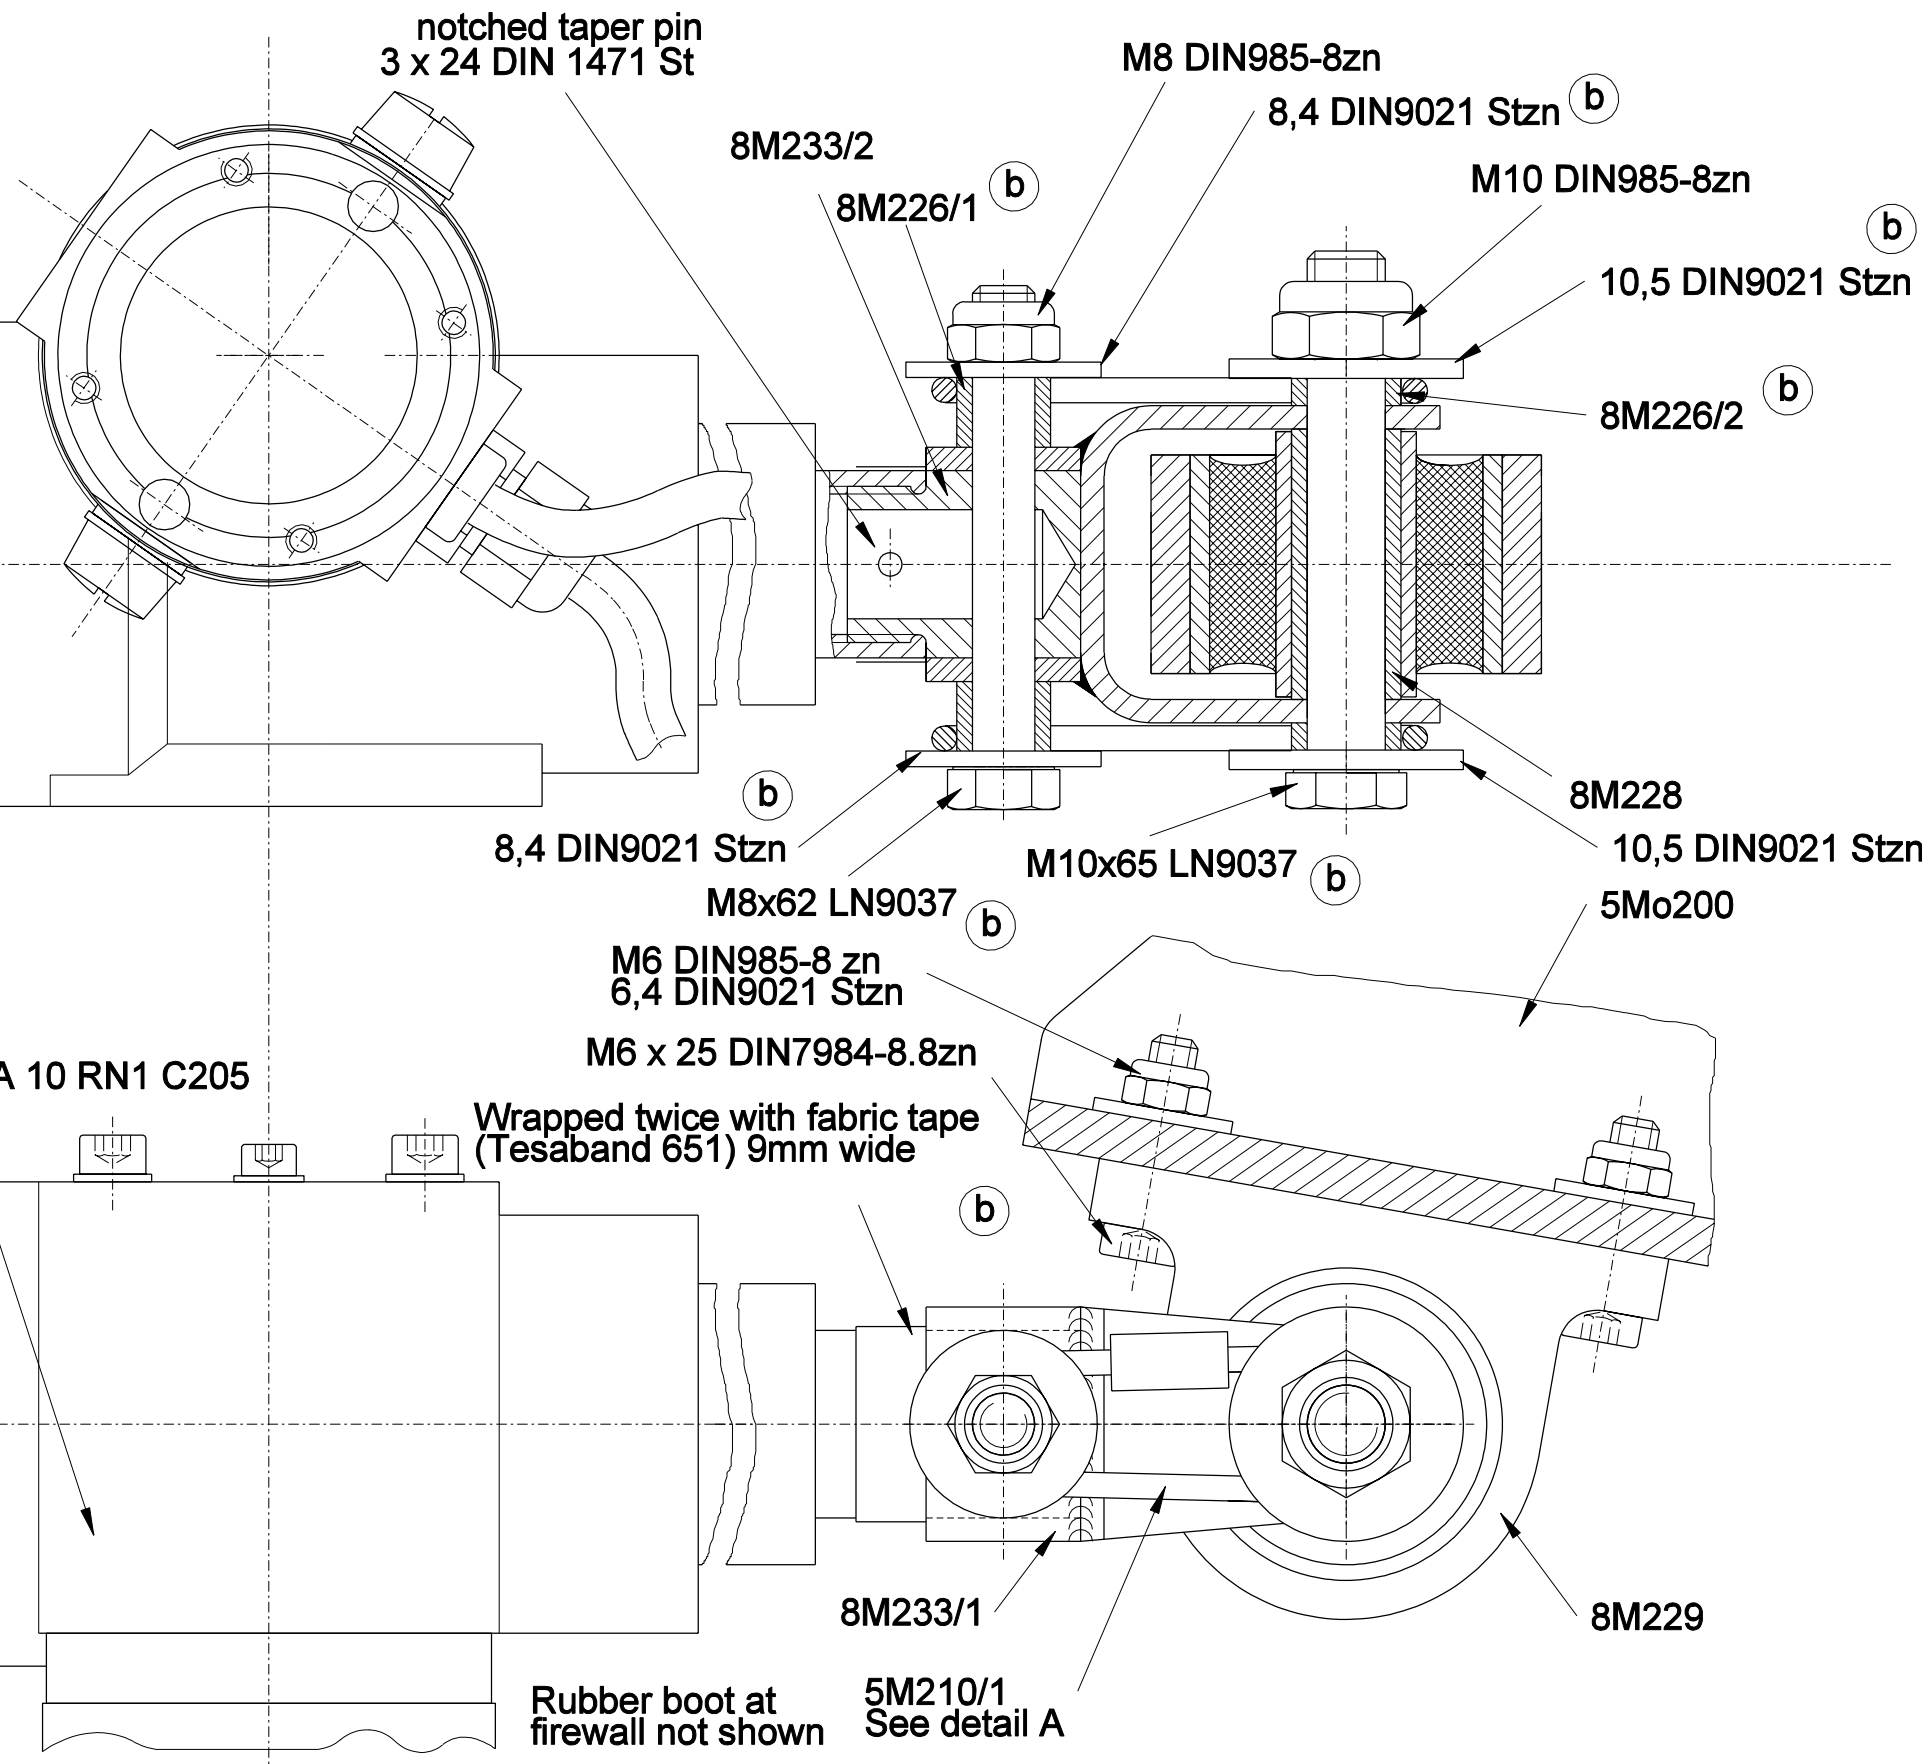
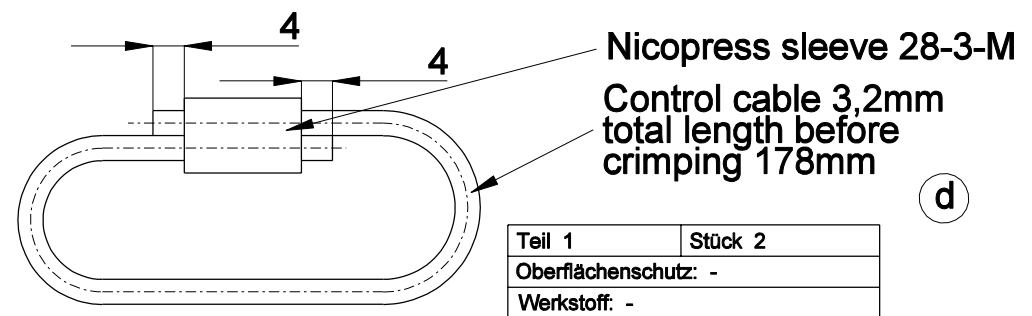
e M5x12 DIN 912-10.9 DAC
secured with Loctite 243

e M5x20 DIN 912-10.9 DAC
secured with Loctite 243

e glued with UHU plus endfest 300
postcured 10 h / 60°C

- Instructions : 1. Remove the spindle drive from the aircraft referring to drawing 5M210.
2. Remove the 4 bolts M5x12 connecting the fork 5M203 to the adapter 5M204 and the 4 bolts M5x20 connecting the adapter to the spindle drive, use a hot air gun to loosen the bolts.

4. Mix UHU plus endfest 300 and apply a thin coat to the contact surfaces. Leave out the areas around the threads. Press parts together.
5. Mount the old bolts again, torque with 5 Nm (3.75 ft lb). Remove excess glue.

6. Let cure for 10 hours at 60°C.
7. Remove the old bolts. Install new bolts M5x12 DIN912-10.9 DAC and M5x20 DIN912-10.9 DAC, secure with Loctite 243. Torque with 5 Nm (3.75 ft lb).
