- Subject** : Canopy lock, rear locking rods, landing gear axles with cone clamping devices, manual revision
- Effectivity** type: DG-1000, DG-500
variants: DG-1000S and DG-1000T
DG-500 all ser. No.'s,

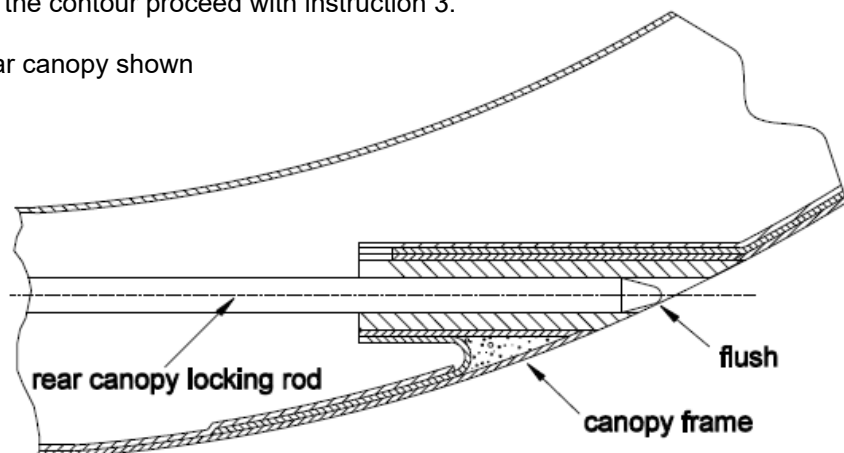
1. With each daily inspection: Check at front and rear canopy if the end of the rear locking rod doesn't protrude over the canopy frame contour with opening mechanism in fully open position. If the rod protrudes over the contour proceed with instruction 3.

Rear canopy shown

3. Repair of the locking mechanism according to repair instruction No. RI-DG-05 if necessary.
4. DG-1000S and DG-1000T ser.No. 10-133 up tp ser.No. 10-267 versions with landing gear without nose wheel: The tightening moments of the nuts of the landing gear axles with cone clamping devices 10FW124 (see diagrams 7a resp. 20 section A-A) and 0FW127 (see diagrams 7a resp. 20 section B-B) should be checked and increased if too low. For correct tightening moments refer the new MM pages issued July 2019 (pages 4.9 resp. enclosure 1 page 7 DG-1000S, resp. enclosure 4 page 6 DG-1000T). To accomplish this you have to remove the baggage compartment floor and back wall. If one axle already moved outwards you have to loosen the nut, push in the axle and tighten the nut see above. If the axle rotates when tightening the nut hold the bolt head.
