DG Flugzeugbau GmbH	Technical note	page 1 from 2
76646 Bruchsal	No. 800/36, 843/30	Revison 1

Subject : Starter ring gear for Solo 2625 01 and 2625 02, zinc coated and painted version

Effectivity : DG-800B, DG-808C and DG-500MB

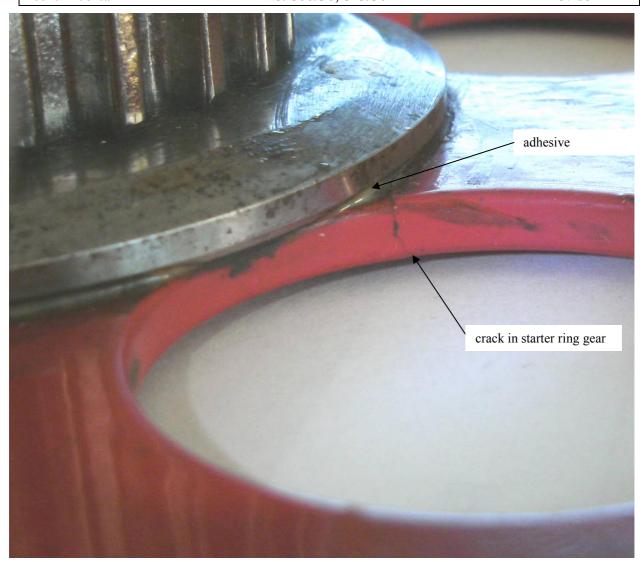
Reason : One of the zinc coated ring gears cracked and the escaping parts caused severe

damage to the starter motor, the engine mount and the drive belt.

As in the meantime reports of cracking on the painted starter ring gears have been received, the manufacturers (Solo) opinion that the zinc plating process may cause Hydrogen embrittlement which encourage cracking must be revised. Therefore all

2. During each pre-flight inspection extend the powerplant just so far, that you can turn the propeller. Clean the lightening holes in the starter ring gear with a piece of cloth soaked with Acetone or cleaning benzine. Check for cracks see photo on page 2.

Caution: Use a powerful torch for the check, otherwise you may not see the cracks.

3. If cracks are visible the starter ring gear must be exchanged prior to next use of the engine. To accomplish this the starter ring gear assembled with adapter and lower drive belt pulley must be removed from the engine according to MM DG-800B and DG-500MB section 4.16.2 item 3, DG-808C section 4.17.2 item 3 and ship the assembly to DG Flugzeugbau for modification.
