- Subject : Bolt of landing gear control interfering with control pushrods
- Effectivity : Type: DG-800, only variant DG-808C, all ser. No.'s
- Accomplishment : Prior to next flight

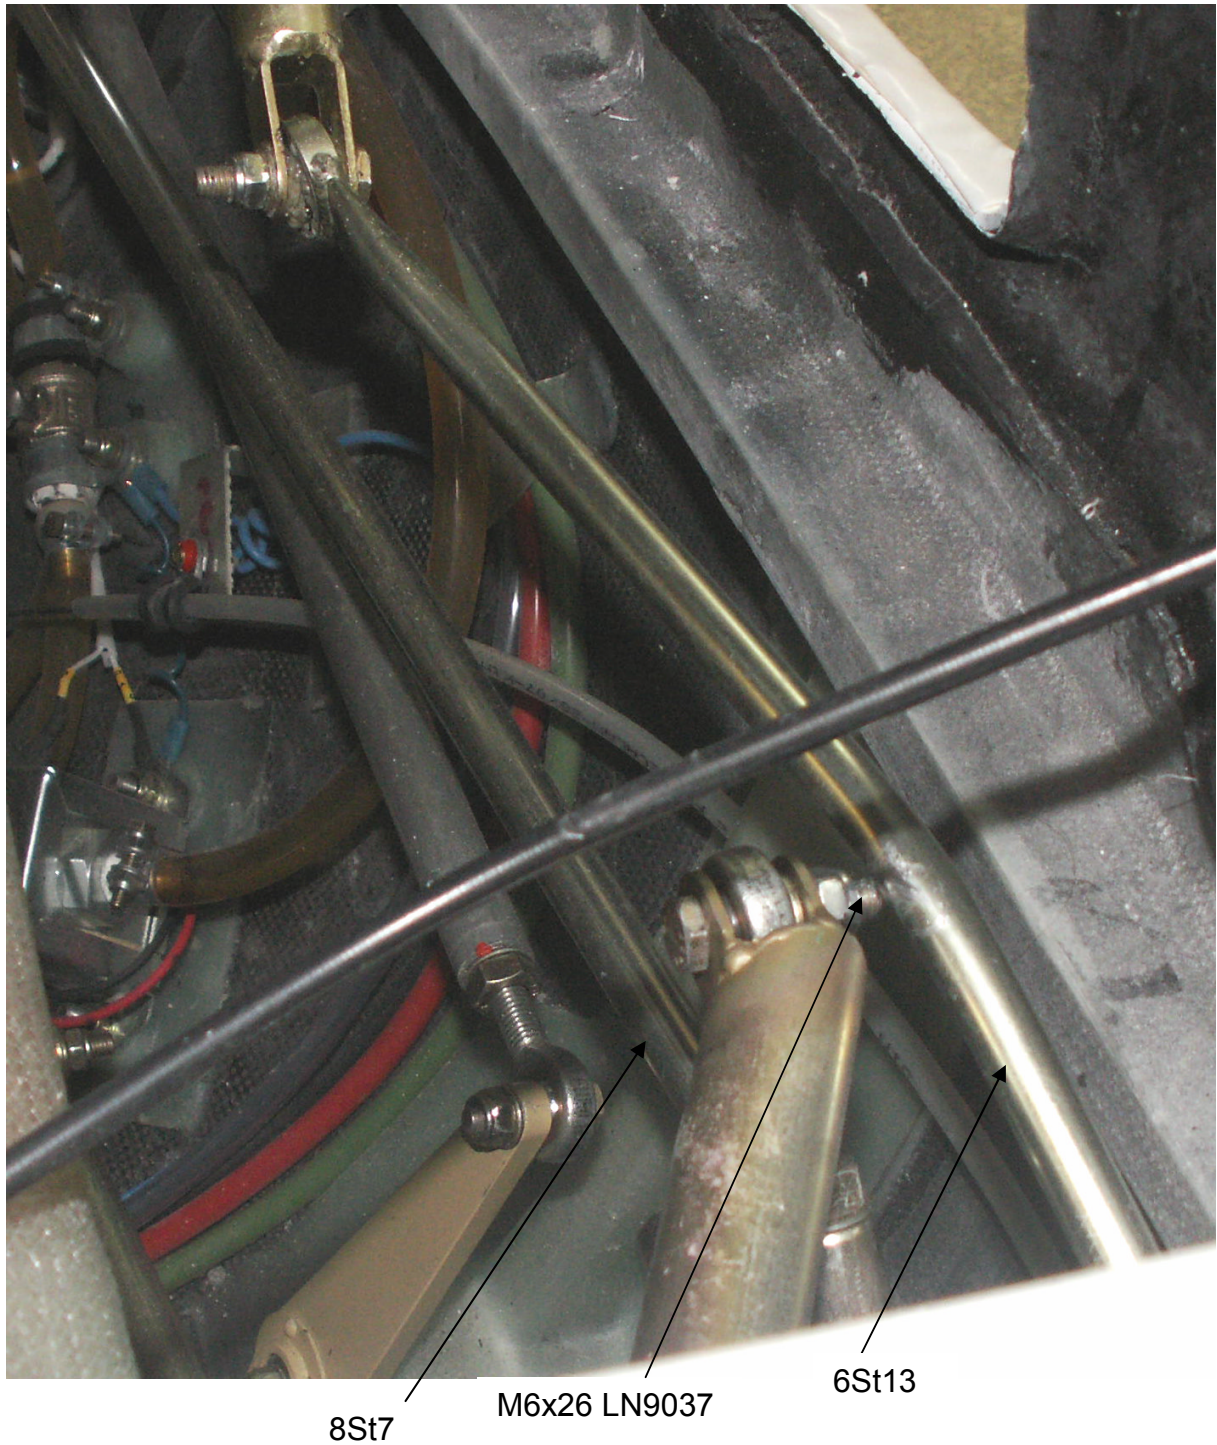
- Reason : Owners found on a DG-808C that the bolt at the landing gear control bellcrank was mounted in the wrong direction and could interfere and damage the air brake push rod in the mid fuselage section. If the landing gear is operated with negative flap settings in addition the wing flap pushrod may be damaged.

**Photo 2: Bolt installed in wrong direction, pushrod 6St13 damaged**

3. If the bolt is mounted in the wrong direction as shown in the photo 2 on page 2 remove the bolt and install in the correctly.  
4. Check if push rod 6St13 (airbrake control) and 8St7 (wing flap control) are damaged. Replace if necessary.
