- Subject : Wingflap handle, manual revisions
- Effectivity Type: LS10
Variants: LS10-s, LS10-st
- Accomplishment : Instruction 1 a): Prior to next flight and at repeat at each annual inspection.
1 b), 1 c): Replace when worn.
Instructions 2: Up to April 31. 2012, but latest prior to the next annual inspection.

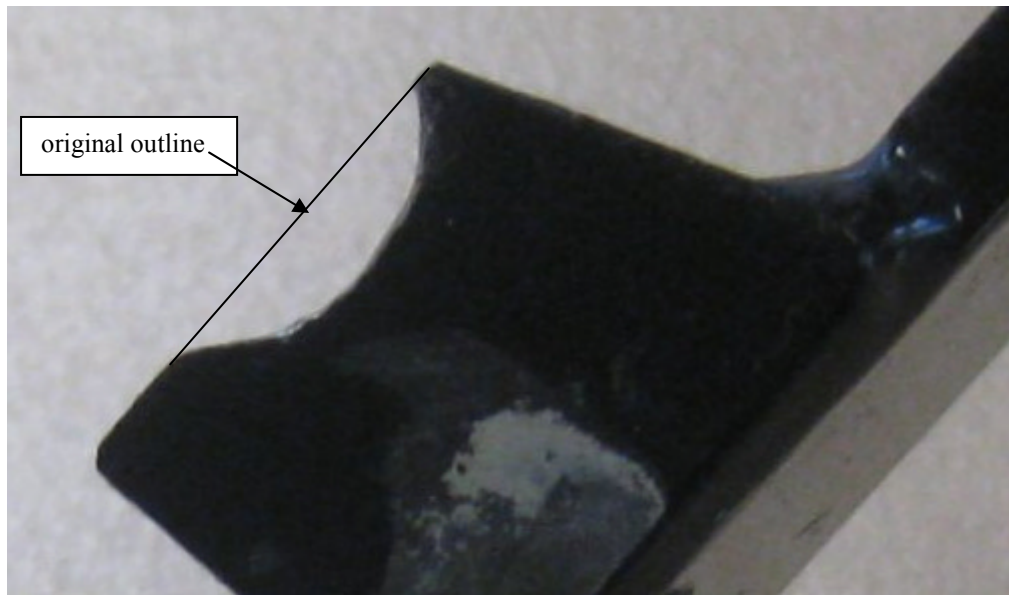
Locking plate at part 9St9

- Reason : 1. The Locking-plate welded to the wing flap handle 9St9 which acts as a detent for the notches in the wing flap guide plate 9St10 was worn quite quickly on some LS10, see photo on the next page.
To use an even harder material for this plate would be the wrong corrective measure, as then the notches in the wing flap guide plate (not removable) will wear out.
To fix the problem a plate made from brass will be bolted to the wing flap handle 9St9. This plate may be exchanged easily when worn (part 9St9/6).

b) If already worn as shown on the picture on page 2 remove the wing flap handle and send it to DG Flugzeugbau for modification. Reinstall the modified item or a new part.

c) Check the locking plate 9St9/6 at each annual inspection and exchange if necessary.
When exchanging the locking plate 9St9/6 it must be fixed with 2 bolts M4x10 DIN933-8.8 BIC to 9St9 and the bolts must be secured with Loctite 243.

Note: Ship the wingflap handle with the riveted in rod-end to DG.

Prior to removal of the handle measure the distance between the front end of pushrod 9St19 (see MM diagram 3) and the axis of the rod-end in 9St9 and adjust to same distance when reassembling.

After reassembling check the wing flap zero adjustment according to MM section 1.4.2 and readjust at the rod-end if necessary.
