Page 1 of 2 Rolladen-Schneider Technical Bulletin No. 6036 / 2 LS6 Flugzeugbau GmbH Edit. 12.Feb.2001 LBA-Nr. EB-4 / I-B16

Subject: Obstruction of emergency canopy jettison and avoidance of possible injuries

Effectivity: All LS6 models.

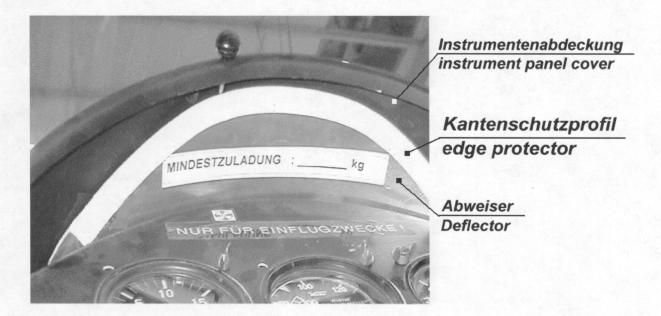
Deflector with edge protector:

Reason: A deflector on the upper instrument panel edge avoids possible jamming of the instrument panel between the canopy mounted panel cover after actuation of the canopy emergency jettison.

- 1. Drill blind rivets. If need be, unscrew upper instruments (Hexagon head 2.5 mm und ratchet with 7mm socket) and place them on top of the second row.
- 2. Mark new fixing holes 10mm (0.4 in) offset from originals and drill. This enables to use the existing holes at the instrument panel edge.
- 3. Shorten straight edge of deflector by 10 mm, soften edge and paint black. Maximum depth of deflector after trimming is 100 mm (3.94 in).
- 4. Rivet deflector back to top of instrument panel, facing towards the pilot (Blind rivets Ø 4mm*6.5, large washers Ø4.3 * 12 * 1mm DIN 9021-St).
- 5. Push edge protector (as long as instrument panel allows) onto deflector edge.

Should the instrument panel cover be too short to allow the protector to fit underneath, contact manufacturer stating model and serial number.
