- Subject : Free play in automatic elevator hook-up, adjustment
- Effectivity type: DG-single seaters  
variants: All types and variants with automatic elevator hook-up only. This TN is not valid for variants with l'Hotellier connections in the elevator control.
- Accomplishment : Latest 3 months after the effective date of the relevant AD or with the next annual airworthiness review, whichever comes first.
- Reason : On a DG-300, the rod end at the upper end of the elevator pushrod in the fin broke off at the thread.  
It was found that the elevator play adjustment screw was turned in too far, which caused jamming of the roller inside the funnel. The roller couldn't be moved up to the front of the funnel, even with higher force.

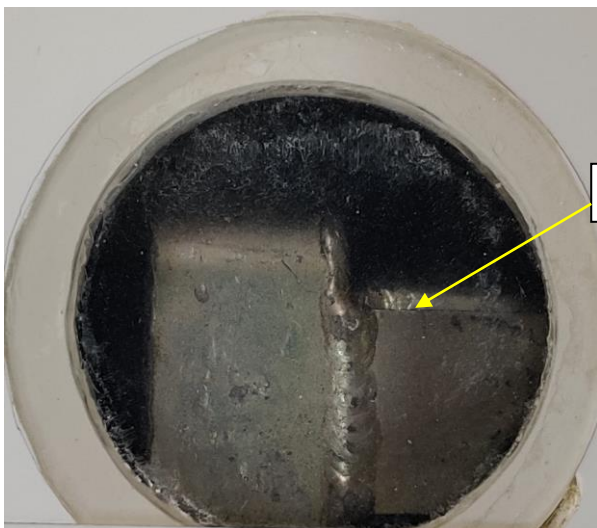
Figure 2, look through the inspection window DG-600

- 2.5 Rig the horizontal tailplane and when moving it backwards, monitor that no larger force is needed. By looking through the Plexiglas window at the upper surface of the stabilizer, check if the roller will be moved up to the front end of the funnel, see also the photos at the end of this TN.

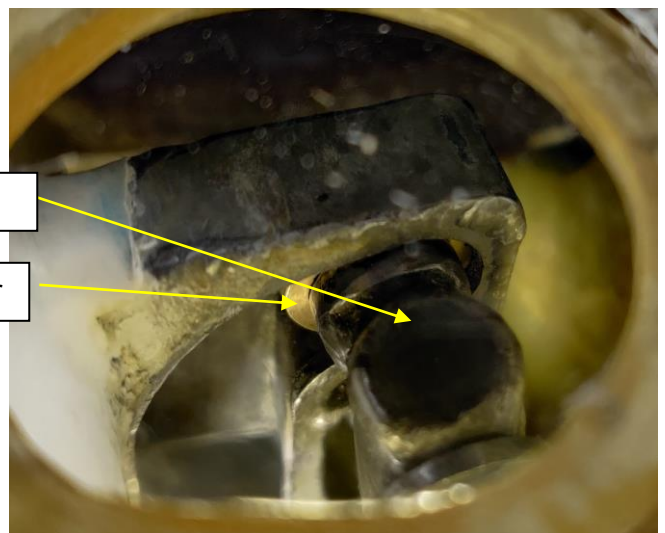
Figure 3, look through the inspection window DG-100-400
