- Subject : Free play in automatic elevator hook-up, adjustment
- Effectivity type: DG-800
variants: all
- Accomplishment : Latest 3 month after the effective date of the relevant AD or with the next annual airworthiness review, whichever comes first.
- Reason : On a DG-300, the rod end at the upper end of the elevator pushrod in the fin broke off at the thread.
It was found that the elevator play adjustment screw was turned in too far, which caused jamming of the roller inside the funnel. The roller couldn't be moved up to the front of the funnel, even with higher force.

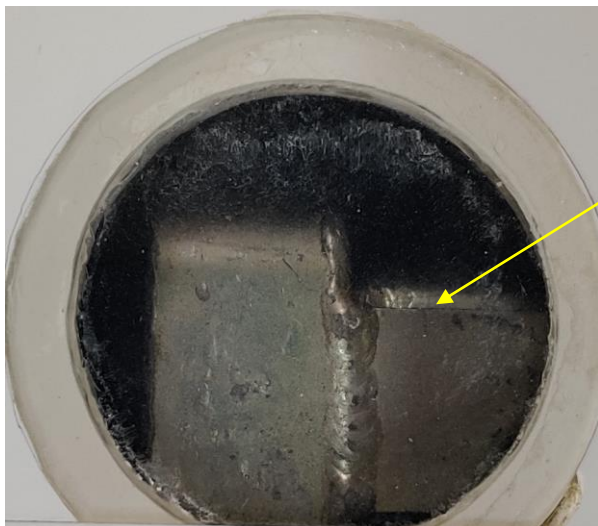
rod-end

look through the window

- 2.5 Rig the horizontal tailplane and when moving it backwards, monitor if you need a higher force. By looking through the Plexiglas window at the upper surface of the stabilizer, check if the roller will be moved up to the front end of the funnel, see also the photos at the end of this TN.
