Subject : Free play in automatic elevator hook-up, adjustment

Effectivity type: DG-1000
variants: all

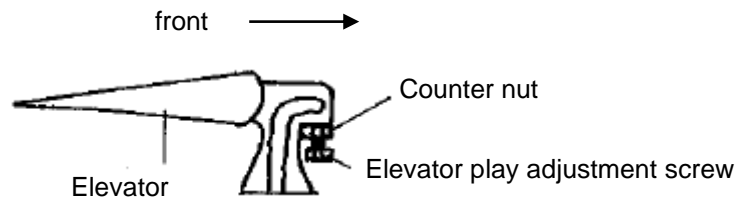
Figure 1, schematical view of elevator

Reason : On a DG-300, the rod end at the upper end of the elevator pushrod in the fin broke off at the thread.
It was found that the adjustment screw was turned in too far, which caused jamming of the roller inside the funnel. The roller couldn't be moved up to the front of the funnel, even with higher force.

Thereby each time when rigging and during operation a bending force acted on the rod end, which caused failure of the rod end with time.

2. Check of the free play adjustment of the automatic elevator hook-up.
2.1 For this step, two alternative methods can be chosen, method a) or method b):

a) Remove the complete rod end with the roller installed by loosening the M5 nut and the M8 lock nut. After the parallelogram lever has been removed, the rod end can be turned out of the control rod. When removing the rod end from the control rod, count the number of rotations for correct re-installation.

b) Remove the roller from the rod end by removing the M6 DIN985 nut and the M6 bolt from the rod end. Then stick the roller on an 8 mm f7 pin.
a) and b) Now enter the roller (at the rod end or on the pin) into the funnel at the elevator and slide it around the corner (horizontal tailplane not rigged to glider). Now move the roller completely to the front. If the roller can't be moved without force completely to the

front, this is an indication the glider was operated with the adjustment screw turned in too far, see instruction 2.2. In this case, turn back the adjustment screw and bend back the sheet metal in the funnel, which was bent by the adjustment screw. Then adjust the free play again and tighten the counter nut.

- 2.2 In case the glider was operated with the adjustment screw turned in too far (see instruction 2.1), the rod end must be replaced by a new one 10St97/1.
