- Subject : Free play in automatic elevator hook-up, adjustment
- Effectivity type: DG-500
variants: all
- Accomplishment : Latest 3 month after the effective date of the relevant AD or with the next annual airworthiness review, whichever comes first.
- Reason : On a DG-300, the rod end at the upper end of the elevator pushrod in the fin broke off at the thread.
It was found that the adjustment screw was turned in too far, which caused jamming of the roller inside the funnel. The roller couldn't be moved up to the front of the funnel, even with higher force.

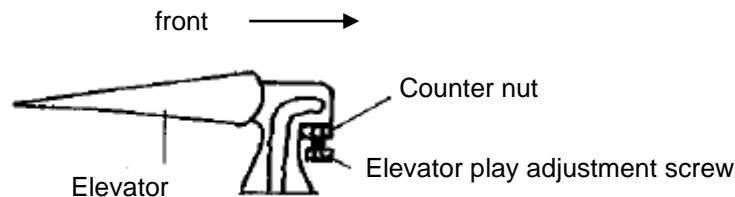
Figure 1, schematical view of elevator

Thereby each time when rigging and during operation a bending force acted on the rod end, which caused failure of the rod end with time.
As the type of automatic elevator hook-up is similar in all DGs equipped with automatic hook-up, the following instructions are valid for all affected DG gliders and motor gliders.

2. Check of the free play adjustment of the automatic elevator hook-up.
2.1 For this step, two alternative methods can be chosen, method a) or method b):

a) Remove the complete rod end with the roller installed by loosening the M5 nut and the M8 lock nut. After the parallelogram lever has been removed, the rod end can be turned out of the control rod. When removing the rod end from the control rod, count the number of rotations for correct re-installation.

b) Remove the roller from the rod end by removing the M6 DIN985 nut and the M6 bolt from the rod end. Then stick the roller on an 8 mm f7 pin.
a) and b) Now enter the roller (at the rod end or on the pin) into the funnel at the elevator and slide it around the corner (horizontal tailplane not rigged to glider). Now move the roller completely to the front. If the roller can't be moved without force completely to the front, this is an indication the glider was operated with the adjustment screw turned in too far, see instruction 2.2. In this case,
