SUBJECT : Ducati Electronic Ignition Boxes

EFFECTIVITY : DG-400 from ser.no. 4-286 to ser.no. 4-290
DG-500 M from ser.no. 5E59 M 24 to 5E90 M 38
and 5E93 M 40

Working Instruction for Service Information 0-6/93

Return Notice for Service Information No. 0-6/93

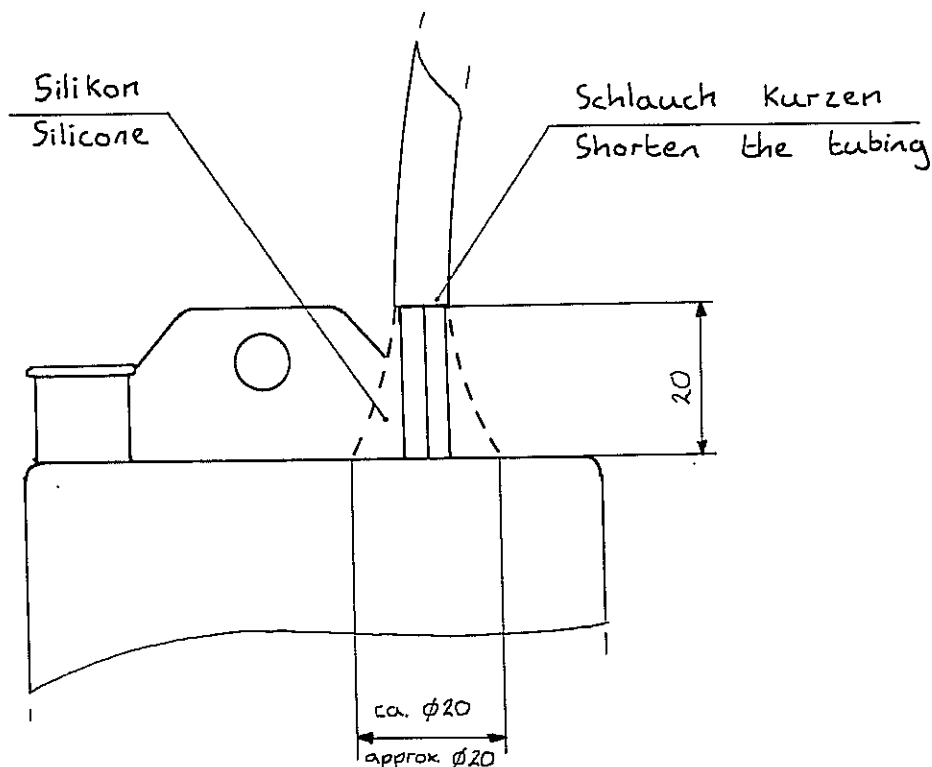
DG
4 M 78

REASON : At one motorglider a break in the cable was
detected after a running time of approx. 40
hours.

a: Ty-Rap 4,8x186

INSTRUCTIONS : 1. Create a flexible connection at the cable
exit by embedding the cable in silicone
rubber. Refer to Working Instructions for
Service Information No. 0-6/93.
2. Fill in the return notice and send it to
Glaser-Dirks.

6. After the silicone rubber has hardened assemble the ignition boxes, using new ty-raps.
Refer also to drawings 4M77 and 4M78 for the DG-400 and 5M74 for the DG-500M.
Caution: The ty-raps (4.8 x 186) marked with "a" in drawing 4M78 secure the 4 plug connectors of the electronic boxes. The ty-raps must be tightened by hand as tight as possible, so that pulling apart of the connectors is prevented. Then fix the wiring with the other ty-raps.
However, this wiring should only be opened with the exchange of ignition boxes.
