- Subject : Tension gas strut
- Effectivity : DG-800B
- Accomplishment : In case of damage of the gas strut
- Reason : It happened that the front fitting of the tension gas strut failed (fixing point to fuselage). Due to engine vibrations the hole in the fitting elongated. For DG-800B's where this failure occurs a modification was developed. The front fitting of the gas strut is equipped with a rubber mount (Ultra-bush).

installation gas strut  
 version with  
 Ultra-bush  
 retrofit DG-800B

**8M194**

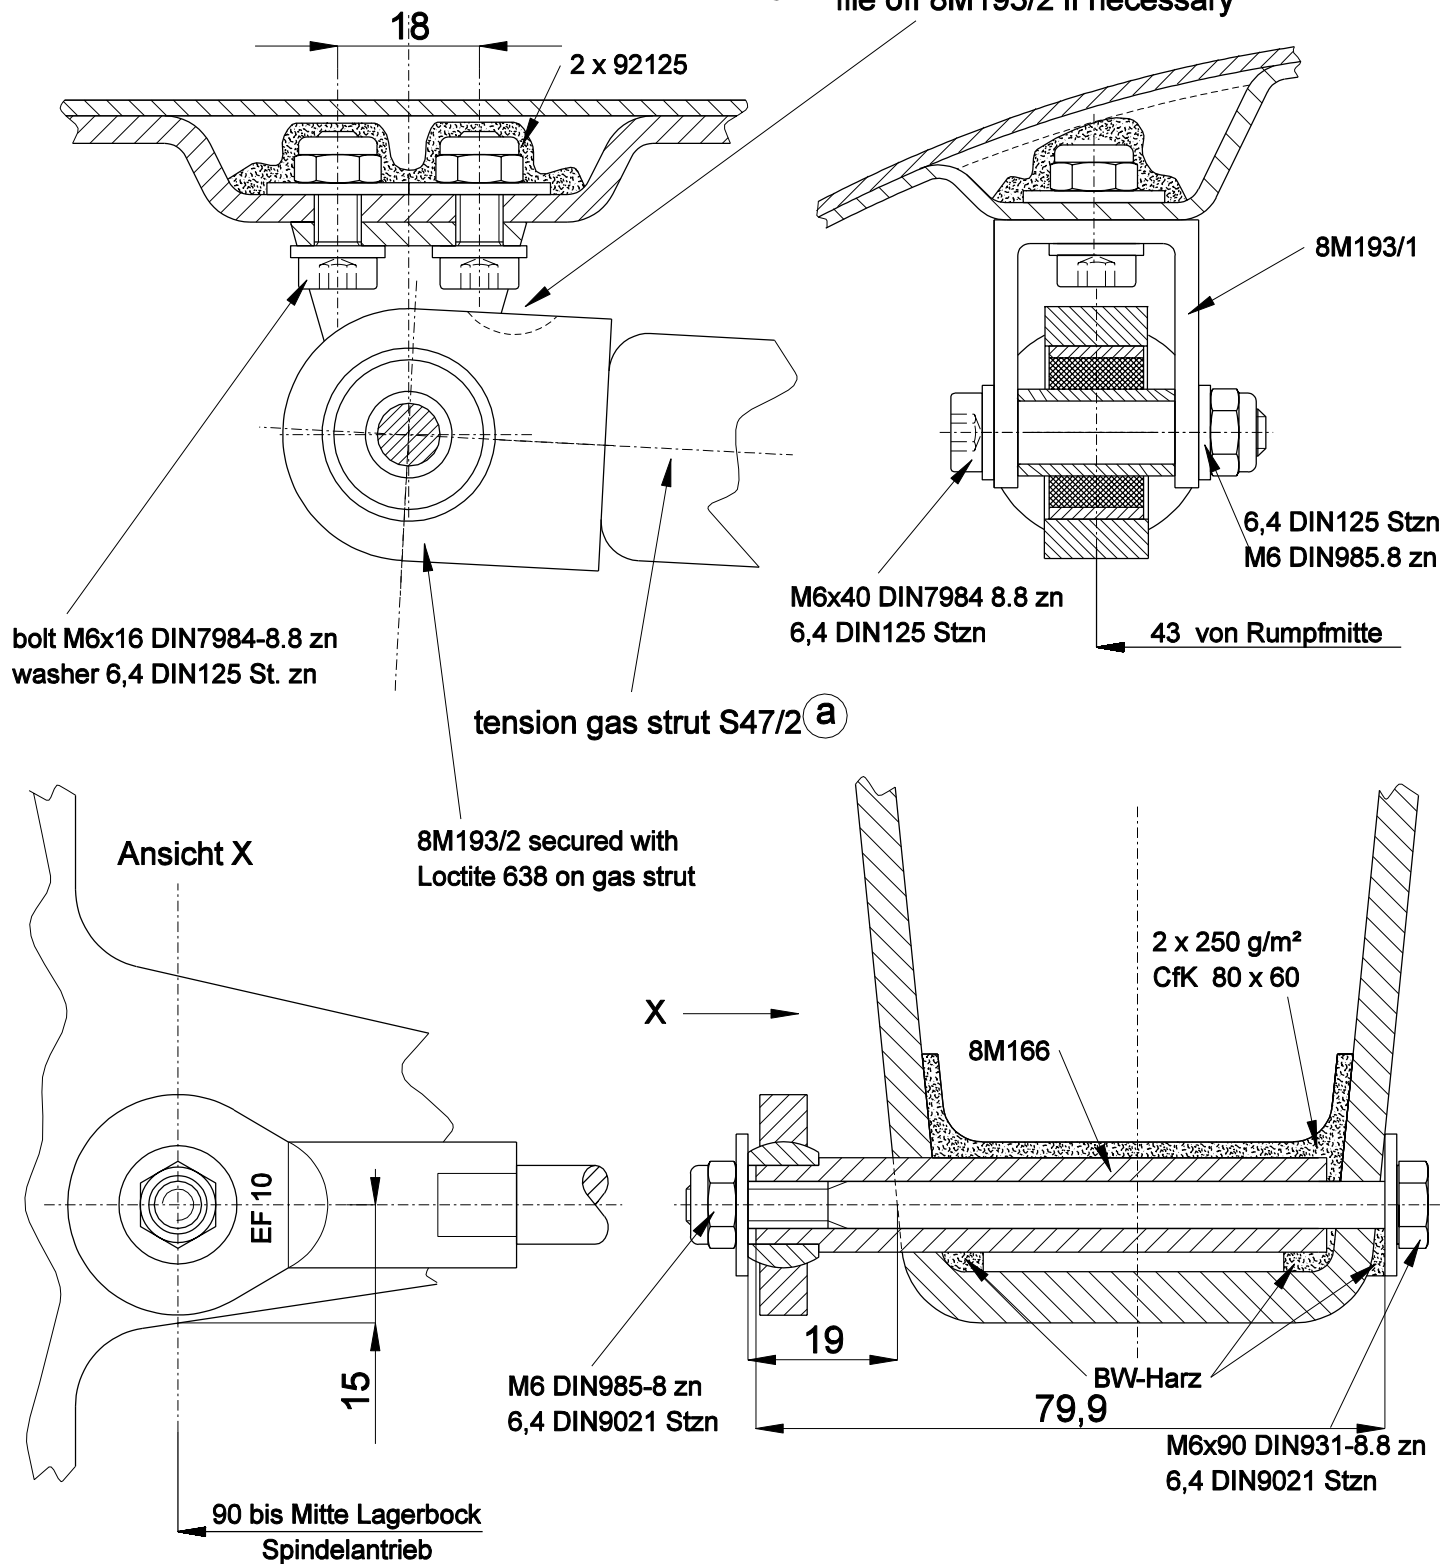
**a** check for enough space in all positions, file off 8M193/2 if necessary

- Instructions :  
1. Remove the damaged gas strut according to MM section 4.13.  
2. Remove the front mounting bracket from the fuselage.  
3. Install the new mounting bracket 8M193/1 according to drawing 8M194.

4. Install the new gas strut S47/2 according to drawing 8M194 and MM section 4.13.
- Material : drawing 8M194  
1 piece tension gas strut Version with Ultra-bush S47/2  
1 piece mounting bracket 8M193/1  
2 pieces bolt M6x16 DIN7984-8.8 zn  
1 piece bolt M8x50 DIN7984 8.8 zn  
1 piece washer 8,4 DIN125 St zn  
1 piece selflocking nut M8 DIN985-8 zn  
3 pieces washer 6,4 DIN125 St zn  
1 piece selflocking nut M6 DIN985-8 zn
