- Subject : Ballast box in the fin, foam rubber rings
- Affected : DG-1000S, DG-1000T, all ser.no.'s
- Urgency : prior to next flight and upon changing the trim ballast in the ballast box

This service info has been approved by EASA date 23. April 2008 with technical note DG-G-04.
Approval No. EASA.A.C.09568.

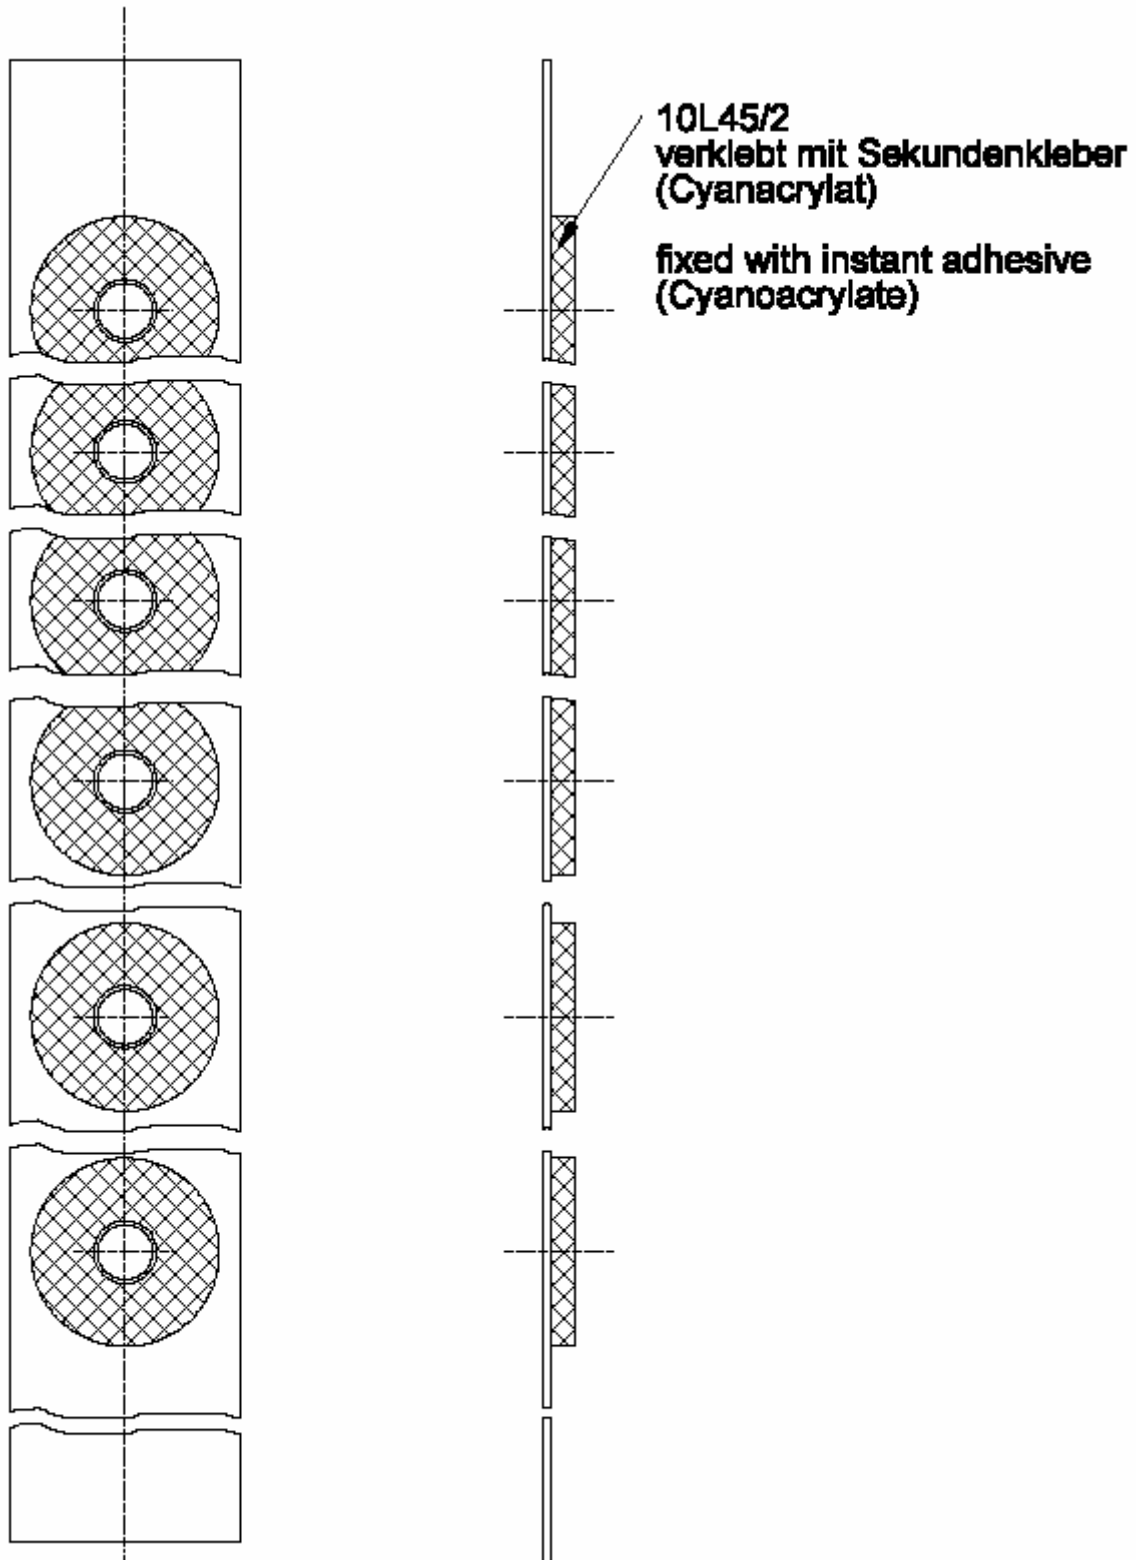
Assembly drawing for foam rubber rings 10L45/2:

- Reason : In a DG-1000T a foam rubber ring glued to the mounting plate of the optical sensors for checking the trim ballast has detached. This caused an indication error of the control lamp in the front instrument panel.

- Instructions : 1. Check condition and correct gluing of the foam rubber rings 10L45/2 (in older factory serial numbers felt strips and/or rings) in the ballast box in the fin.

2. Remove detached and damaged rings and replace them by new rings according to drawing on page 2. If felt strips are installed, replace them if damaged by foam rings.
Remove adhesive remains before bonding the new rings.

3. Check the foam rubber rings according to point 1 when changing the trim ballast.
- Material : - order no. 41020452 Foam rubber rings 10L45/2
- order no. 30002009 Instant adhesive (Cyanoacrylate)
Type Pattex Blitz
