## Maintenance manual DG-800 B MW

No.	Page	Description	Datem
1	2, 3, 4, 25, 28, 49,	Manual revision TN 873/27	Nov. 2001
	86, 91, 93,		
	8E101, 8E105		
2	1 - 5, 43, 44, 47,	Fuel hoses	October
	92, diagram 11	TN 800/44	2016
3	1-6, 33,34, 44, 93,	manual revision, coolant hoses	July 2017
	diagrams 3, 9	TN800/45	
4	1-3, 5, 45-47, 47 a,	manual revision, life time drive	May 2023
	48, 49	belt	
		TN800/45	
5	1, 2, 8 - 10	TN800/50	December
		adjustment of elevator free	2023
		play

Issued: December 2023 TN 800/50 2

Issue: December 2023 TN800/50 8

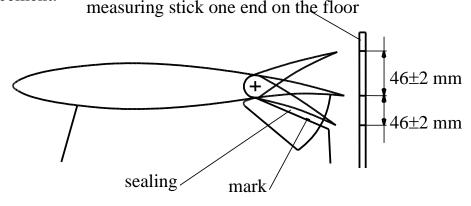
#### 1.2.2 Elevator deflections and tolerances

Up  $46 \pm 2 \text{ mm} \quad 1.81 \pm 0.08 \text{ in.}$ Down  $46 + 2 \text{ mm} \quad 1.81 + 0.08 \text{ in.}$

measured at 134 mm (5.3 in.) from hinge axis which is directly at the edge of the cut-out for the rudder.

Hold a measuring stick with one end on the floor. Deflect the elevator to neutral position by bringing the mark at the sealing in line with the upper end of the fin. Mark the 0-point on the stick. Then mark the up and down displacement.
