# Landing gear positive locking device

diagram17  
issued February 2008  
TN1000/13

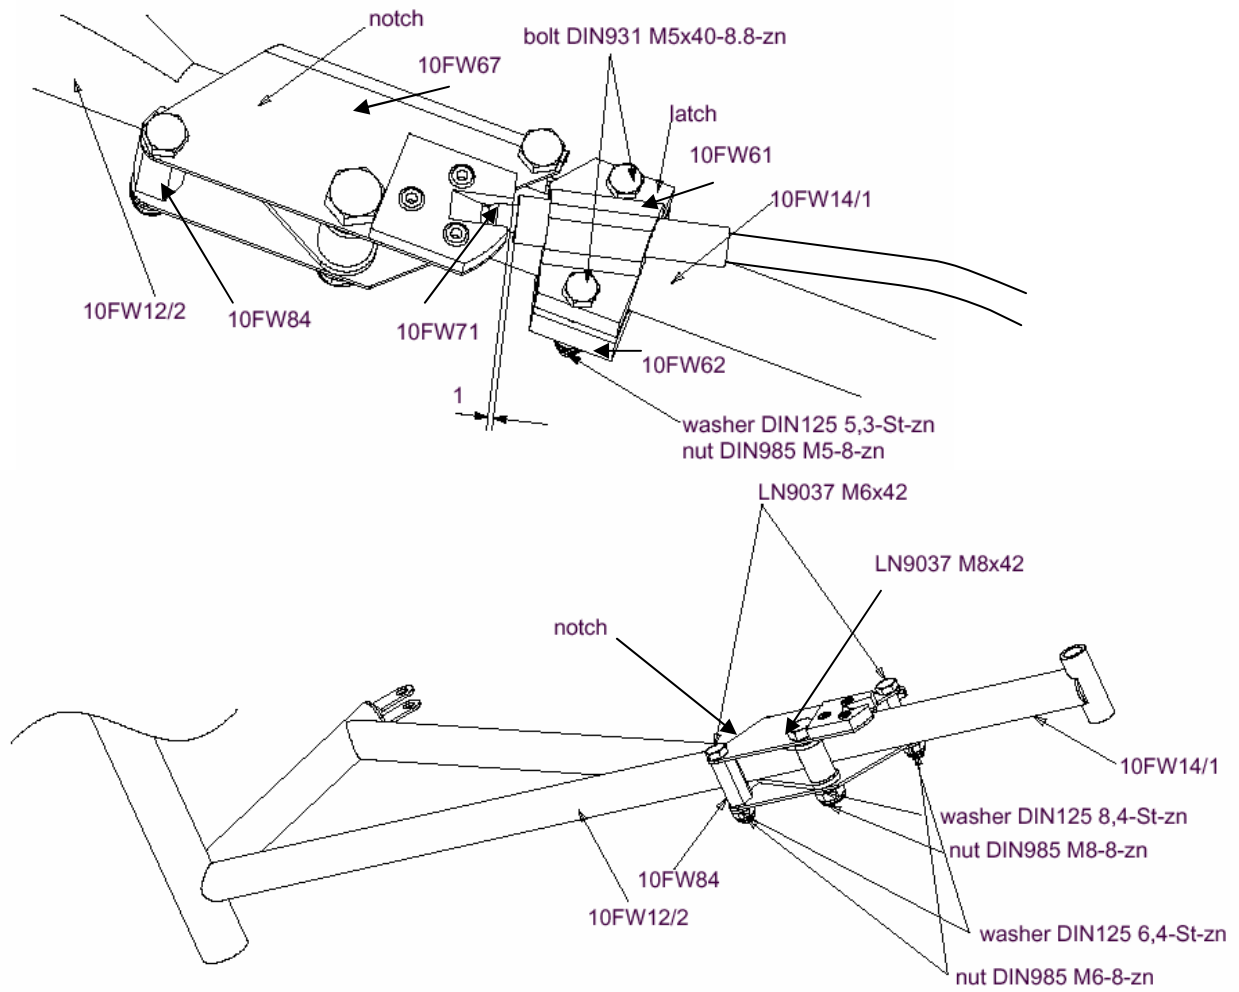
installation of the notch (LG extended) to 10FW12/2

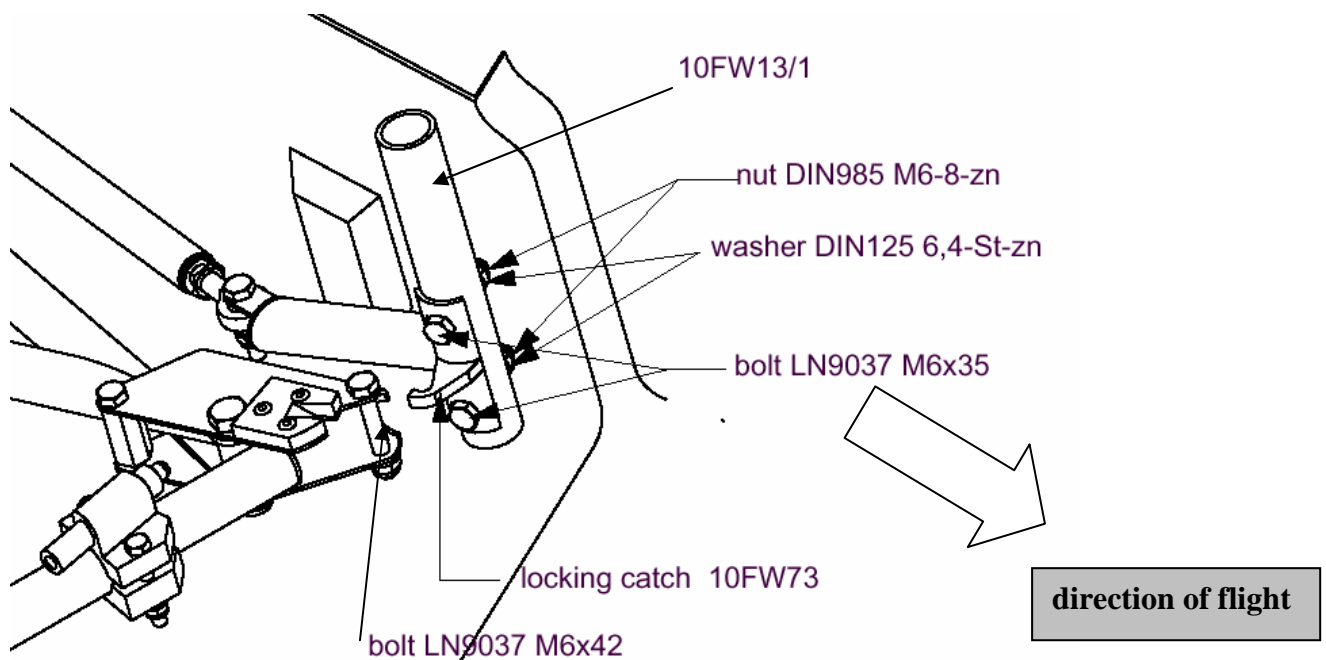
Installation of the locking catch. View LG retracted, locking catch not engaged
