Working instruction for installation of a landing gear positive locking device

DG Flugzeugbau GmbH Working instruction No. 1 for TN1000/13

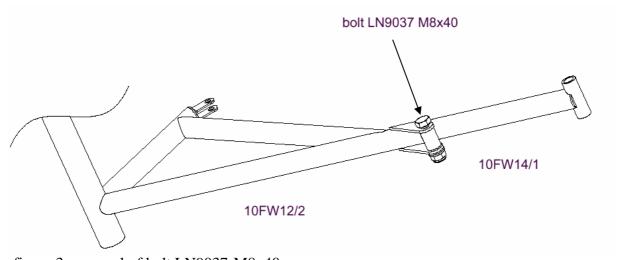
- 1. Extend the landing gear but don't lock it over centre.
- 2. Remove the rubber cords of the landing gear doors, open and fix the doors with tape to the fuselage.
- 3. The forced landing gear locking device will be installed at the left struts of the landing gear. Therefore remove the bolt LN9037 M8x40 which connects the left strut 10FW14/1 to the rear fork 10FW12/2, see figure 3. (will no longer be used)

figure 3: removal of bolt LN9037-M8x40

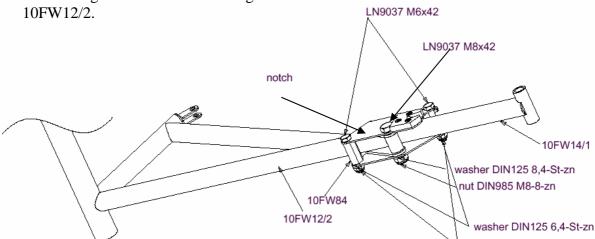
- 4. Push the notch unit over the lugs of strut 10FW12/2 and install the bolt LN9037-M8x42 from the inside to the outside according to figure 4. If a grub screw DIN913 M5x8 is already installed in the notch it must be removed.
- 5. Mount the hexagon 10FW84 (with eccentric borehole) into the notch unit according to figure 4. Mount all bolts from the inside to the outside.

Extend the LG to the fully extended (over centre locked) position. Rotate the hexagon just so far that the front bolt LN9037 M6x42 of 10FW84 doesn't quite touch the tube of strut

10FW14/1 (one flat of the hexagon must be flat to the tube of 10FW12/2). Apply Loctite 243 to the grub screw and turn the grub screw into the notch until it touches the tube of

figure 4: installation of the notch

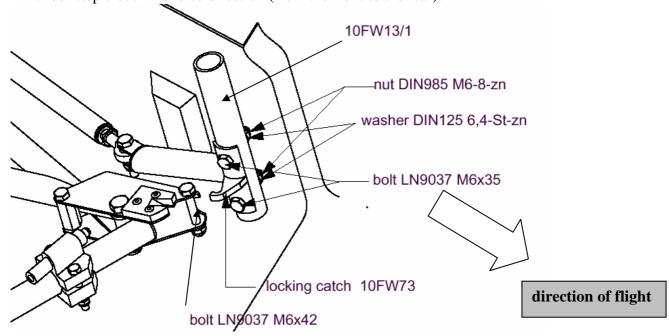
- 6. Retract the LG halfway. Proceed with the further steps in this position.
- 7. Remove the 2 bolts LN9037 M6x35 which connect the front upper fork 10FW13/1 to the shaft 10FW15/3.
- 8. Install the locking claw 10FW73 according to figure 5. Reinstall the 2 bolts removed under step 7 but in reverse direction (from the front to the rear).

figure 5: installation of the locking catch. View LG retracted, locking catch not engaged.

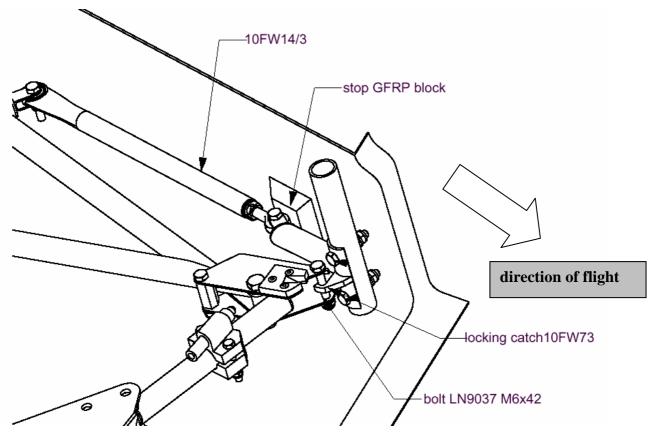
figure 6: Installation of the locking catch. View landing gear retracted, locking catch engaged.

- 12. To enlarge the travel of the locking catch 10FW73 you may file off some of the GFRP stop blocks (see figure 6) if necessary.
- 13. As soon as the adjustment is correct tighten the 2 bolts LN9037 M6x35.

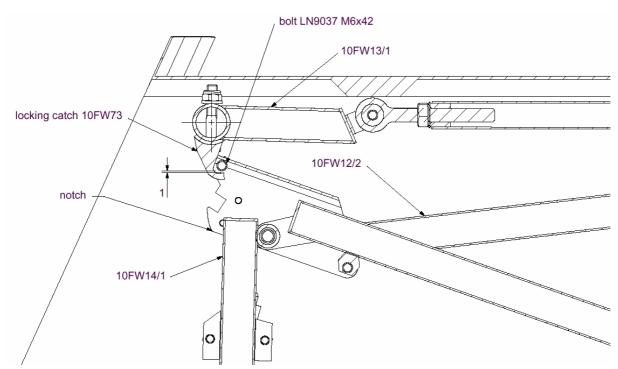
- 11. Check if the locking catch 10FW73 engages with the bolt LN9037 M6x42 at the notch.. If the bolt stays below the locking catch (LG fully retracted), file off from the stop block at the rear upper end of the LG box (stop for 10FW12/2) so far that the bolt comes up high enough to enable the locking catch to engage. Rotate the catch if necessary. The distance between the bolt and the locking catch should be approx. 1 mm see figure 7.

figure 7: Adjustment (Cross section through the landing gear struts)

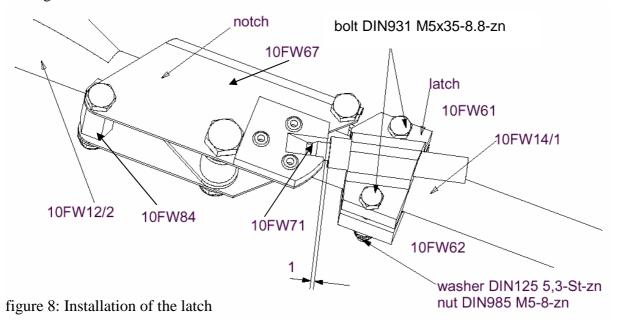
- 14. Extend the landing gear completely (locked over centre).
- 15. Install the latch consisting of the 2 parts 10FW61 and 10FW62 which form a pipe clamp to strut 10FW14/1 see figure 8. Insert the locking pin 10FW71 with pressed in Bowden cable and the compression spring into the latch housing. Fix the cable with a clamp so that the pin can't fall out.

Rotate the clamp so far that the latch pin 10FW71 is centred to the notch.

Important: There should be a distance of 1 mm between the notch and the latch housing see figure 8.

- 3. Install the adjustment screw to 10FW74. Insert the Bowden cable through the adjustment screw and through a Nicopress sleeve 28-1-C, lay around the thimble and insert into the Nicopress sleeve again. Pull the cable tight but not quite operating the locking pin 10FW71 (see figure 8). Mark the position. Unscrew the bolt which connects the thimble to the actuation unit, unfasten the adjustment screw, remove the bowden cable and pull it up and press the Nicopress sleeve.

- 4. Reinstall the bowden cable with thimble.
- 5. Adjust the cable via the adjustment screw so that the locking pin disengages when retracting the landing gear. The distance 1mm according to figure 8 also applies for the disengaged locking pin.

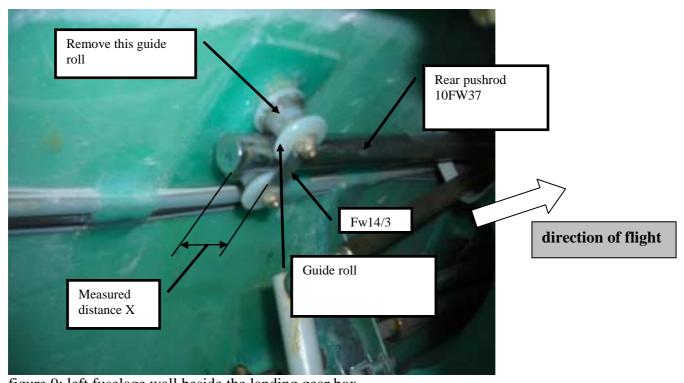
- 1. Remove the left hand side cover in the rear cockpit
- 2. Remove the baggage compartment floors and the back cover
- 3. Measure the distance from the end of the pushrod 10FW37 to the sheet FW14/3 (=X) (see figure 9). Make a note of the measurement.
- 4. Remove pushrod 10FW20, spring 2St22, the guide rollers of the pushrod 10FW37 and the pushrod 10FW37. (see figures 9 and 10)

figure 9: left fuselage wall beside the landing gear box

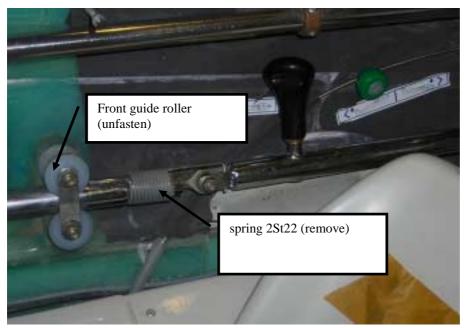
figure 10: left fuselage wall in rear cockpit

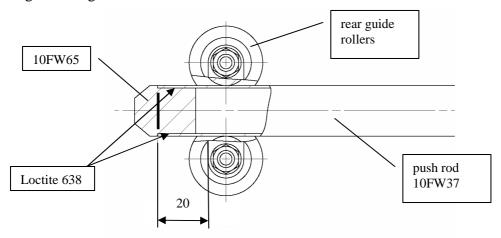
5. Cut off X-20 mm from the pushrod 10FW37 (X see 3.). Glue part 10FW65 according to fig. 11 using Loctite 638.

figure 11: installation of part 10FW65

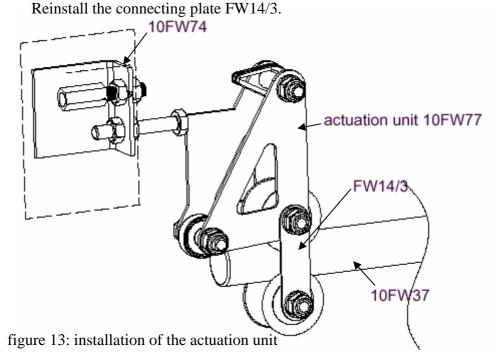
7. Install the actuation unit 10FW77 at the stud bolt for the rear upper guide roller (see figure 13 and MM diagram 18). The existing upper roller will no longer be used. Reinstall the push rod 10FW37 at the same time with the rollers.

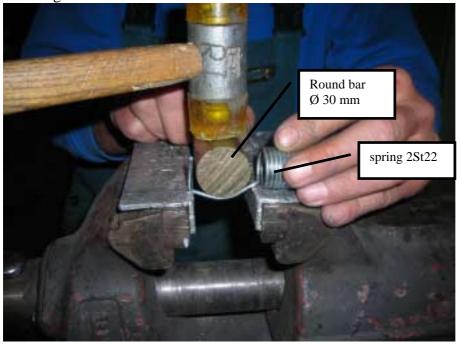
- 8. Fasten the nuts of the front guide rollers.
- 9. Turn in the rod end between pushrods 10FW37 and 10FW38 (see figure 15) completely and thereafter unscrew it a half turn.
- 10. Deform the spring 2St22 at a vice according to drawing figures 14 and 15. New designation is 2St22/2.

figure 14: Deforming the spring 2St22

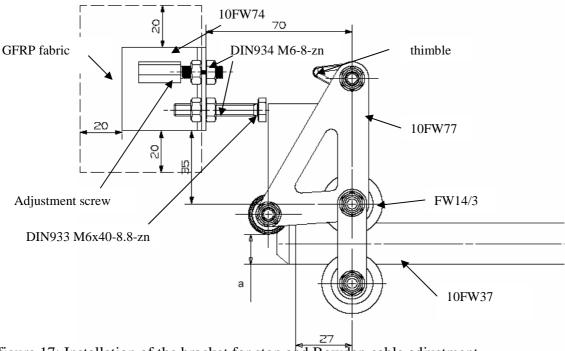
13. Fix the bracket 10FW74 (for stop bolt and Bowden cable) to the left fuselage wall according to figure 17. To accomplish this roughen the gluing areas (fuselage and both sides of 10FW74. Mix resin L285 with hardener H286 and thicken with cotton flocks. Apply the mix to the gluing surface of 10FW74. Mix UHU Plus and thicken with cotton flocks. Position 10FW74 at the fuselage wall and apply the UHU Plus mix to the 4 edges of 10FW74. Hold 10FW74 until the UHU Plus has cured. Then fix 10FW74 with 2 layers of glasfibre fabric 92125 ±45° and resin / hardener mix L285 / H286. Let cure over night at room temperature. Then postcure for min. 18 hours at 54°C.

figure 17: Installation of the bracket for stop and Bowden cable adjustment

- 1. Install stop bolt DIN933 M6x40 to 10FW74. Adjust the stop (see figure 17) so that dimension a will be between 14.5 and 15.5 mm.
- 2. Extend the landing gear completely.

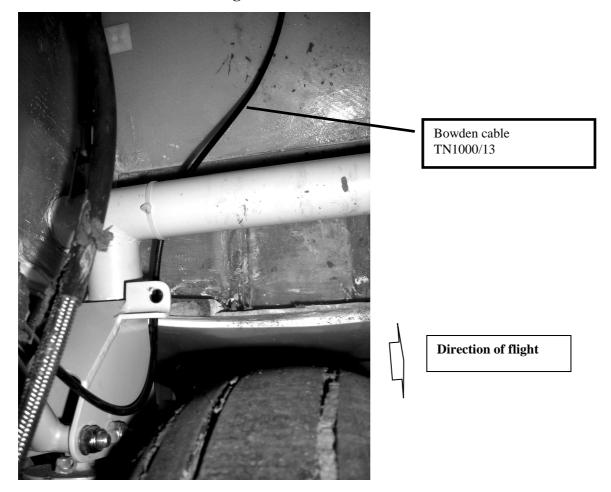
figure 18: LG extended, rubber buffer not installed

- 16. Adjust the over centre lock in the retracted position according to MM section 1.6.1.2 b).
- 17. Reinstall and adjust the rubber buffer according to MM section 1.6.1.2 a) but adjust to 2 2.5 mm instead of the value 4 5 mm.
- 18. Slide a 5 mm bowden cable outer over the bowden cable. Length 2800 mm DG-1000T resp. 2860 mm DG-1000S.
- 19. Route the Bowden cable outer inside the landing gear box according to installation plan 10EP15 and push it through the foam rubber in the rear lower end of the landing gear box parallel to the wheel brake hose (see figure 18)

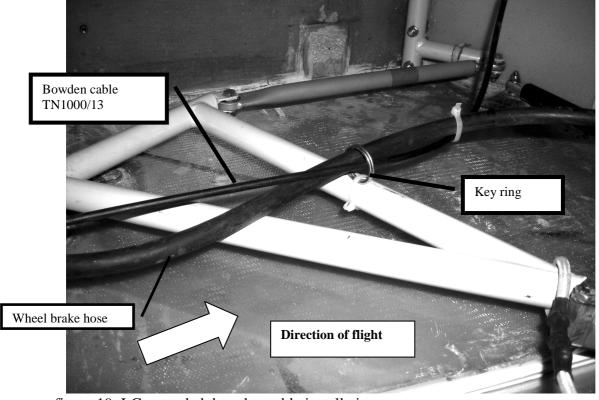
figure 19: LG extended, bowden cable installation

- Secure the Bowden outer inside the landing gear box with a Ty-Rap to the wheel brake hose according to installation plan 5EP15. (see also figure 18 20)

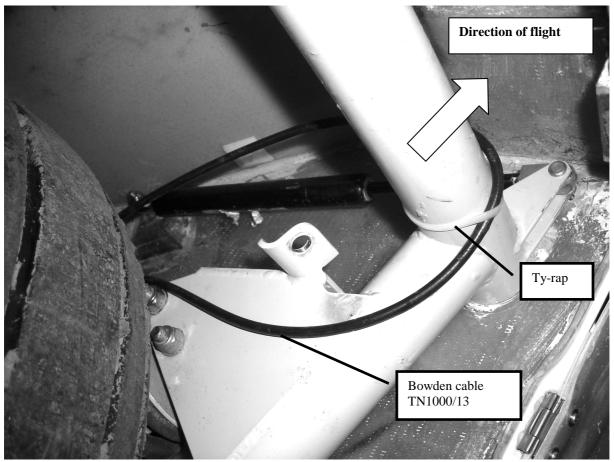
figure 20: Landing gear in the retracted position
