Working instruction for supplemental securing of the connection between the spindle drive “Stross BSA10” and the spindle drive motor on the DG-500MB.

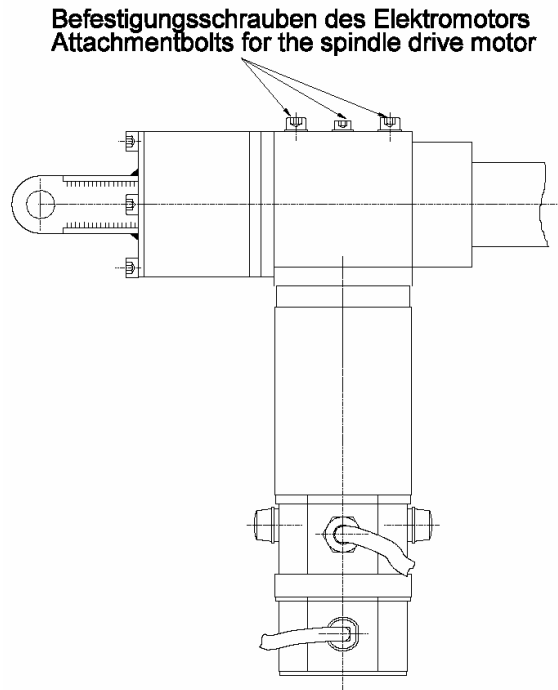
1. Remove the spindle drive from the aircraft.
2. Remove the motor attachment bolts at the gear housing with an Allen key wrench size 3mm (see drawing).

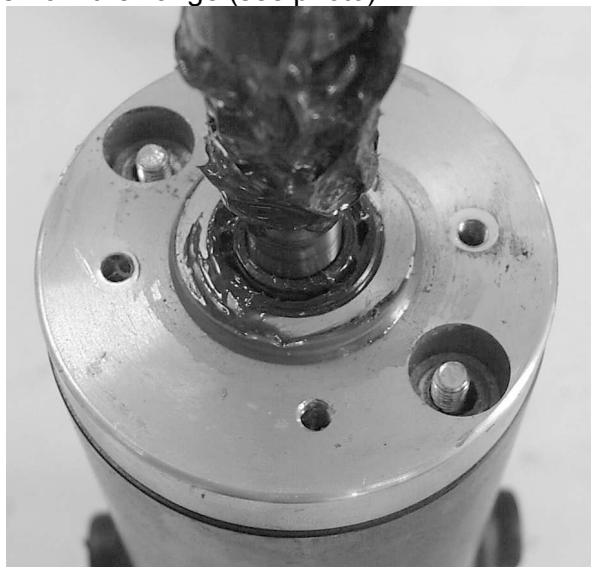
Picture 1: Silicone already removed

3. After removal of the motor, two countersunk nuts, cast in silicone, become visible on the flange. In most cases the nuts are only tightened during production, but not secured by additional measures. Remove the silicone around the nuts and remove the nuts with a 7mm socket wrench. Remove any sealing compounds and contaminations from the flange (see photo).

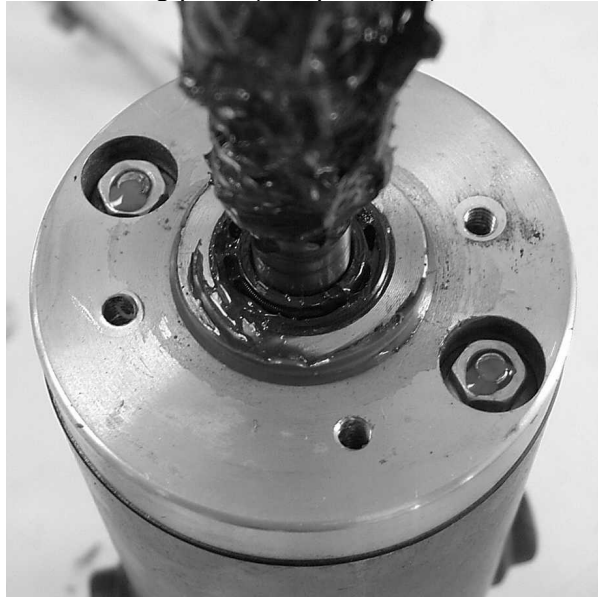
Picture 2

4. If there are any remains of old Loctite on the threads, they should be removed. Reassemble the original nuts, secure with Loctite 243 (torque to 2.5 Nm (1,9 ft lb)) and mark with red securing paint (see picture 2).

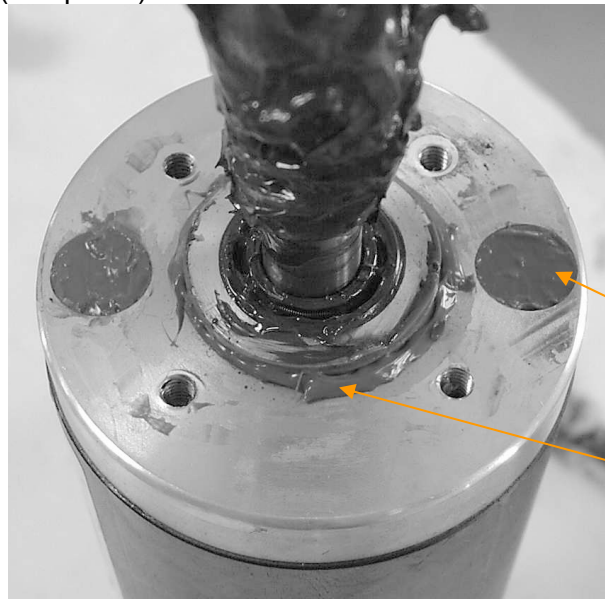
Picture 3

5. Fill the remaining cross section with acetic acid free silicone (for example Dow Corning 736) (see photo).

Aufgefüllte Bohrung
Filled blind hole

Dünne Dichtraupe
Thin silicone sealing

6. Apply a thin (!) rim of silicone sealing around the collar of the flange, to prevent the outflow of grease during operation (see photo 3)
7. Install the motor to the gear housing with the original Allen key bolts, secure the bolts with Loctite 243 (torque to 2.5 Nm (1,9 ft lb)) and mark with red securing paint.
8. Install the spindle drive to the aircraft.
