- Subject** : PU fuel hoses, limitation of life-time, replacement by new types of fuel hoses
- Effectivity** type: LS8, LS10
variants: LS8-t, LS10-st
- Accomplishment** : Instructions 1, 2 and 7 up to 30 April 2018 but prior to the next annual inspection.
Instructions 3, 4, 5 and 6 when replacing the fuel hoses, latest when the fuel hoses have reached a service time of 6 years, respectively with the interim regulation latest end of 2018.

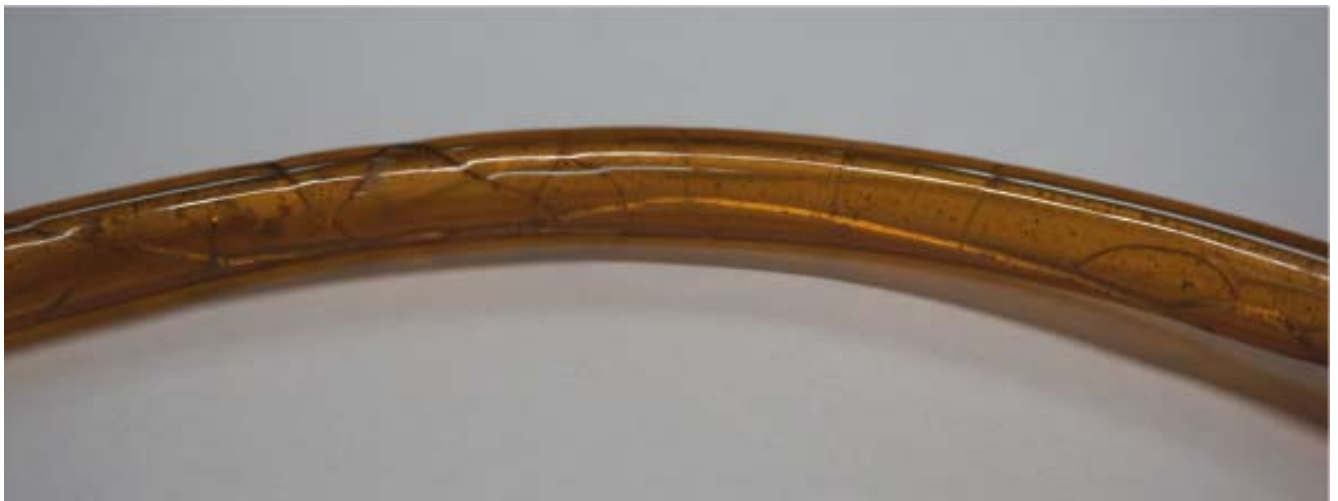
Photo for instruction 3

- Reason** : 1. The PU fuel hoses used so far in the LS8-t and LS10-st had no life-time limitation.
During maintenance work on a 10 years old DG-808C a broken hose was found. In addition the look of the hoses had changed.
Therefore the life-time of the PU fuel hoses will be limited to 6 years.

PU hose with crack lines starting at the inside of the hose

2. Interim regulation for PU fuel hoses having already a service-time of more than 6 years: Check the fuel hoses for damage and changed look see the photo on page 3. To enable the inspection you have to remove baggage compartment floors and rear wall.
To check the hoses with metal shield it is sufficient to perform a random examination: Open the hose clamp at the connection of the fuel supply line (red), coming from the fuselage, to the mechanical fuel pump (see diagram 2 resp. 2a LS8-t and 22 resp. 23 LS10-st) and slide the shield downwards by approx. 10 cm. To accomplish this you have to remove the red heat shrink tubing. After the inspection slide down the shield again and fix the hose clamp. It is not necessary to replace the heat shrink tubing.
If a failure is found all fuel hoses must be replaced immediately, otherwise the replacement must be done latest end of 2018.

3. Replace all fuel hoses in the fuselage by fuel hoses DIN 73379-2A and fire resistant fuel hoses ISO 7840-A1 in the engine area according to the fuel system diagrams issued with this TN.
Notes: Fuel hoses supplied by DG which are marked "COH-Line 2134" correspond to DIN 73379-2A.
 Any springs which may have been installed to prevent kinking of the hoses are no more necessary.
 The pipe clamp which fixes the impulse line and the supply line to the engine must be exchanged by a large pipe clamp size 18-15
 To exchange the impulse line at the crank case it is necessary to remove the carburetors according to working instruction No. 1 for TN8026.
