Subject : Landing gear lock

Effectivity : DG-1000S and DG-1000T up to ser. no. 10-79 (standard from 10-80 on)

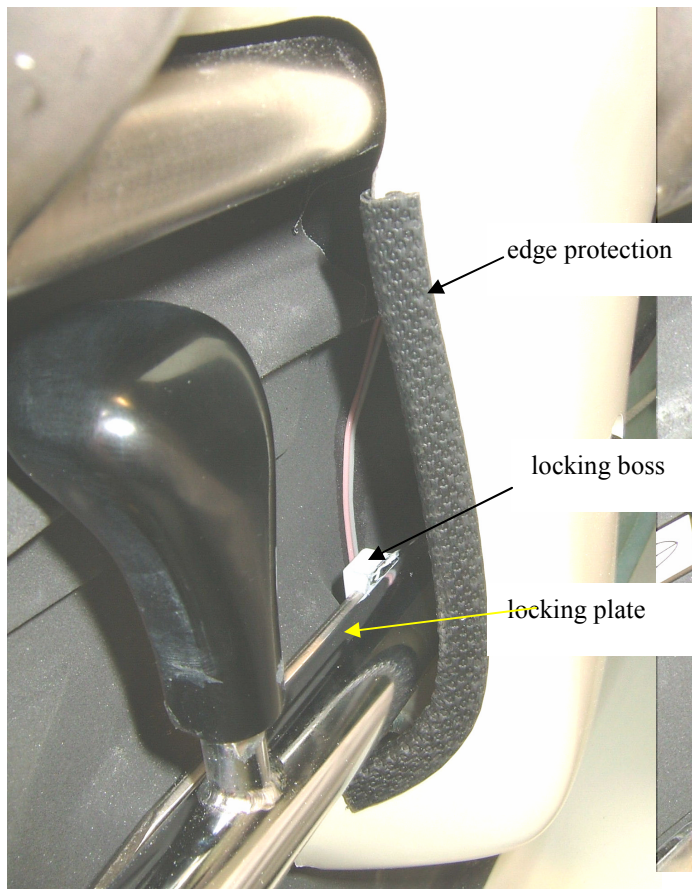
Reason : 1. To enable the instructor to visually check the correct locking of the landing gear in extended position the left side cover in the rear cockpit shall be modified.
2. It happened on one DG-1000 that the over centre lock of the landing gear unlocked and the landing gear extended during trailer transport.

Instructions : 1. Remove the left side cover from the rear cockpit and enlarge the opening in the front wall according to photo 1. Smoothen the edge and apply an edge protection. Paint the locking boss at the control rod with suitable white paint. Photo 1 shows the locked position. On photo 2 the landing gear is extended but not locked.
2. If the landing gear unlocks during trailer transport on your DG-1000 you may increase the locking force by gluing a 3mm thick piece of felt to the stop block in the left upper edge of the landing gear box, see sketch 3. After installation of the felt check if the landing gear can still be extended and retracted and locked from the front seat.
If you have to retract the landing gear from outside the cockpit always do it from the rear cockpit as the operating loads are smaller than from the front cockpit.

Material : edge protection 125 mm long
felt self-adhesive 3mm x 20mm x 20mm
