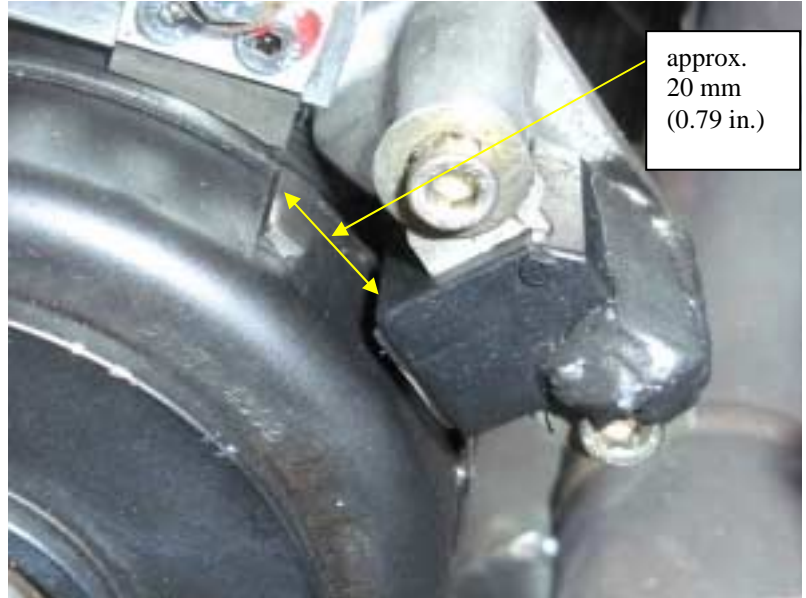
If during engine retraction the propeller can't be stopped in the vertical position, the relation between propeller and motor must be checked. With the propeller vertical, there should be an approx. 20mm distance (as in the picture to the right). See also: Maintenance Manual DG-800B, DG-808C and DG-500MB section 1.11.4

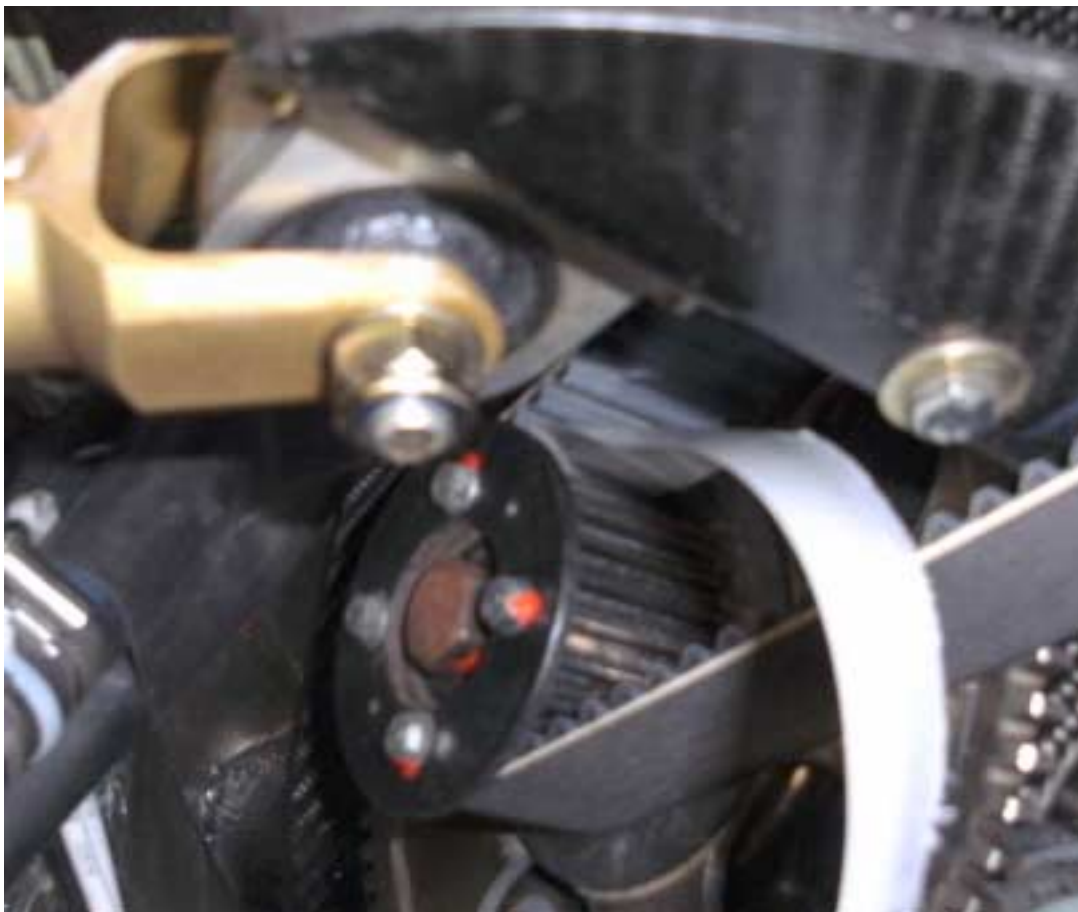
If the drive belt jumped, the problem may be easily corrected with an approx. 30mm wide by 100mm long piece of Mylar tape.

If the distance is less than 20mm, for instance 0mm, the piece of Mylar tape must be inserted as shown in the photo below and run between the bottom pulley and drive belt by turning the propeller. The propeller must be turned until the tape fully emerges from the other side.

If the distance is much larger than 20mm, the piece of Mylar tape should be placed on the other side.

Repeat the procedure as necessary until the correct distance is reached.
