Subject: Airbrake torque tube in the fuselage, airbrakes in the wings

Effectivity: All types and serial numbers: DG-100, DG-200, DG-400

Inspection and reinforcement of the airbrake torque tube (DG-100, DG-200, DG-400)

Inspection and repair of the airbrakes (DG-100, DG-200, DG-400)

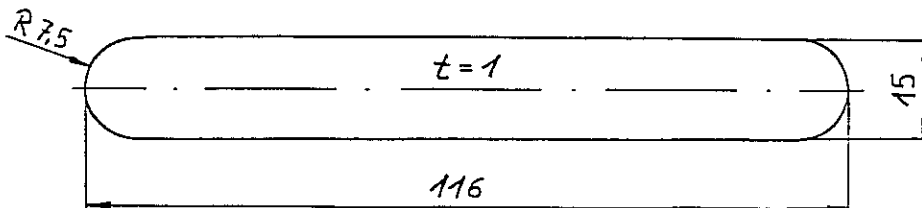
Thickness: 1mm

Material: 1.7734.4

If necessary the welded joint of torque tube and operating lever must be reinforced by welding an additional steel sheet 1-St-12/2 made of material 1.7734.4 (s. sketch). Visible cracks or other defects of the original joint must be repaired first. All welding must be done with the TIG-welding system (tungsten inert gas) using welding wire 1.7734.2. Where welding is to be done cadmium plating or painting must be removed first by sandblasting.
