REPAIR MANUAL
FOR SAILPLANES AND MOTORGLIDERS

DG-1000

TYPE: DG-1000
VARIANT: DG-1000S
DG-1000T
DG-1000M

Repair manual DG-1000

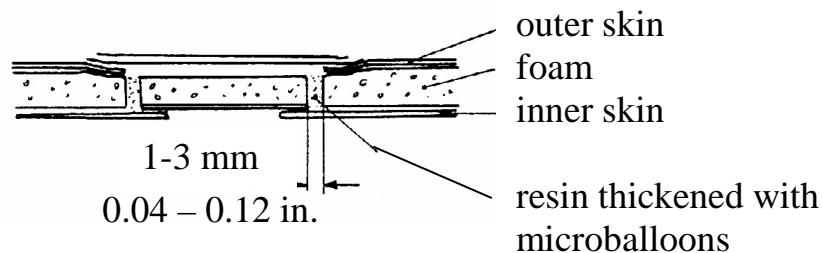
For lay up of the fabric to the foam, a layer of microballoons-resin should be applied first to eliminate the formation of airbubbles.

Apply the outer layers as in section 5.3.
