Service Information No. 116-25

- Subject : Propeller adapter with rubber damper element
- Effectivity type: DG-1000
variants: DG-1000T, all S/N.
- Accomplishment : Before next engine use.

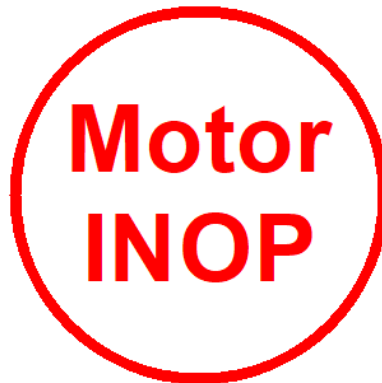
- c. On the upper end of the refueling connector in the engine bay.
 - d. Covering the starter button of the throttle lever in the front cockpit.
 - e. On the front side of the throttle lever in the rear cockpit, if installed per TN1000/15.

Placard as per instruction 2.c. (Ø 24 mm)
