Maintenance Manual DG-200

1.13 Free play in Control Systems

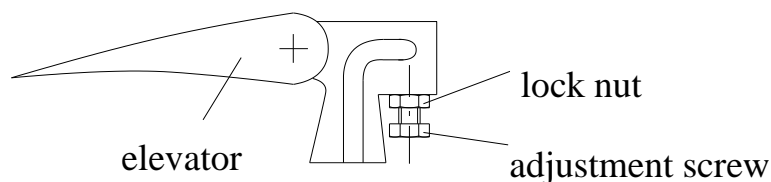
In case the roller has too much free play on the rod end or if the roller is no more round you must replace the roller by a new one 2L24.

In case the glider was operated for a longer time with the adjustment screw turned in too far the rod end must be replaced by a new one 2L19/1.

Within the automatic elevator connection there should be no free play noticeable in the zero position when the elevator is moved at its trailing edge.

Warning: In case the adjustment screw was turned in too far, the roller will jam inside the funnel and can't be moved or only with larger force to the front of the funnel. Moving the horizontal tailplane backwards for rigging might not be possible or only with large effort. Each time a bending force will act on the rod end which might lead to failure of the rod end with time.

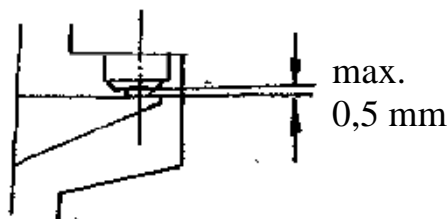
Rudder free play:

The maximum allowable vertical play in the rudder hinges is 0,5 mm measured at the top hinge.

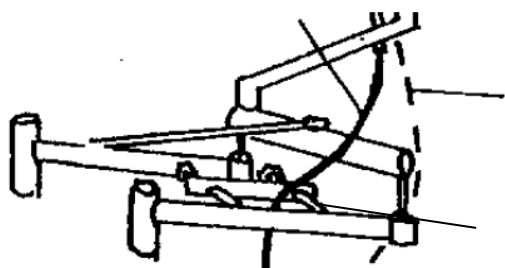
In case of replacement it is of importance that the cable should be placed between the two parallelogram arms of the control column (see drawing).

Placement of the cable outside the parallelogram might lead to blocking of the control mechanism.

1.14 Repair of the bowden cable in the parallelogram stick mechanism
