Maintenance Manual DG-300

1.2 Elevator deflections and adjustment

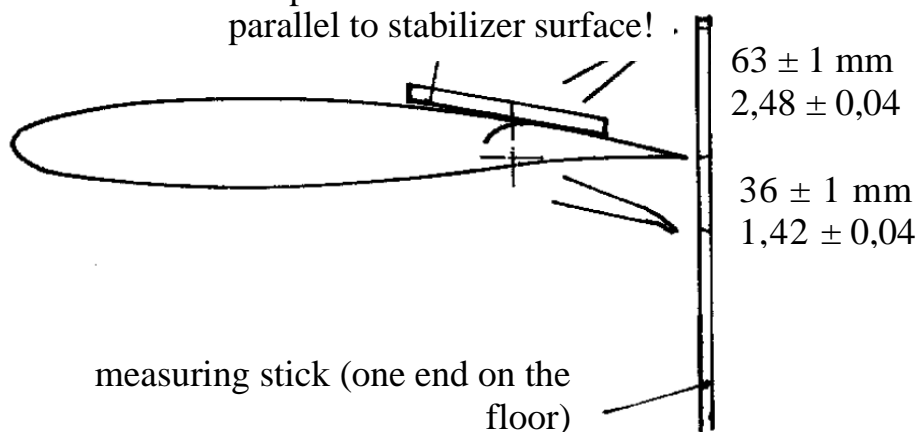
measured 150 mm (5,9 inch) from hinge axis.

The adjustment is made at the base of the control column. To measure the displacement lay a straight edge over the elevator and trailing surface of the stabilizer (which is flat in this area). The straight edge must lie parallel to the stabilizer surface. Holding a measuring stick with one end on the floor mark the 0 point on the stick. Then measure the up and down displacements from this zero point.

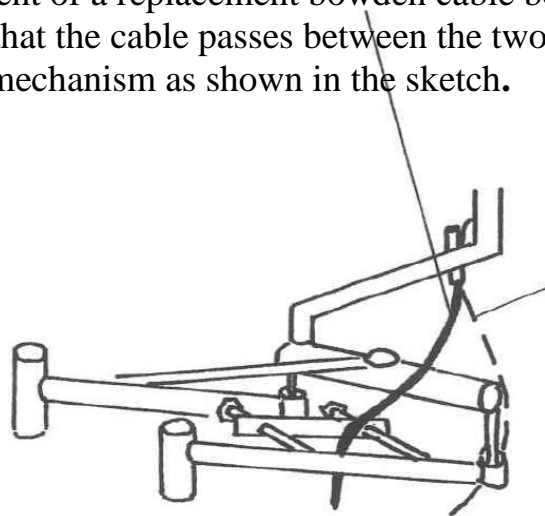
In the event of a replacement bowden cable being installed, it should be ensured that the cable passes between the two parallel arms of the control column mechanism as shown in the sketch.

Note: if the cable passes outside the mechanism control column movement could be blocked
